### DDASAccident127

# DDAS Accident Report

<b>Report date:</b> 15/05/2006	<b>Accident number:</b> 127
<b>Accident time:</b> not recorded	<b>Accident Date:</b> 19/03/1998
<b>Where it occurred:</b> Shoorandam Village, Daman District, Kandahar Province	<b>Country:</b> Afghanistan
<b>Primary cause:</b> Field control inadequacy (?)	<b>Secondary cause:</b> Inadequate training (?)
<b>Class:</b> Excavation accident	<b>Date of main report:</b> [No date recorded]
<b>ID original source:</b> none	<b>Name of source:</b> MAPA/UNOCHA
<b>Organisation:</b> Name removed	
<b>Mine/device:</b> PMN AP blast	<b>Ground condition:</b> hard
<b>Date record created:</b> 13/02/2004	<b>Date last modified:</b> 13/02/2004
<b>No of victims:</b> 1	<b>No of documents:</b> 1

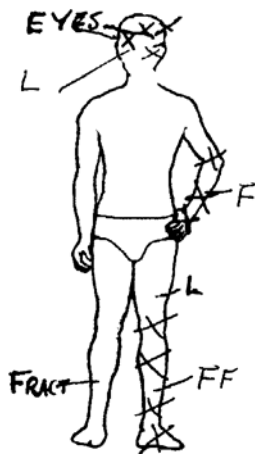
The initial field report recorded the injuries as, "injury of both eyes, multiple injuries on face; left shoulder anterior wounds; fracture of both bones, left leg; fracture of both bones, left forearm; superficial wounds on right thigh and leg". A sketch made by the field medic shows left arm, hand and leg injury, and face and eye damage.

The injuries indicate that the victim was stepping on the shovel when the initiation occurred, so allowing the energy to transfer to his leg and arm with bone breaking force. His eye and face injuries confirm that he was not wearing his visor. This was not noted by the investigators.
