### DDASaccident370

# DDAS Accident Report

REPORT FOR ACCIDENT INVESTIGATION BOARD OF INQUIRY – No 015/2001

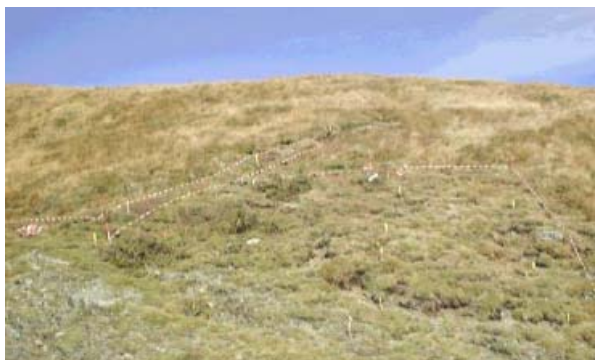
8) It is a possible that the angle of the prodder when the Victim was investigating the detector reading was not at 30 degrees. Given that he was prodding up hill into a slope in the kneeling position meant that the angle of his prodder to the ground would have more likely been at an angle greater than 30 degrees and probably nearer 90 degrees. Another possibility is that mine may have been face onto him and therefore detonated when he prodded into it.

9) An on scene investigation of the accident site revealed that the inside the Victim's protective visor was covered in dust and dirt from the blast. The outside of his visor was clean and did not have any such evidence. This obviously indicates that the blast from the explosion was directed up under the visor and into the eyes. In order for this to occur, the visor could not have been worn correctly coupled with the fact he was in the kneeling position and above the blast. If the Victim was in the prone position whilst prodding, the angle of the prodder would tend to be more naturally at the correct angle. If there did happen to be an

The picture above shows the accident site on a hillside.

The Demining group amend their SOPs to state that when conducting prodding on a slope, all deminers must carry this out in the prone position, and ensure that the angle of the prodder remains at 30 degrees to the ground at all times.

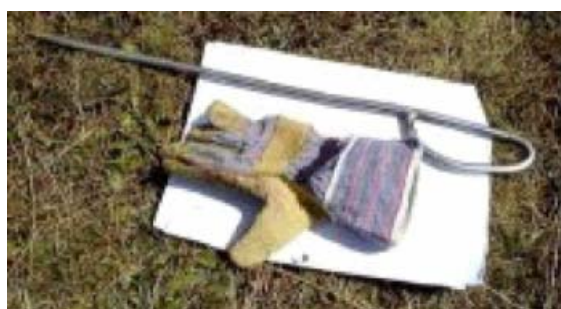
The picture below shows the victim's right glove and prodder.

There is no damage to the prodder or to the right glove. The Victim did not suffer any injuries to his hands.

22) The Victim was investigating a reading from his metal detector with his prodder at the time of detonation. There was no damage to either his detector or prodder.

The fact that the deminer’s prodding tool, glove and hand were not damaged in the blast imply that they were not directly over the mine as they would have been if he was prodding too steeply.
