DDASaccident503

DDAS Accident Report

AMAC HERAT INVESTIGATION ON MINE CLEARANCE ACCIDENT

AT 17th DIVISION-MF-0337, HERAT ON 15TH NOVEMBER 2006

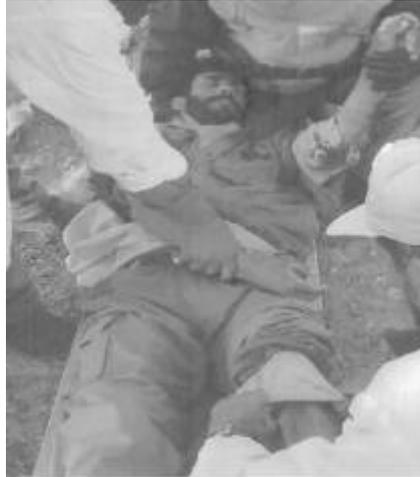
As a result of the explosion the deminer received minor injuries to his left hand and crush injuries to his left arm plus a single wound (1 to 1.5cm) to his left thigh where a foreign body penetrated the muscle. The [National demining agency] doctor indicated this object to be a small stone. These injuries indicate that his left hand was close to the point of detonation and he was facing sideways to allow the foreign object to pass under his protective vest. This is not consistent with proper use of the prodder but could be said to be consistent if sitting or kneeling sideways using a shovel in a sweeping motion?

Deminer's Injuries shown below.

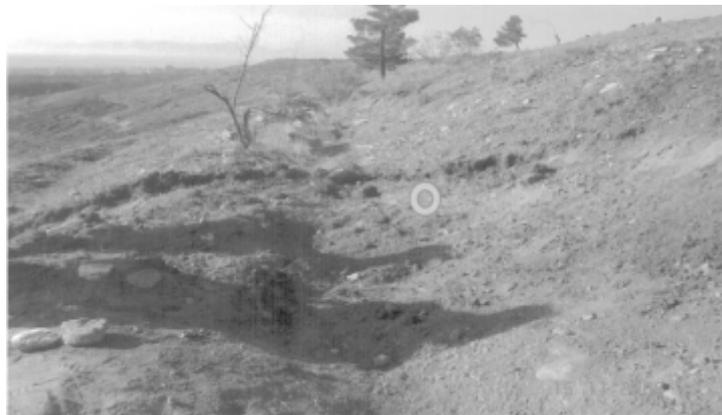
The site consists of a 35/40-degree slope with terraces cut into the slope at regular intervals. The accident occurred on the uphill side of one of the terraces very close to the flat ground of the terrace. The area shown in the photograph below is a known mine belt that stretched for many hundreds of metres in both directions into a small valley and extends around the other side of the valley as well.

The soil is soft and spongy from recent heavy rain and contains small rocks and stones. There is extensive evidence of erosion, which has helped to reshape the terraces with deposits from above. The investigating team believe the mine was buried deeper than normal because of accumulated soil.

This picture shows the accident site, the location of the detonation and the terrace.

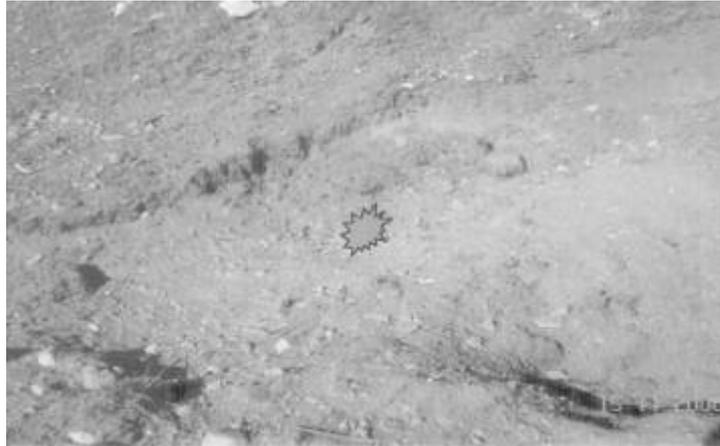
These photographs show the edge of the initial excavation of 130mm. [The point of initiation appears to be well inside the cleared area.] It is possible the deminer was using the shovel to speed up clearance and used it as a digging tool? Why he would do this is a mystery as all members of this team were experienced with this site and knew that mines had been found elsewhere at greater depths.

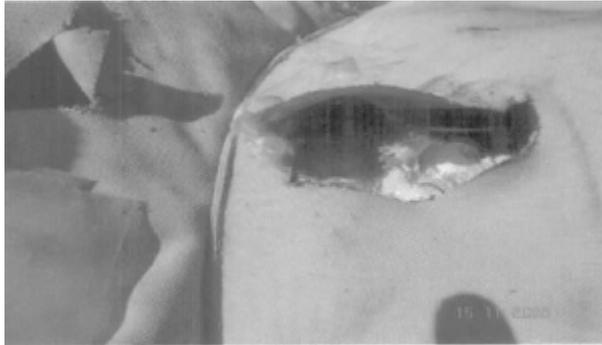
[The picture below shows damage to the body armour. This must have been struck by a sharp edge.]

The crush injury to the Victim's arm and the cut into his body armour were caused by a large object hitting both. The part that hit the armour was sharp. These facts lead to the conclusion that the Victim was using his shovel at the time, as was admitted in one of the statements.
