DDASaccident814

DDAS Accident Report

Report date: 08/04/2019	Accident number: 814
Accident time: 11:40	Accident Date: 25/09/2017
Where it occurred: Sarichashma MF-10, Shamsiddin Shohin district, TAB, Khatlon Province	Country: Tajikistan
Primary cause: Victim inattention (?)	Secondary cause: Field control inadequacy (?)
Class: Excavation accident	Date of main report: 29/09/2017
ID original source: MAR #1/17	Name of source: [Name removed]
Organisation: [Name removed]	Ground condition: hard; metal fragments; rocks/stones; steep slope
Mine/device: PFM-1 AP blast	Date last modified: 08/04/2019
Date record created:	No of documents: 2
No of victims: 1

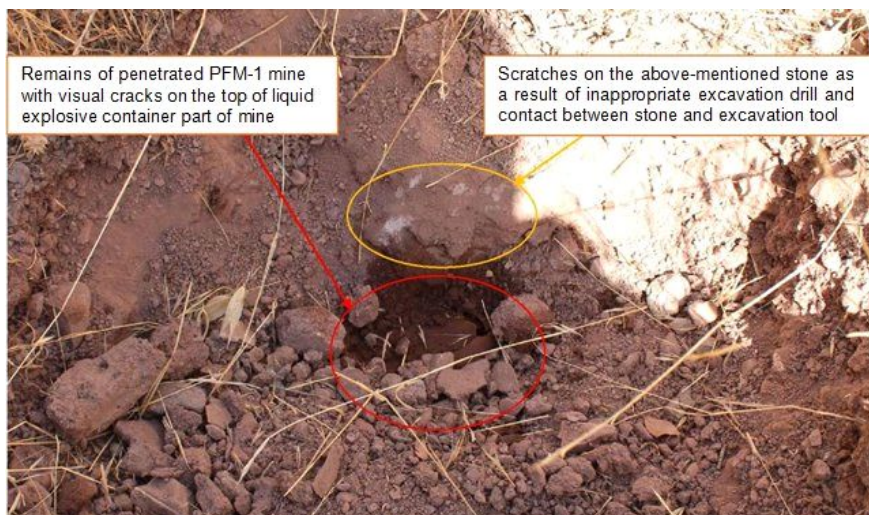
As detonation did not occur, there is no crater or other similar remaining signs of an accident. Remains of the PFM-1 mine are still at the accident location and approximately 30 cm from the base stick.

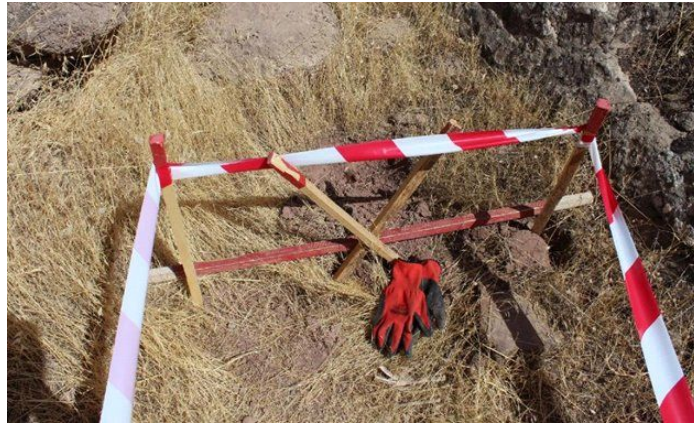
An additional fragment/ remnant of PFM-1 mine was found during the investigation above the penetrated mine, leading the board to believe that there was a fragment/ remnant of one PFM-1 found before the PFM-1 mine which caused the accident. It is assumed that the deminer may have believed that there is no risk as she had found just a fragment and therefore excavated less cautiously.

Her rubberised working gloves were found next to the base stick with stain signs of what could be the results of liquid explosive spraying onto them.

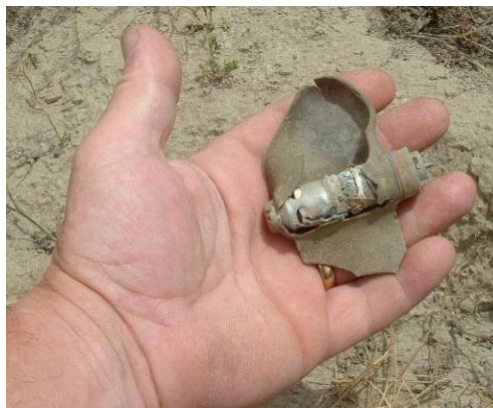
The accident raises questions over why a live PFM-1 did not detonate when pressure was applied to its flexible body. The PFM-1 mines were deployed from a helicopter, so were not intentionally buried. The weather (snow and rain) had washed them to a level ridge where they had subsequently become buried. The potential for the mines to have been gathered in close proximity or on top of each other was obvious. However, most PFM-1 mines that have been exposed to sunlight (UV) for a long period in Tajikistan have split and their volatile liquid explosive has been dissipated as shown below.

The casing of the mine involved in this accident was intact but may have been hardened by the sun before it became buried, so making it easier to accidentally break open without the case flexing and pushing the liquid explosive into the fuze and making it detonate.
