# DDASaccident819

Database of Demining Accidents  
*DDAS*

# DDAS Accident Report

<b>Report date:</b> 11/04/2019	<b>Accident number:</b> 819
<b>Accident time:</b> Not recorded	<b>Accident Date:</b> 20/01/2019
<b>Where it occurred:</b> MASAM compound, Marib City, Marib governate	<b>Country:</b> Yemen
<b>Primary cause:</b> Field control inadequacy (?)	<b>Secondary cause:</b> Inadequate training (?)
<b>Class:</b> Handling accident	<b>Date of main report:</b> 21/01/2019
<b>ID original source:</b>	<b>Name of source:</b> Press/social media
<b>Organisation:</b> [Name removed]	<b>Ground condition:</b> hard; residential/urban
<b>Mine/device:</b> AT (unrecorded)	<b>Date last modified:</b> 11/04/2019
<b>Date record created:</b>	<b>No of documents:</b> 1
<b>No of victims:</b> 5

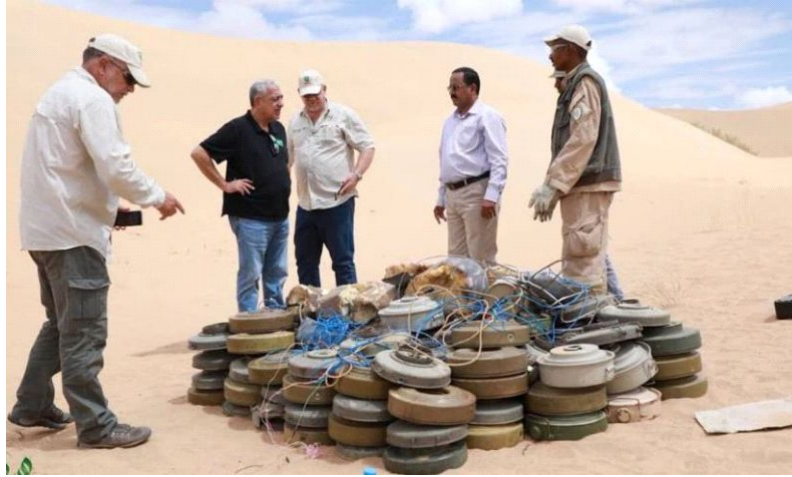
[This photograph apparently shows preparations for a previous demolition. Some mines shown may still be fuzed. The pile appears to have IEDs or IED components on top. No PPE is being worn.]

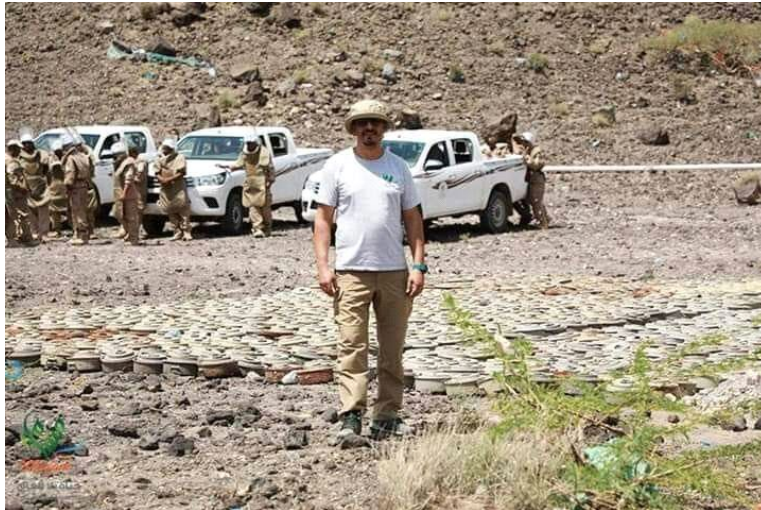
[This picture shows [Victim no.1] in front of hundreds of recovered AT mines, all of which would have been transported in the back of the pick-up trucks behind. As is common, the supervisor is proudly photographed not wearing any PPE.]

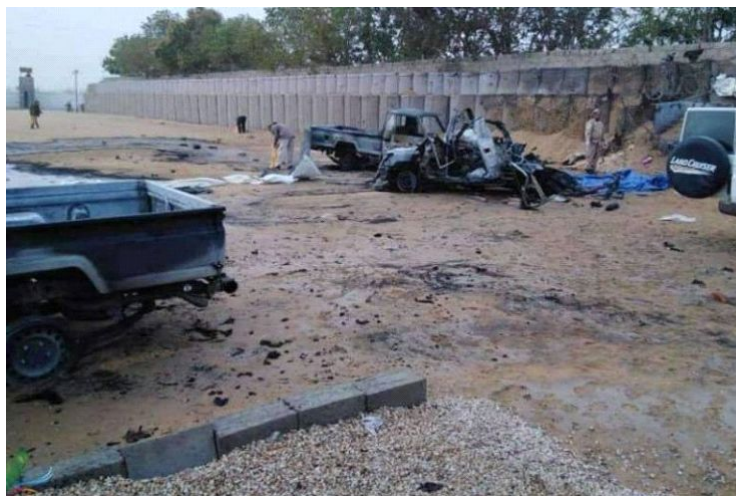
[This picture was taken after the pickup truck top centre has exploded. The blast damage indicates that it occurred in the back of the truck. Two other trucks are wrecked. People

anywhere close by would have been killed by the blast and fragmentation from the metal mine casings and the truck. The blue tarpaulin may conceal body parts.]

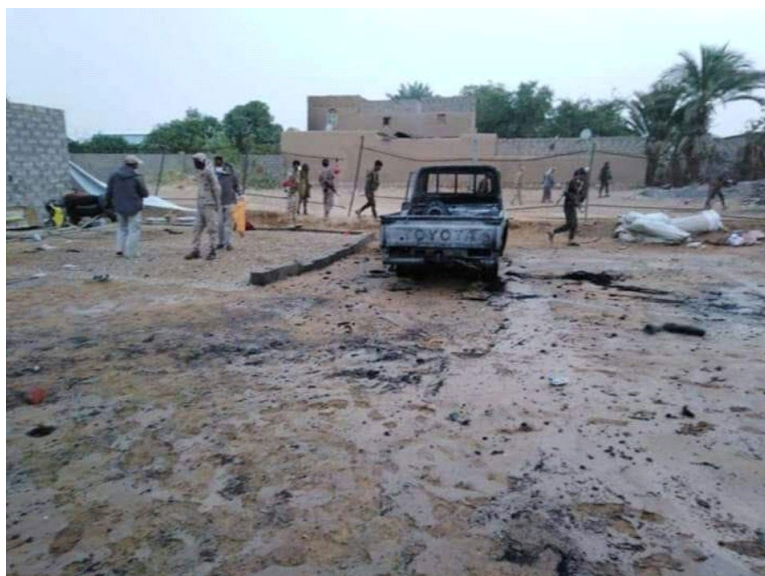
[Another view shows a third burned out pickup truck and seems to confirm that this happened inside a compound, not in transit.]

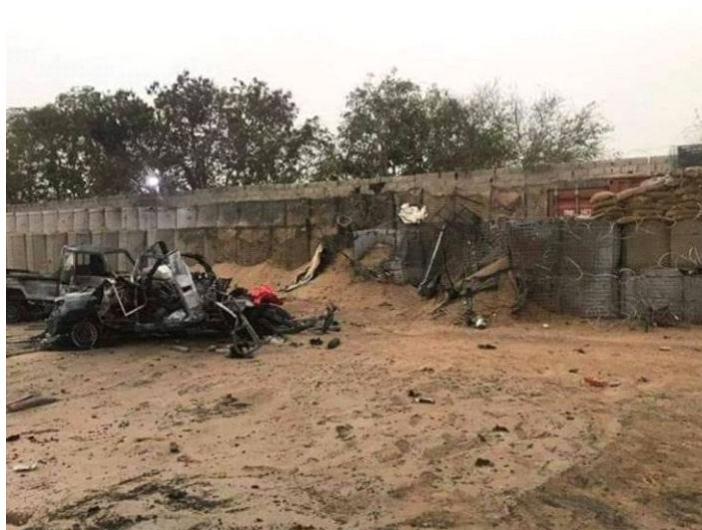
[The storage area for explosives may be behind the protected door on the right.]

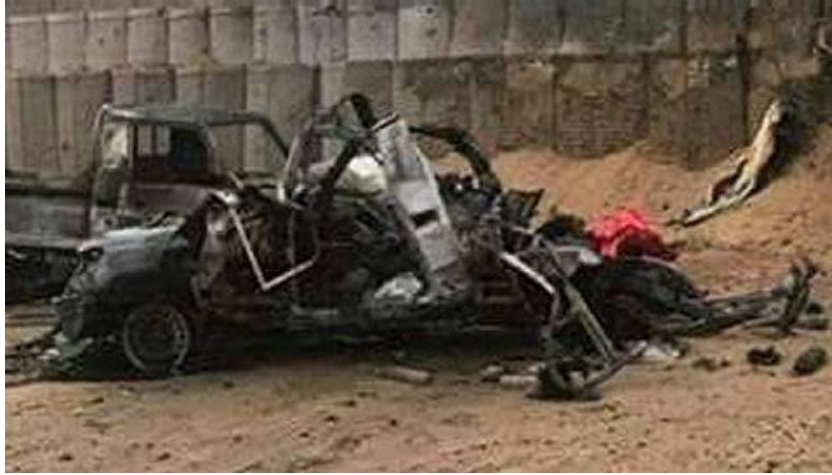
[A major detonation occurred in the back of this truck, destroying the second pickup truck close by. A third pickup truck some 25 metres away caught fire and burned out, which implies a very significant blast or may imply that other munitions, possibly including incendiary materials, were being transported along with the mines.]

The primary cause of this accident is listed as a 'Field control inadequacy' because the person in charge at the site had decided to move fuzed explosive hazards and did not enforce safety distances that would have reduced the casualty toll in the event of an accident.
