DDASaccident821

Database of Demining Accidents
DDAS

DDAS Accident Report

Anti-tank mine explosion kills two: Fri, 15 March 2019

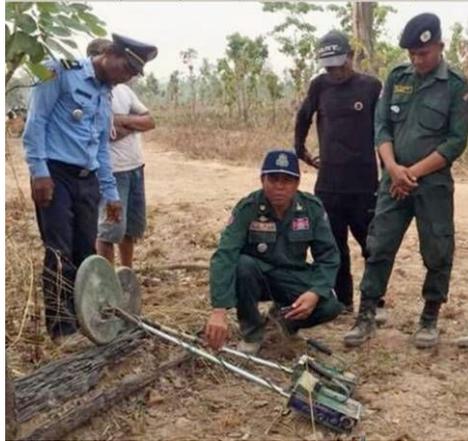
[Picture shows] Authorities pose next to a pair of mine detectors which were used by victims of a bomb explosion in Oddar Meanchey on Thursday.

The ‘Inadequate equipment’ listed under notes refers to the hoe being used as an excavation tool.

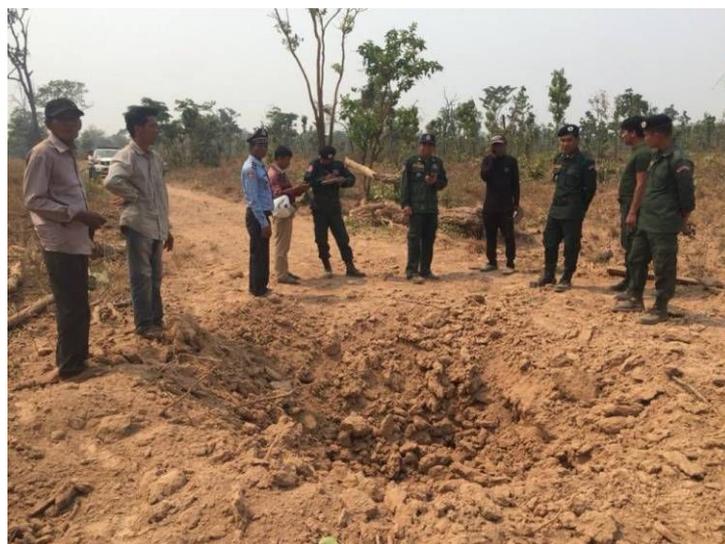
[The picture shows the crater which appears to be at the side of a dirt road.]

The use of a hoe to dig out a deep metal-detector signal implies that the explosive hazard was struck with great force by the tool. However, the hazard was not identified so it may have been something sensitive enough to be initiated without a great force. The crater is unusually deep and broad, so implying that the hazard may have been unusually large.
