DDASaccident823

DDAS Accident Report

Report date: 16/11/2019	Accident number: 823
Accident time: 10.05	Accident Date: 07/05/2014
Where it occurred: Ayta al Jabal village	Country: Lebanon
Primary cause: Unavoidable (?)	Secondary cause: Unavoidable (?)
Class: Excavation accident	Date of main report: 07/05/2014
ID original source: 05/2014	Name of source: LMAC
Organisation: [Name removed]	
Mine/device: BLU-63	Ground condition: agricultural (abandoned); hard; rocks/stones
Date record created:	Date last modified: 16/11/2019
No of victims: 1	No of documents: 2

The Board of Investigation report records that this was a BAC accident involving an “uncontrolled detonation” of a submunition. It was investigated at Ayta el Jabel on 7th May 2014 by the Chief of QA from the Regional Mine Action Centre (N).

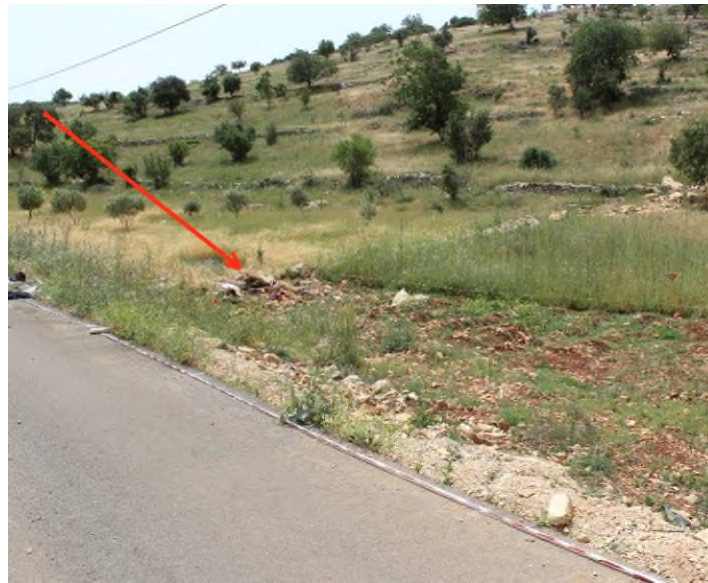
The area of the accident was in the lane of the searcher [the Victim].

[The arrow shows where the accident occurred.]

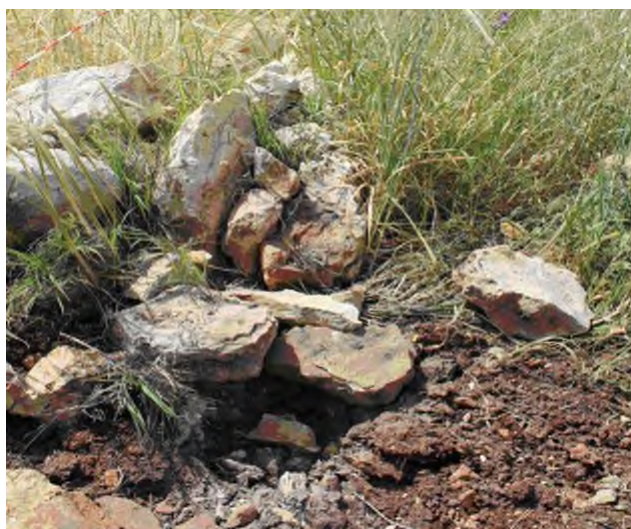
Crater: The crater diameter was about 30 cm with 20 cm depth.

[The crater is in front of the rocks with a broken rock lying in it.]

- b. The fingers amputation proves that the item was stuck on the bottom of the stone and while the searcher was removing the stone, suddenly the item fell and hit the ground and detonated.

- a. Two days refresher training to be conducted for all [International demining NGO] BAC teams and to focus on following the correct procedures whilst conducting clearance in rocky areas.
- b. Closer supervision from all levels to ensure there is strict adherence to [International demining NGO] SOP especially on rocking areas.
- c. Any searcher should be careful and cautious in moving stones,.
- d. In such situation, stones to be remotely moved.

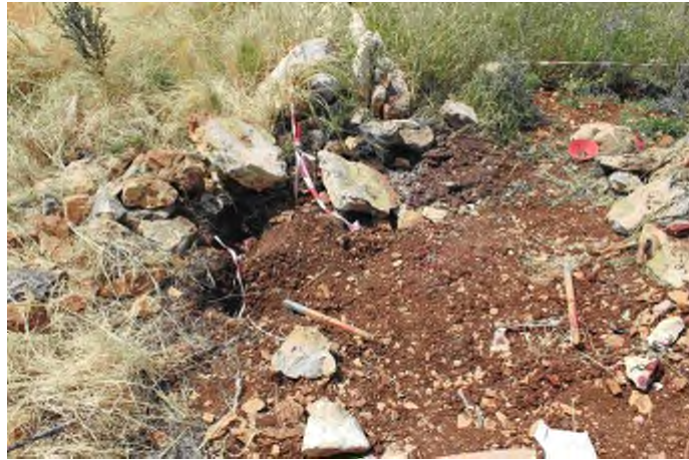
Marking in general on the task was in accordance with [International demining NGO] Lebanon SOPs and NMAS, marked except for the base stick that was found at 1.5 meters backward from where the searcher was on his access lane due to the blast of the explosion.

[Picture shows the position of the broken base stick.]

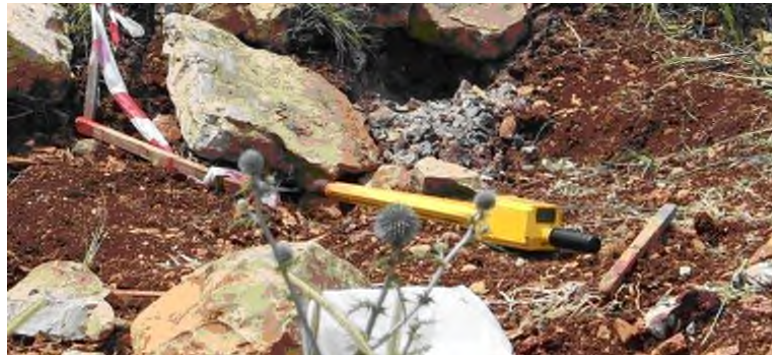
The schonstedt locator was located behind the searcher and no damage happened to the locator.

[The pristine appearance of the locator (compared to the base-stick) may imply that it was not in this position when the accident occurred.]

- d. It's unknown if the Schonstedt has detected the submunition under the stone.
- e. The supervisor was away 15 meters from the searcher and this distance is in accordance with [International demining NGO] SOP as for the safety distance between the supervisory person and the searcher, which should be a minimum of 5 meters.

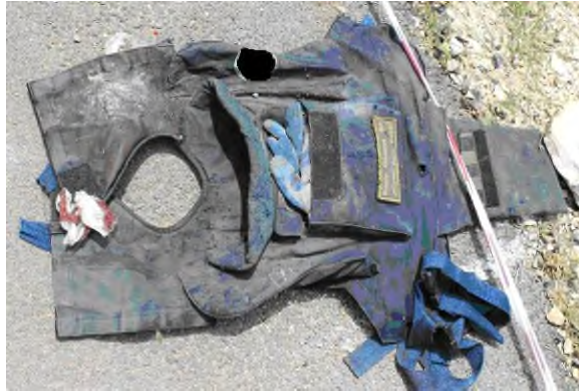
As for the [Victim's] body armor, there was many small holes from the outside but no fragmentations broke through in it and it was covered by blood in the top part.

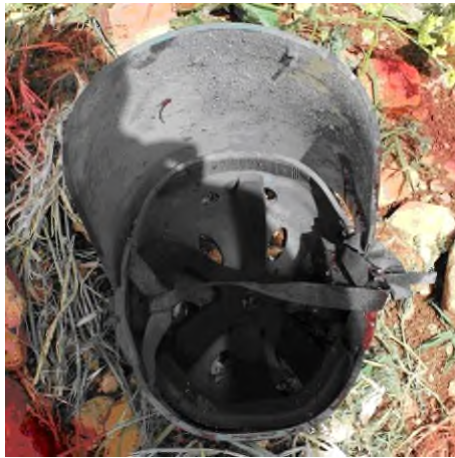
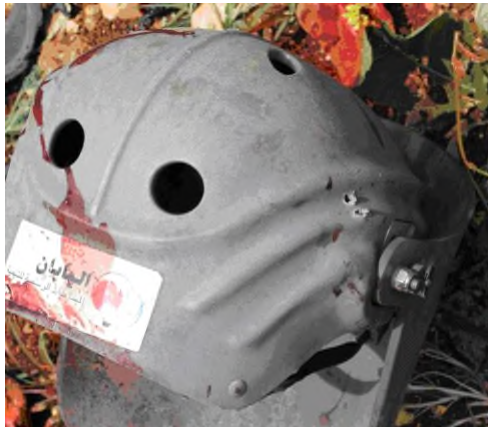
Concerning the visor, it is obvious from the holes that the fragmentations has been penetrated from the outside layer through the visor to his face until his brain .

[The picture shows exit holes on the side of the helmet.]

- c. Some fragmentations penetrated straight to the head and helmet through the visor which prove that those protective helmets do not provide adequate protection for the head.

The plastic helmet used with this visor is not sold as offering any ballistic protection, merely as a ventilated head-support for the visor, so it did not 'fail' to protect because it was never designed to do so. The 5mm polycarbonate visor has a NATO STANAG V50 rating of around 260 m/s and (when made without stresses) can provide very effective protection against blast and environmental fragmentation - but rather limited protection against metal fragmentation. The damaged face of the visor shows that it stopped the small environmental fragmentation. The body armour used gave protection against fragments flying at up to 450 m/s and was not compromised. For a visor to provide the same protection it would need to be more than 13mm thick, and that is usually considered to be too heavy for protracted wear.
