DDASaccident823

DDAS Accident Report

Report date: 16/11/2019	Accident number: 823
Accident time: 10.05	Accident Date: 07/05/2014
Where it occurred: Ayta al Jabal village	Country: Lebanon
Primary cause: Unavoidable (?)	Secondary cause: Unavoidable (?)
Class: Excavation accident	Date of main report: 07/05/2014
ID original source: 05/2014	Name of source: LMAC
Organisation: [Name removed]	
Mine/device: BLU-63	Ground condition: agricultural (abandoned); hard; rocks/stones
Date record created:	Date last modified: 16/11/2019
No of victims: 1	No of documents: 2

The Board of Investigation report records that this was a BAC accident involving an “uncontrolled detonation” of a submunition. It was investigated at Ayta el Jabel on 7th May 2014 by the Chief of QA from the Regional Mine Action Centre (N).

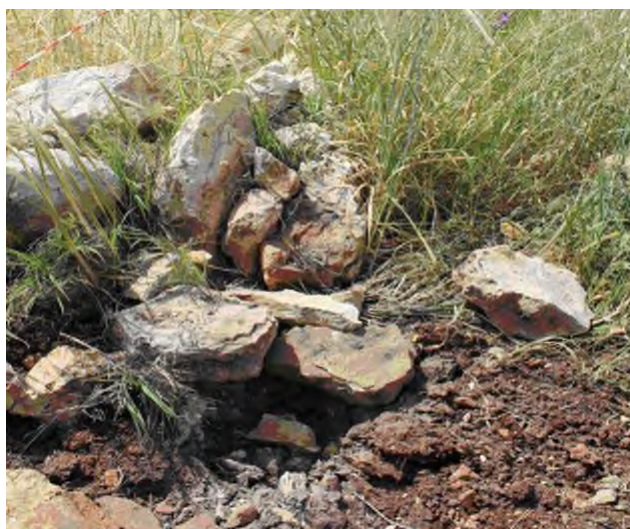
Crater: The crater diameter was about 30 cm with 20 cm depth.

[The crater is in front of the rocks with a broken rock lying in it.]

- b. The fingers amputation proves that the item was stuck on the bottom of the stone and while the searcher was removing the stone, suddenly the item fell and hit the ground and detonated.

- a. Two days refresher training to be conducted for all [International demining NGO] BAC teams and to focus on following the correct procedures whilst conducting clearance in rocky areas.
- b. Closer supervision from all levels to ensure there is strict adherence to [International demining NGO] SOP especially on rocking areas.
- c. Any searcher should be careful and cautious in moving stones,.
- d. In such situation, stones to be remotely moved.

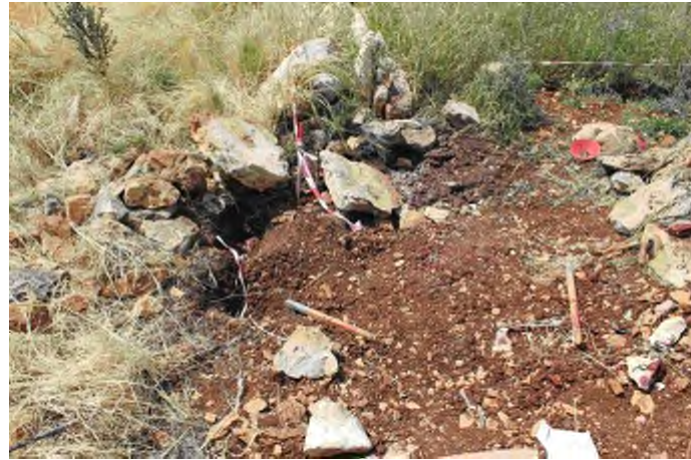
Marking in general on the task was in accordance with [International demining NGO] Lebanon SOPs and NMAS, marked except for the base stick that was found at 1.5 meters backward from where the searcher was on his access lane due to the blast of the explosion.

[Picture shows the position of the broken base stick.]

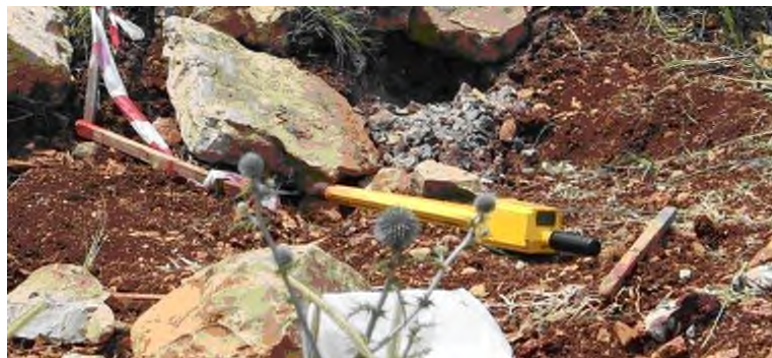
The schonstedt locator was located behind the searcher and no damage happened to the locator.

[The pristine appearance of the locator (compared to the base-stick) may imply that it was not in this position when the accident occurred.]

- d. It's unknown if the Schonstedt has detected the submunition under the stone.
- e. The supervisor was away 15 meters from the searcher and this distance is in accordance with [International demining NGO] SOP as for the safety distance between the supervisory person and the searcher, which should be a minimum of 5 meters.

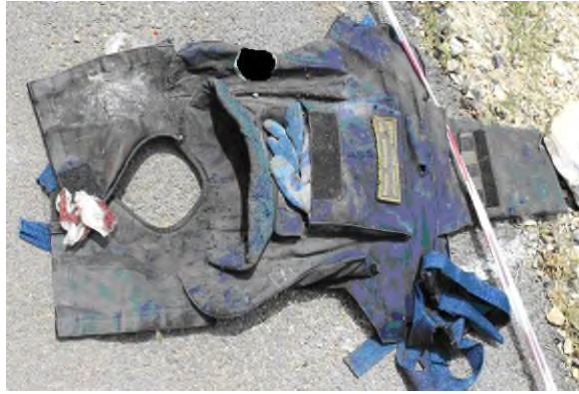
As for the [Victim's] body armor, there was many small holes from the outside but no fragmentations broke through in it and it was covered by blood in the top part.

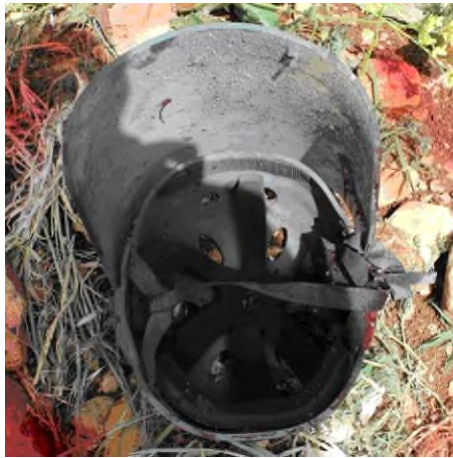
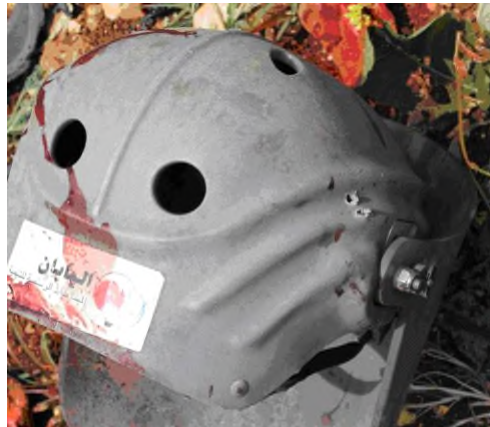
Concerning the visor, it is obvious from the holes that the fragmentations has been penetrated from the outside layer through the visor to his face until his brain .

[The picture shows exit holes on the side of the helmet.]

- c. Some fragmentations penetrated straight to the head and helmet through the visor which prove that those protective helmets do not provide adequate protection for the head.

The plastic helmet used with this visor is not sold as offering any ballistic protection, merely as a ventilated head-support for the visor, so it did not 'fail' to protect because it was never designed to do so. The 5mm polycarbonate visor has a NATO STANAG V50 rating of around 260 m/s and (when made without stresses) can provide very effective protection against blast and environmental fragmentation - but rather limited protection against metal fragmentation. The damaged face of the visor shows that it stopped the small environmental fragmentation. The body armour used gave protection against fragments flying at up to 450 m/s and was not compromised. For a visor to provide the same protection it would need to be more than 13mm thick, and that is usually considered to be too heavy for protracted wear.
