DDAS Accident Report

Report date: 07/12/2019	Accident number: 824
Accident time: 07:19	Accident Date: 01/07/2009
Where it occurred: Yohmor Village, Nabatiyeh District, South Lebanon	Country: Lebanon
Primary cause: Unavoidable (?)	Secondary cause: Unavoidable (?)
Class: Excavation accident	Date of main report: 01/07/2009
ID original source: 03/2009	Name of source: LMAC RMAC- Nabatiyah
Organisation: [Name removed]	
Mine/device: Submunition	Ground condition: agricultural (abandoned); hard; rocks/stones
Date record created:	Date last modified: 07/12/2019
No of victims: 1	No of documents: 1

BOARD OF INQUIRY (BOI) INVESTIGATION REPORT

Report Category: Accident: BAC, SUBMUNITION

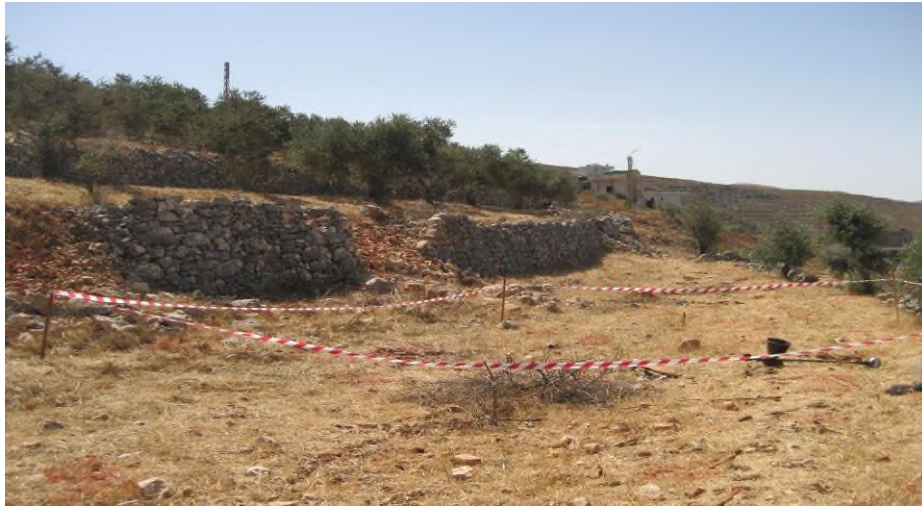
[The accident site.]

Crater: There is evidence of a crater around 35cm across and 10cm deep, and explosive residue caused by an explosive device.

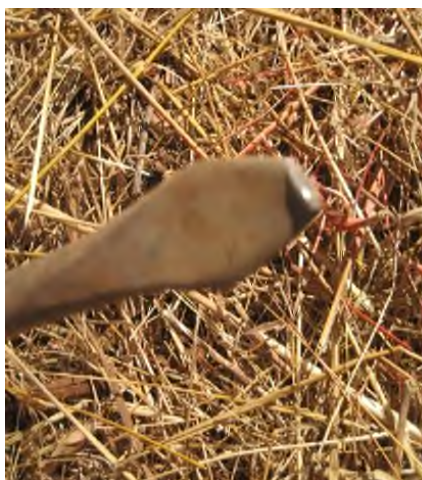
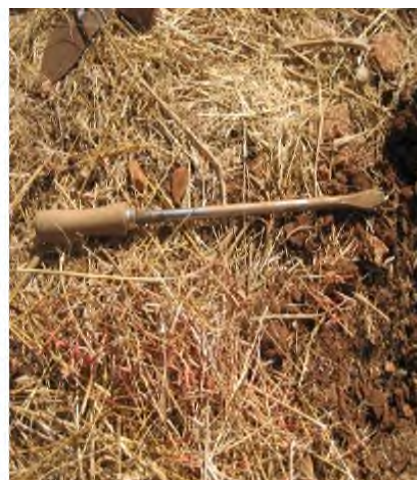
Demining Tools: Vegetation cutting / removal tools (shears), prodder and small shovel had been used during the subsurface BAC process. The prodder had a direct connection with the accident.

The inadequate equipment referenced in the Notes refers to the prodder, which appears to have been a wooden handled mild-steel screwdriver. These are not designed to be blast resistant or to serve as PPE (as recommended in the IMAS). They are also not a suitable tool to allow efficient and safe excavation of hazards. However, they had presumably been detailed in the organisation's SOPs which the MAC had approved for use at the time.

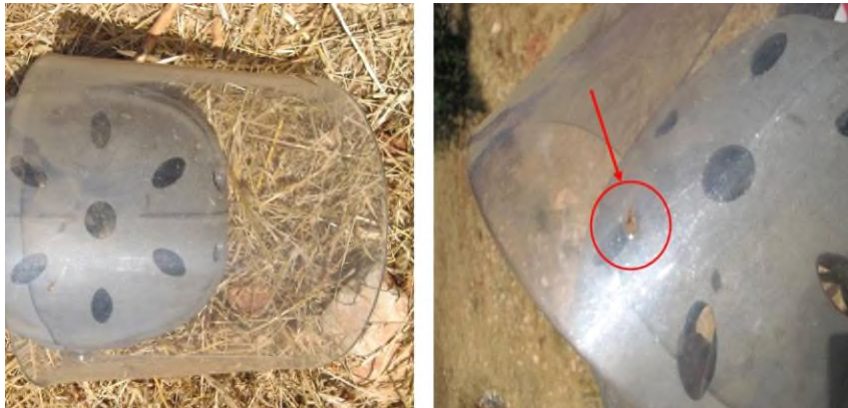
Ballistic Helmet / Visor: There is one partial penetration to the light-weight demining visor which can be attributed to the effects of an explosion and there's some minor scratches on the visor lens caused from dust and small rocks due to the explosion.

There is a common misconception that the expensive helmet and visor that was used offers 'ballistic' protection. The helmet to which the visor was attached is not 'ballistic' and is not designed to offer any significant protection in the event of an explosive accident. The 5mm polycarbonate visor is intended to offer significant protection against blast and some protection against fragmentation. The helmet merely holds the visor in place.

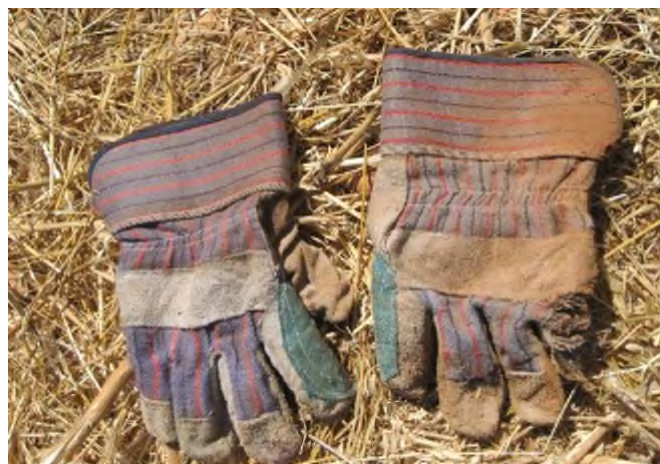
Casualty's Clothing: Damage to the left hand glove.
