# DDAS Accident Report

BOARD OF INQUIRY (BOI) INVESTIGATION REPORT, Ref No. 11/2016

On the 29th of November 2016 at [International demining organization] task NDO-235 S, an uncontrolled detonation of a GYATA 64 AP mine occurred while [International demining organization] MTT 1 deminer [the Victim] was working in his lane (11 minutes into his second shift) and led to an injury.

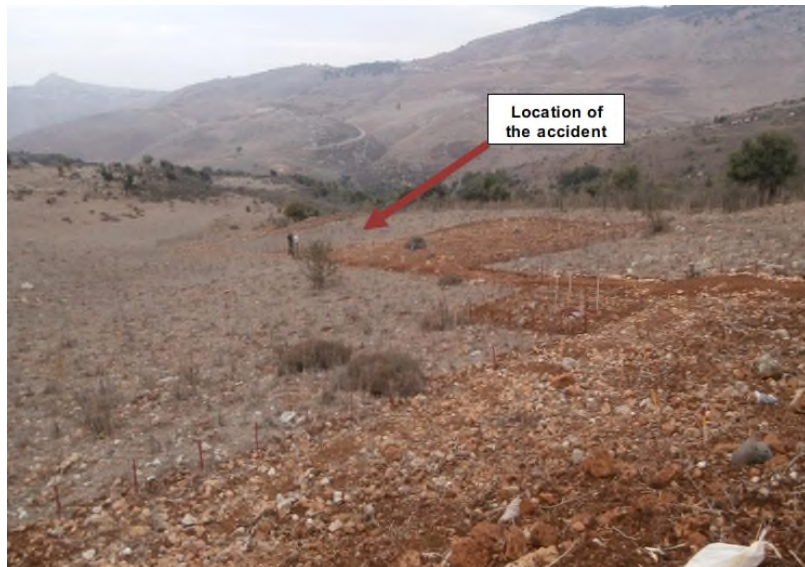
Location of the accident

The location of the accident was on the western side of NDO-235 S. The area consists of a low slope uphill terrain with few rocks and stones in the area. The land is not cultivated but sometimes used as grazing for goats.

The location of the accident was in the beginning of the lane being cleared by the deminer [the Victim] conducting manual full excavation technique.

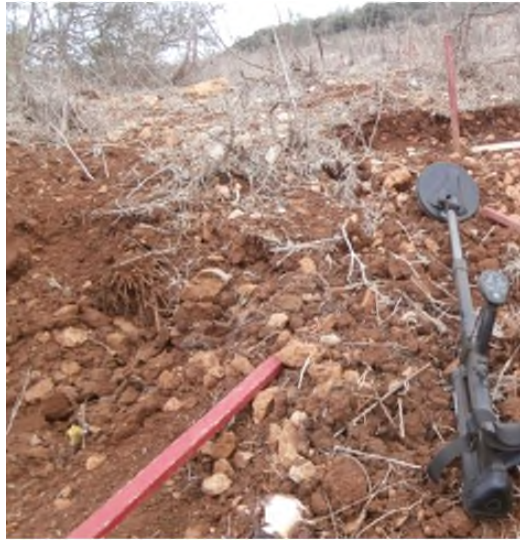
Marking in general on the task was in accordance with NMAS and [International demining organization] SOP, except for [the Victim]'s lane where it's obvious that the base stick was put

there right after the accident (the base stick is not broken, has no scratches even no dust from the explosion on it).

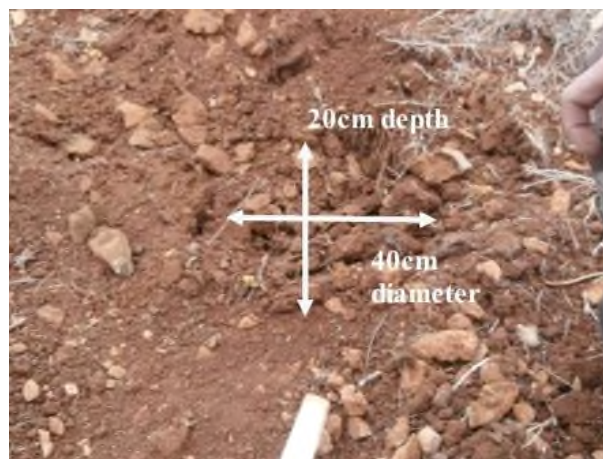
The crater [was] located just following the base stick and at the left side next to the detector. The crater created by the explosion is about 20 cm depth and 40 cm in diameter as shown.

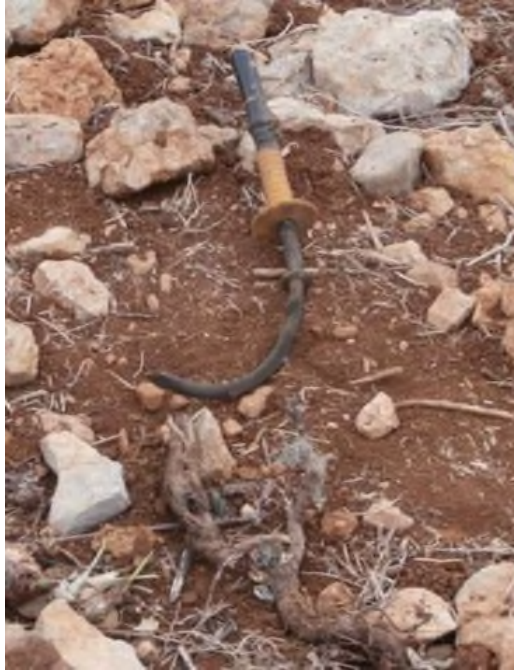
The excavating tool ( prodder) was found 12.5 m away from the explosion place.

The excavating tool (prod) which was found 12.5 m away from the explosion location was severely bent as shown.

The tool used for excavation was long and malleable and appears to have been made for the purpose, but it does not appear to be an ideal tool for area excavation or for the cautious excavation of a metal-detector reading in hard ground with many stones. No other tools are shown in the photographs. If this was the only excavation tool issued to the deminer, the provision of tools was inadequate.

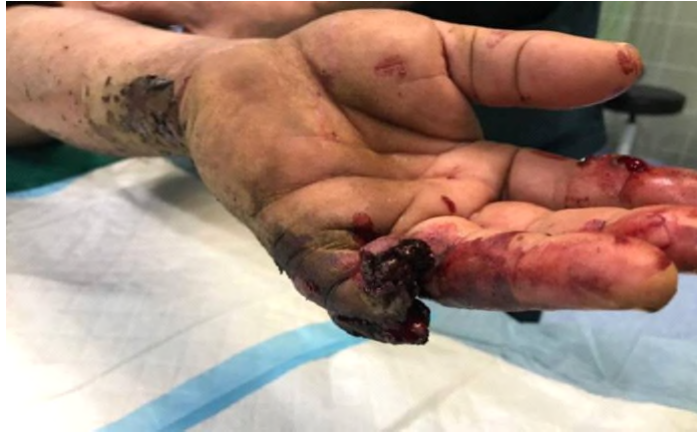
- Amputation of his left pinky finger at the middle bone level.
- Severe wound in his left index finger.
- Burns in his left wrist.
- Wound in his right forearm.
- Minor wounds and scratches in the front thighs area of both of his legs.
