DDAS Accident Report

Report date: 09/12/2019	Accident number: 826
Accident time: 07:33	Accident Date: 06/09/2017
Where it occurred: Area 2, CBU-575 FO, UTM 704262-3667890, Tayr Harfa village	Country: Lebanon
Primary cause: Field control inadequacy (?)	Secondary cause: Management/control inadequacy (?)
Class: Vegetation removal accident	Date of main report: 06/09/2017
ID original source: 9/2017	Name of source: RMAC-N
Organisation: [Name removed]	Ground condition: bushes/scrub; dense vegetation; trees; woodland
Mine/device: M77 Submunition	Date last modified: 09/12/2019
Date record created:	No of documents: 1
No of victims: 1

REGIONAL MINE ACTION CENTRE - NABATIYEH (RMAC-N)

BOARD OF INQUIRY (BOI) INVESTIGATION REPORT Ref No. 9/2017

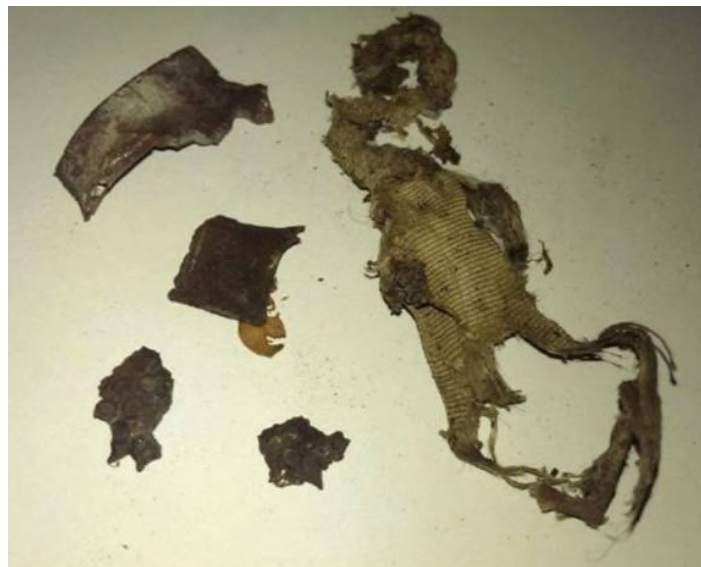
The type of explosive ordnance involved in the accident is believed to be one M77 sub-munitions; weighing approx. 250 g in total (Dual Purpose sub-munitions containing approx. 45 g of high explosives(RDX/TNT), point detonation impact fuze). [The weight of the firing pin falling through a few millimetres provides enough inertia to carry the striker forward into the stab-sensitive detonator.]

[The picture shows fragments recovered from the site.]

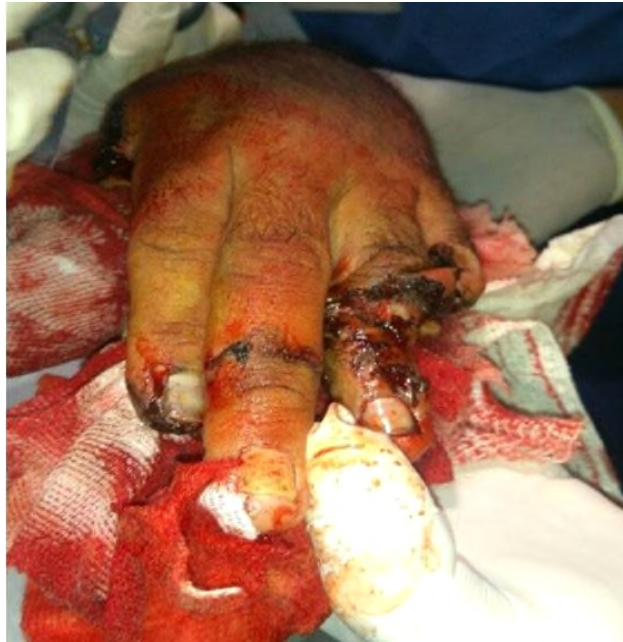
The searcher sustained:

- Fragmentation in the right eye which resulted in him losing that eye.
- Fragmentation below the left eye which was removed and he still has vision.

- Fragmentation went through the inside right of his helmet and caused injuries to his head which are not believed to be life threatening.
- There are minor lacerations on his right hand which not serious.
- Ali received numerous injuries on his left hand resulting in the loss of his small finger. He received other serious injuries to his left hand but we do not know to what extent at this time.
- Broken right knee cap.
- Fragmentation in both legs.
- Fragmentation in the chest which is believed to have entered his right lung. (medical report attached) [Medical report not made available.]

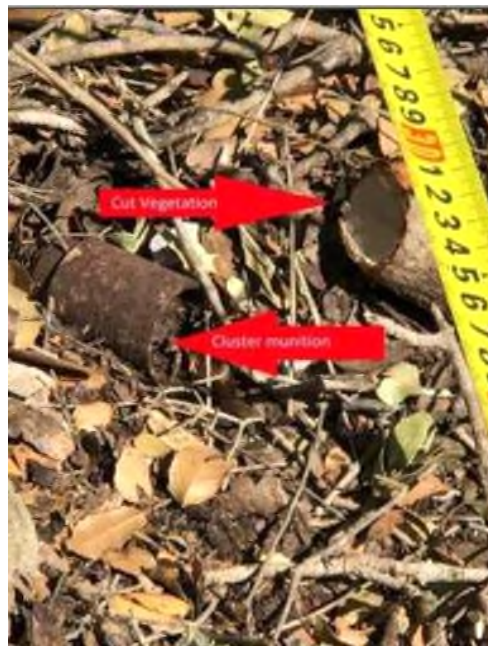
At the lane where the accident occurred the injured searcher was cutting vegetation in the un-cleared area using a saw (Schonstedt locator was found turned on with high sensitivity setting, located just behind the base stick, about 70 cm away from the explosion location; the base stick was 50 cm behind the accident location and vegetation was cut to an extent of 120 cm following the base stick towards the dangerous area).

During the internal investigation an M77 sub-munition was located on the surface right next to cut vegetation in a different lane than the one where the accident occurred; which shows weakness in supervision, command and control not just in the lane where the accident occurred, but in the entire task.
