Humanitarian Demining Accident and Incident Database
AID

DDAS Accident Report

BOARD OF INQUIRY (BOI) INVESTIGATION REPORT Ref No. 01/2010

Accident during BAC involving a SUBMUNITION

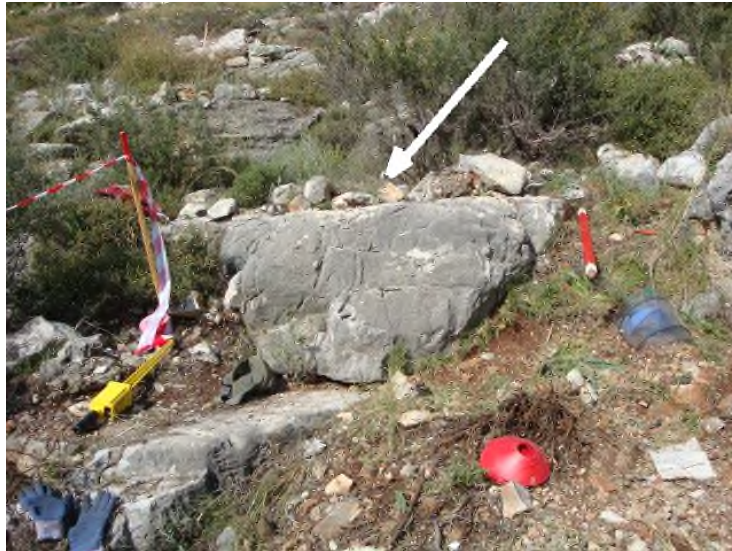
The area of the accident was in an area being cleared by [the Victim] just on the other side of a large boulder that he had to climb over to progress forward. [The white arrow points to the place of detonation.]

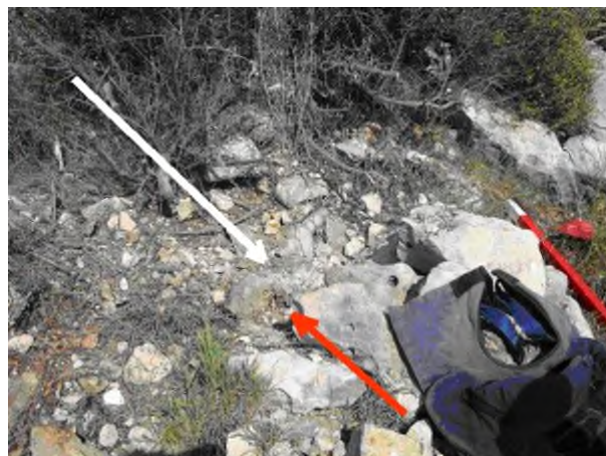
Crater

The crater was located on the reverse side of a large boulder, with scattered rocks in the vicinity.

[The white arrow points to the crater. The red arrow shows the direction of clearance.]

The photographs show that the submunition detonated in front of a large rock in the lane. It is not clear that the Victim could have used the locator to search directly in front of the rock without being to one side of it. A larger detector search-head on a conventional metal-detector could not have been placed close to the ground but could have signalled on the submunition if held in the air above the rocks (the submunition being a large piece of metal). The Schoensdat locator stick is a low-cost, simple and robust ferrous metal detector that is not designed for wide area search so it should not be used when a conventional metal-detector could be used.

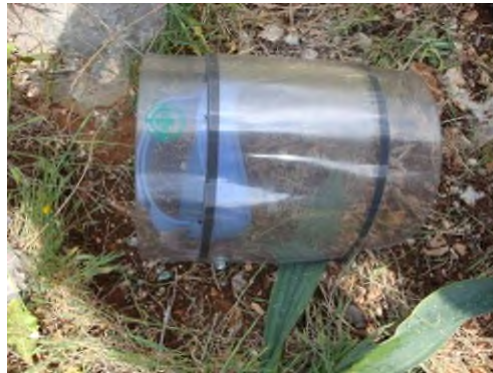
Visor: this is a polycarbonate visor that offers protection to the front of the head and the throat. There was no evidence of damage caused by the effects of an explosion found on the visor.
