DDASaccident830

Humanitarian Demining Accident and Incident Database

1. Introduction

The accident occurred at 1240hrs (local time) on the 19th October 2012 in Area 3-010 CBU 319 Coordinates 36S 730688-3680080 which is near the village Talloussa.

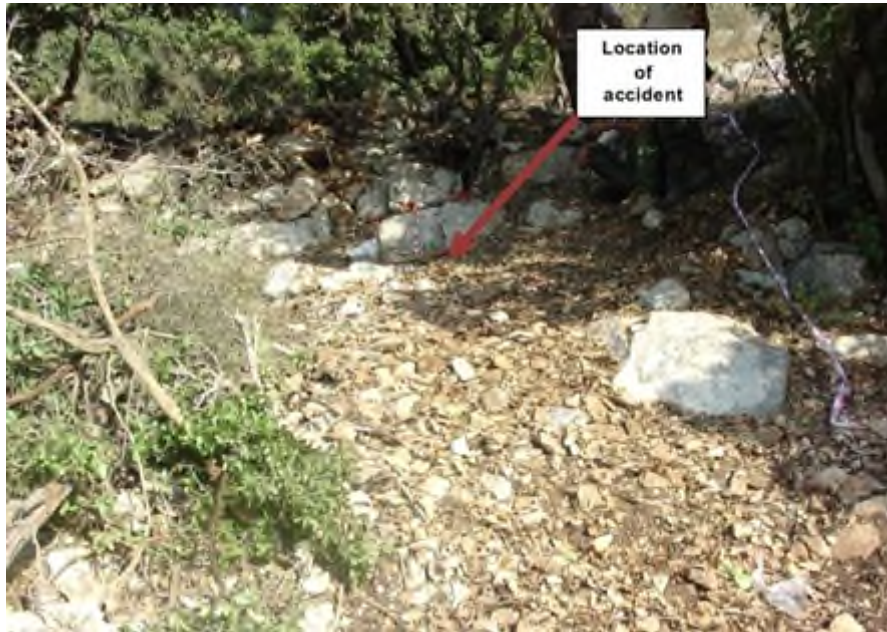
The site of the accident was on the eastern slope of a valley running south to north. This slope consisted of rocky terrain interspersed with trees, bushes, grass and soil. There are large boulders and smaller rocks and stones strewn across the slope. The land is not cultivated or being used by local people.

The area of the accident was in an area cleared by [Name removed] going upward in a rocky and very steep area.

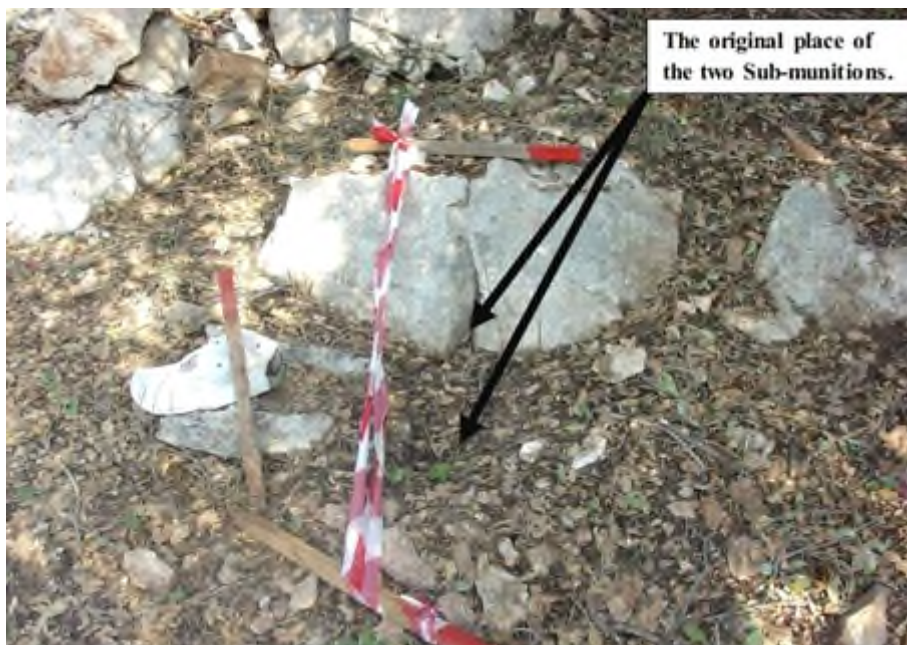
Location of accident

Marking: Marking in general on the task was in accordance with [International demining organization] Lebanon SOPs and NMAS, where the two items were marked with three pickets in the same triangle due to the close distance in between (10cm).

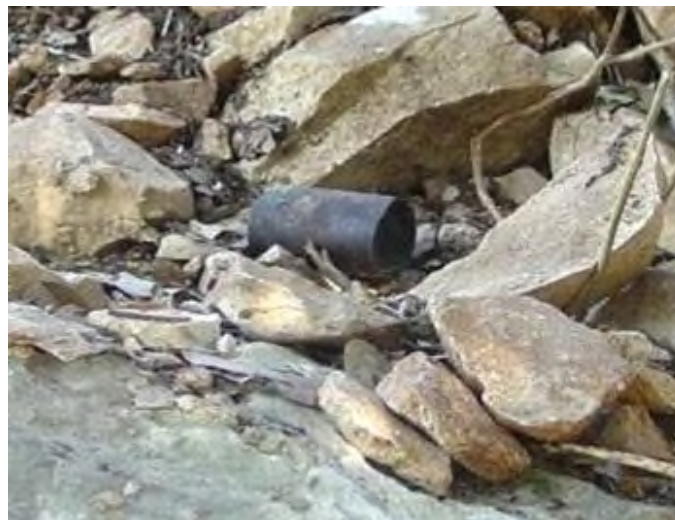
The primary cause of this accident is listed as 'Victim inattention'. Without the witness statements, the analysis cannot be conclusive but it is clear that the Victim deliberately handled the submunitions in breach of SOPs, had not ordered a safety cordon to be established prior to a demolition, and had not taken the necessary demolition equipment from the car (although he did apparently have a detonator in his pocket). The Victim's Leatherman tool was open on the ground along with one of the two submunitions scheduled for demolition.

This submunition has not detonated in a conventional way and it is not likely that it could have had its fuze system and content removed by the detonation of the other submunition. The Victim should not have picked up the submunition at all. He was standing and the complete amputation of the left hand at the wrist implies that the munition was lying laterally in that hand with the shaped charge facing towards his wrist while the other end (the fuze mechanism) was exposed to be worked on. After the accident, the Victim asked a deminer to take the detonator from his pocket and throw it aside, which may have been to avoid anyone knowing that it had been in his pocket and criticising him. After his death, that would have no longer mattered.

If the Victim was deliberately disarming the submunitions, there should have been a separated fuze system, copper cone and bits of explosive on the ground. None is visible in the photograph made available but it could have been removed (the second stage of the investigation happened days later).
