### DDASaccident833

Humanitarian Demining Accident and Incident Database  
*AID*

### REGIONAL MINE ACTION CENTRE - NABATIYEH (RMAC-N)

#### BOARD OF INQUIRY (BOI) INVESTIGATION REPORT Ref No. 01/2014

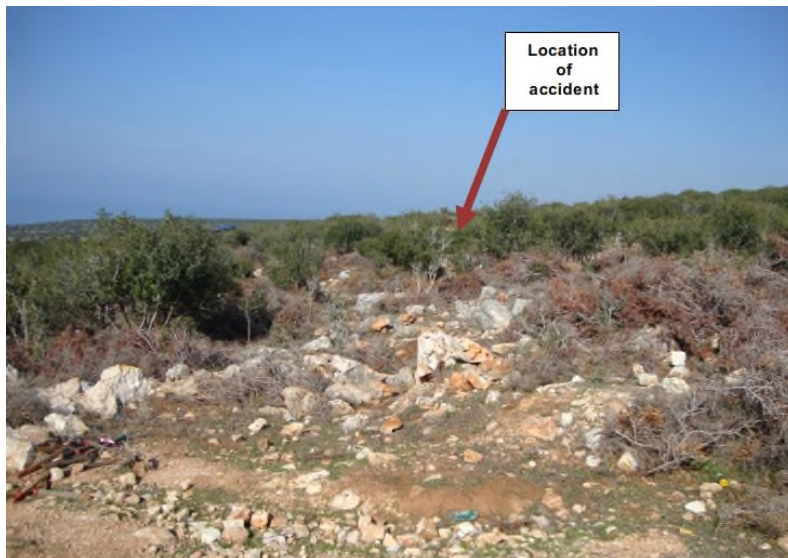
The location of the accident was on the eastern side of the CBU 849. The area consist of a terrain condensed with trees, bushes and grass. There are large boulders and smaller rocks and stones strewn across the area. The land is not cultivated or being used by local people.

The area of the accident was in the lane of the searcher [Victim No.1].

**Vegetation:** The vegetation consists of grass, plants, bushes and trees varying in size from knee to overhead height, which grow in irregular patches across the area.

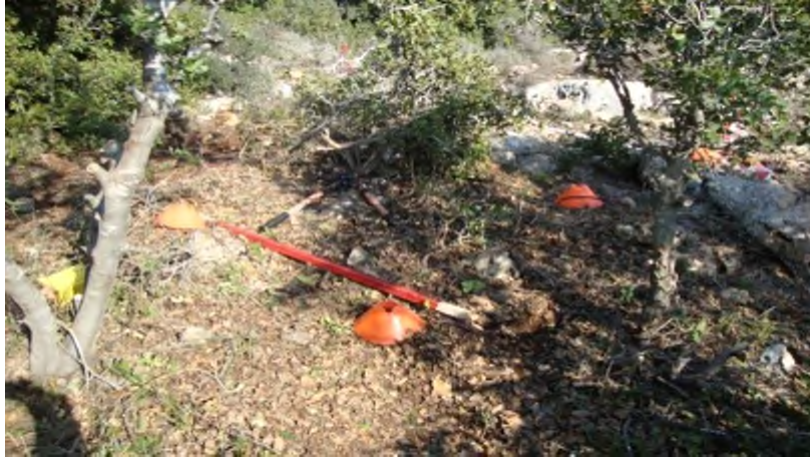
Location of accident

**Marking:** Marking in general on the task was in accordance with [International demining organisation] Lebanon SOPs and NMAS, except for the base stick that was 80cm backward from where the searcher was cutting, and this was due to the fact that the base stick was sliding on the rocks as per [the statement of] searcher [Victim No.1].

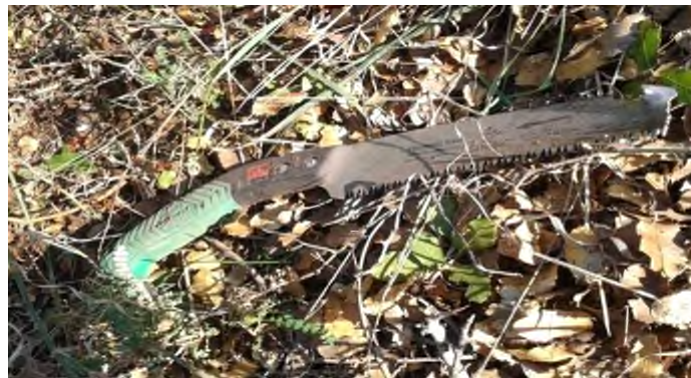
- The schonsted locator was located behind the searcher and no damage happened to the locator.

- The saw used during cutting the tree was ripped off by approximately 10cm.
- The gloves have some small holes and blood which means that the searcher was wearing them on the explosion.

- a. One day refresher training to be conducted for all [International demining organisation] BAC teams and to focus on vegetation cutting drills and how to wear personal protective equipment correctly. (Completed)
- b. Closer supervision from all levels to ensure there is strict adherence to [International demining organisation] SOP especially on vegetation cutting drills.
- c. BAC team 2 to be moved to another site until having a new supervisor to command the team, and send the team later back to CBU 849 ASAP to conduct normal BAC operations.
- d. It will be more trustworthy for [International demining organisation] to switch the saw used with the searchers by a shorter one that will be no longer than 30cm.

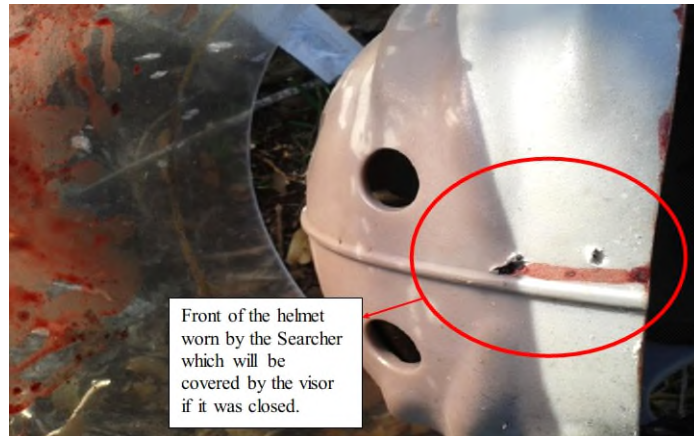
Concerning the visor, it is obvious from the scratches and damages found on the outside layer of the visor and that there's no scratches from the inside, that the visor was worn and was not fully opened. But from the injuries happened to the eyes of the searcher and from his statement during the investigation with the BOI in the hospital on the 21st of January 2014, he confirmed that the visor was not locked [down] as it should be, which contradicts with safety regulations and [International demining organisation] SOP & NMAS.

In addition to that there's a hole in the front of the plastic helmet which cannot be reached if the frame in front of it was not lifted up to a certain level which is not acceptable for the safety requirements.

- c- From the injuries in the searcher's face and eyes, and the statement of the searcher confirmed that the visor was not secured as it should be, also this wrong position of the visor contradicts with safety regulations of using PPE/Visor in [International demining organisation] SOP and NMAS. This breach of safety resulted of this severe injury in the eye of [Victim No.1].
