DDAS Accident Report

Report date: 30/12/2019	Accident number: 833
Accident time: 07:05	Accident Date: 15/01/2014
Where it occurred: Area 1-005 CBU 849, Ter Harfa village	Country: Lebanon
Primary cause: Victim inattention (?)	Secondary cause: Field control inadequacy (?)
Class: Vegetation removal accident	Date of main report: Not recorded
ID original source: 01/2014	Name of source: RMAC-N
Organisation: NPA	
Mine/device: M42/M46 submunition	Ground condition: bushes/scrub; rocks/stones
Date record created: 29/12/2019	Date last modified: 29/12/2019
No of victims: 2	No of documents: 1

BOARD OF INQUIRY (BOI) INVESTIGATION REPORT Ref No. 01/2014

Location: Ter Harfa. **Date:** 15 January 2014

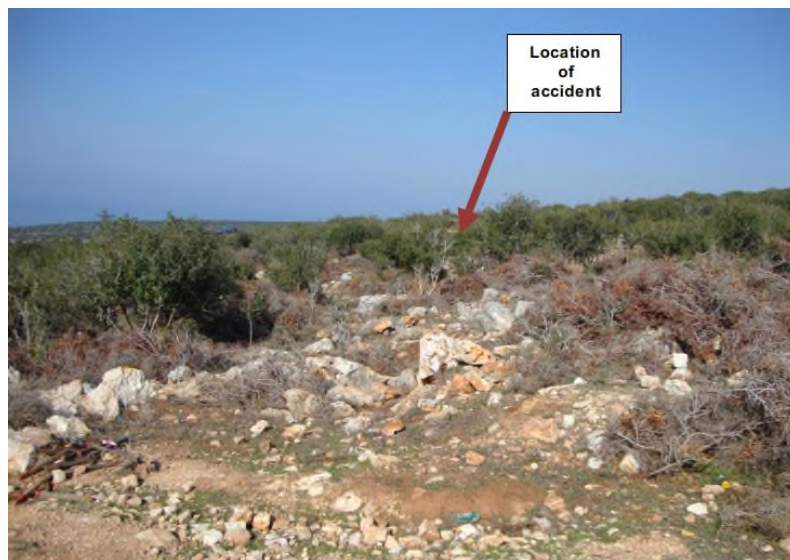
The location of the accident was on the eastern side of the CBU 849. The area consist of a terrain condensed with trees, bushes and grass. There are large boulders and smaller rocks and stones strewn across the area. The land is not cultivated or being used by local people.

The area of the accident was in the lane of the searcher [Victim No.1].

Vegetation: The vegetation consists of grass, plants, bushes and trees varying in size from knee to overhead height, which grow in irregular patches across the area.

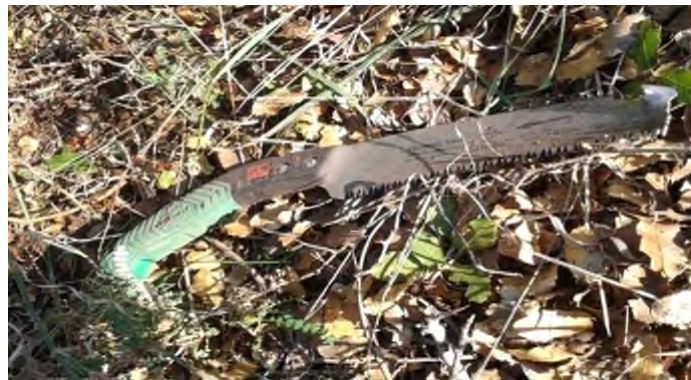
- The schonsted locator was located behind the searcher and no damage happened to the locator.

- The saw used during cutting the tree was ripped off by approximately 10cm.
- The gloves have some small holes and blood which means that the searcher was wearing them on the explosion.

- a. One day refresher training to be conducted for all [International demining organisation] BAC teams and to focus on vegetation cutting drills and how to wear personal protective equipment correctly. (Completed)
- b. Closer supervision from all levels to ensure there is strict adherence to [International demining organisation] SOP especially on vegetation cutting drills.
- c. BAC team 2 to be moved to another site until having a new supervisor to command the team, and send the team later back to CBU 849 ASAP to conduct normal BAC operations.
- d. It will be more trustworthy for [International demining organisation] to switch the saw used with the searchers by a shorter one that will be no longer than 30cm.
