Falkland Islands Malvinas Exploitation Report 2013

Demining Programme Office in the Falkland Islands – Exploitation 2015

FALKLAND ISLANDS LANDMINE EXPLOITATION – MARCH 2015

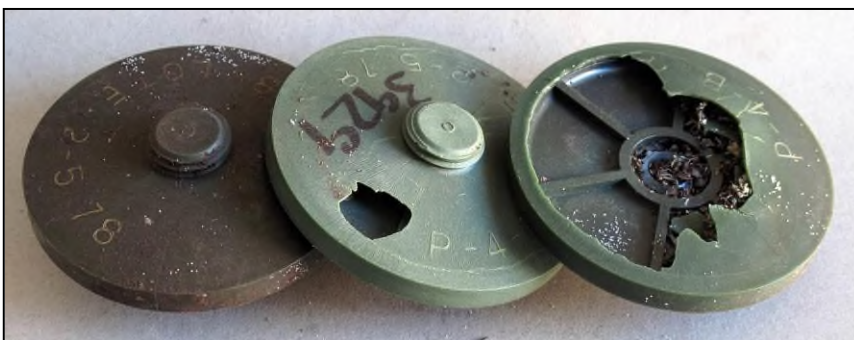
A significant proportion of the fuze casings had hardened and cracked, with many partially disintegrated. The proportion of degraded fuzes recovered so far during Phase 4A is substantially greater than on previous phases.

A range of degradation was present among P4B fuze casings

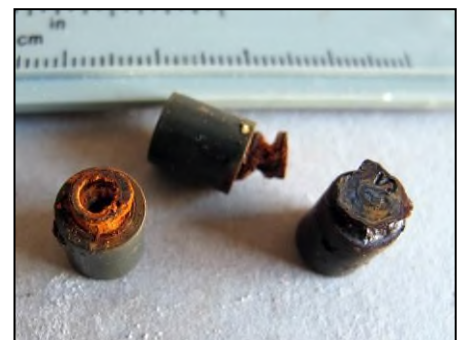
Any corrosion of the striker spring reduces its metallic mass and makes it even less detectable.

Many springs were corroded

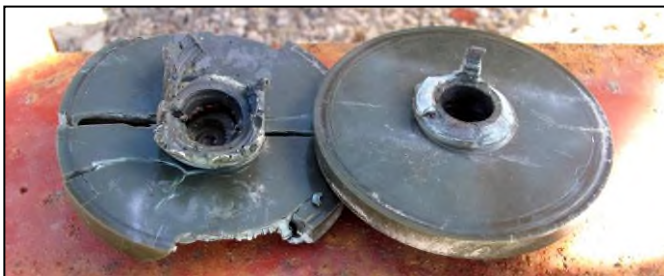
Out of those that exploded, the majority produced a weak effect that would probably fail to propagate to the main charge. In other words, actuation of mines in this category would be unlikely to cause injury.

Results from P4B detonator testing. The fuze on the left was one of the few that detonated fully; the one on the right barely had the energy to break the housing and would not have detonated the main charge

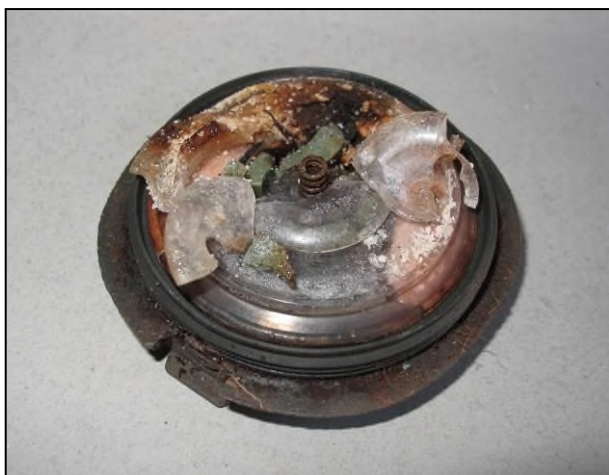
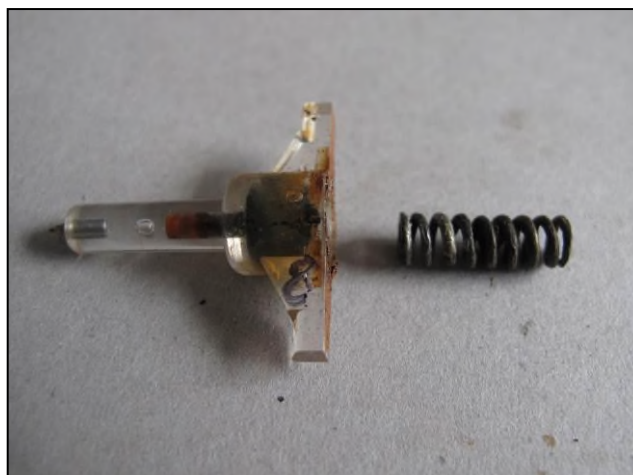
Even where water had entered the mines, rusting of the striker springs was generally light and superficial. This means that the metal content of both mine types still remains well above the detection threshold.

Even when rusted, the steel springs had lost little of their original mass (SB-33 left, SB-81 right)

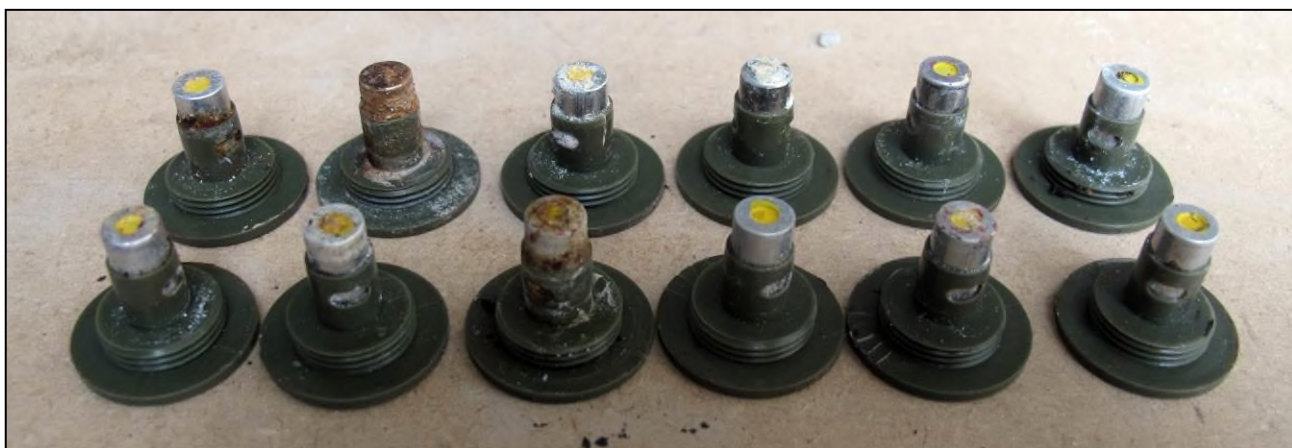
Most detonators appeared to be in good condition; however, some had white crusting (probably aluminium oxide from the detonator capsule) while others had a brown gelatinous exudation from the stab receptor.

Detonators from the SB-81 mines, some of which show signs of deterioration

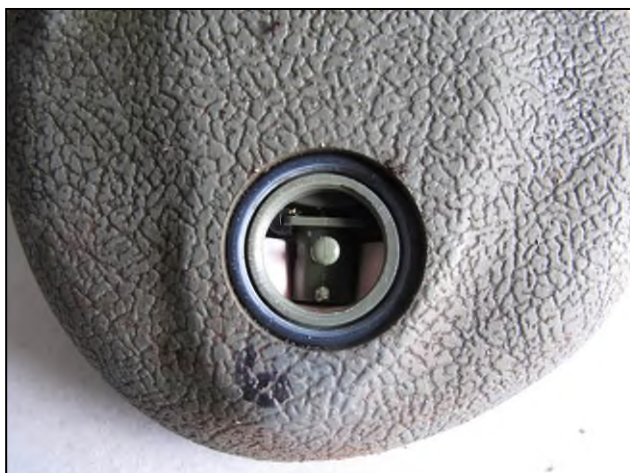
The presence of the firing pin in the stab receptor of the detonator is a major and unexpected hazard, since further movement could cause initiation. During disarming, the detonator is withdrawn from the mine body at right angles to the firing pin, meaning that the two components scrape together. If the detonator is still active, this could initiate the mine in the hands of the deminer.

An SB-33 detonator plug removed to reveal the detonator still in position, impaled on the firing pin

- Trials are arranged to assess the feasibility of using GPR for the detection of the P4B.
- No attempt should be made to defuze SB-33 mines in the field.
- SB-33 mines should be recovered, fully fuzed, and demolished within the minefield. A special demolition procedure should be developed to ensure complete destruction.
- Scientific analysis should be conducted to investigate the changes occurring within the mine detonators, including the causes.
- The effects of ageing on recovered mines and other significant ordnance⁴ continue to be monitored in future phases.
- Further data are needed on the location and circumstances of recovered mines in order to understand the factors affecting their condition. All contractors and authorities involved in demining operations should consider ways to collect such data without impeding clearance work.

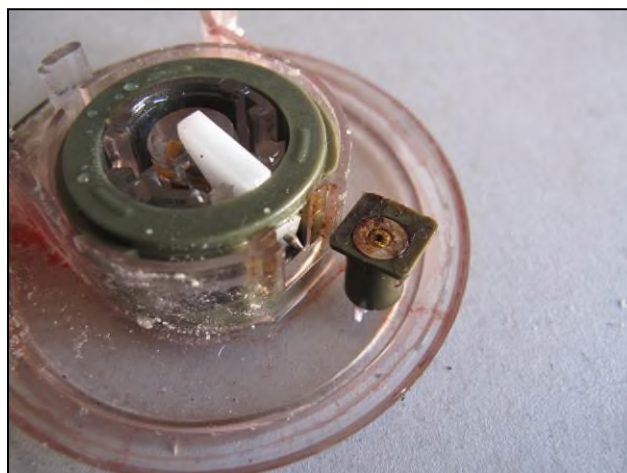
The gradual decline of detonators within SB-33 mines was also apparent from mines that had failed to fully function when actuated. Of the 16 mines examined, 6 had the firing pin embedded in the detonator, which did not initiate.

An SB-33 disassembled, showing the pin in the fired position and a hole visible in the detonator
