Falkland Islands Malvinas Exploitation Report 2010

Demining Programme Office in the Falkland Islands – Technical Support 2010

TECHNICAL SUPPORT TO THE FALKLANDS DEMINING PROGRAMME

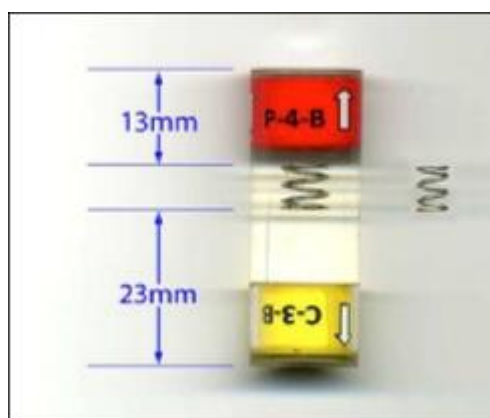
Figure 3

A detection test piece developed by CKA.

Note that in the image the spring inside the detection piece is magnified by the curve of the polymer surface making it appear larger than the free air example on the right. The two springs are actually identical

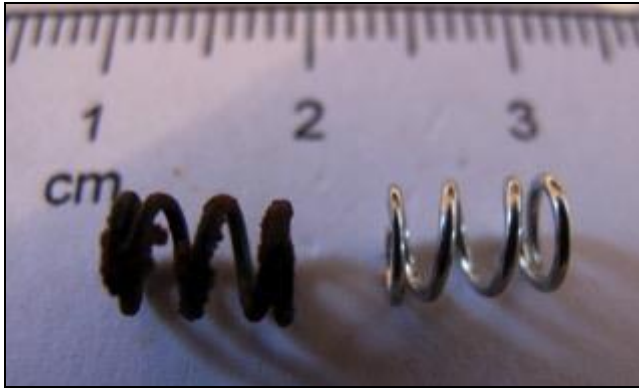
Figure 4

Corrosion testing.

Two springs of the type used in the Spanish P4B and C3B mines. The spring on the left has been immersed in weak saline solution for two weeks. The effect indicates that the spring is vulnerable to rusting, which might reduce its detectability

14. The conclusion of the corrosion test was that springs were likely to be heavily rusted if water had penetrated the fuze assembly. If so, the detection signature might be even lower, making the mine virtually undetectable⁴.

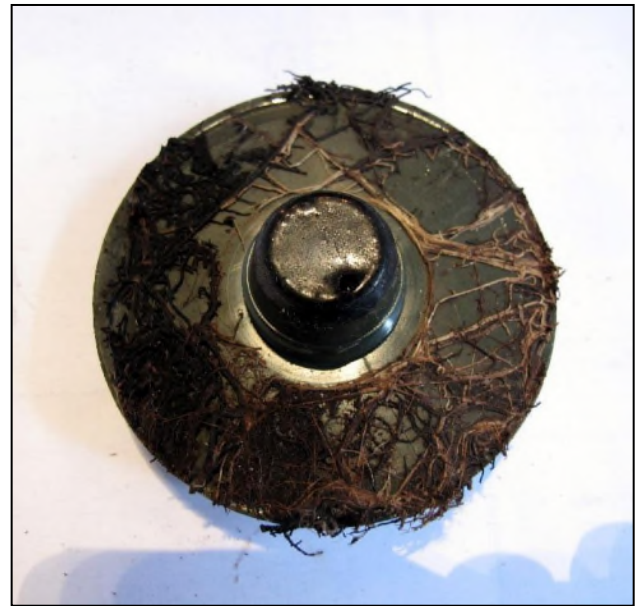
Figure 2

Many had some degree of root penetration between the underside of the fuze (Figure 2) and the mine body. This type of growth would not affect performance, although it is possible that further enlargement of the roots might eventually force the two assemblies apart, resulting in malfunction.

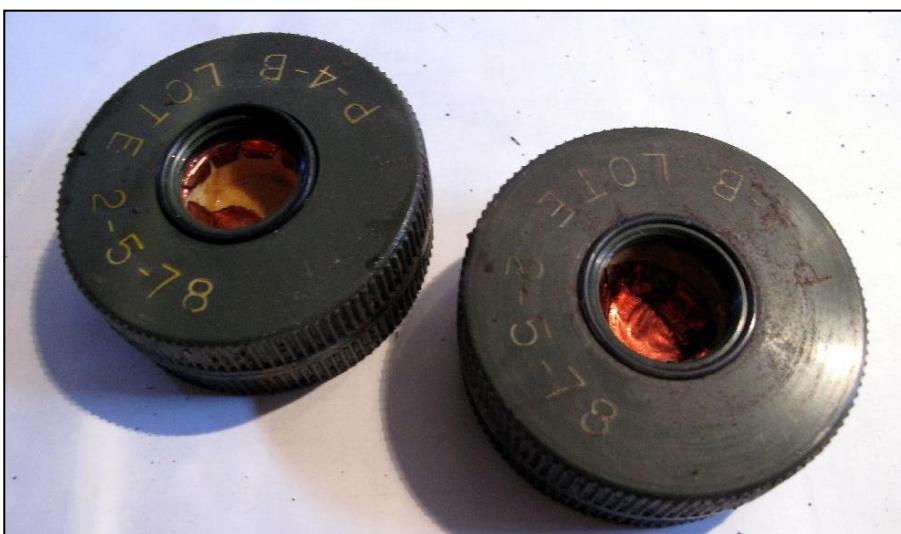
Figure 3

Throughout the course of the clearance operation, all but one of the P4B mines examined had the red lacquered lead foil present in fuze well. As the fuze assembly is fitted, this foil ruptures in unpredictable patterns (Figure 3). The shape of the ruptured foil is known to affect the return on short-wave radar and may also affect the signature with some metal detectors.

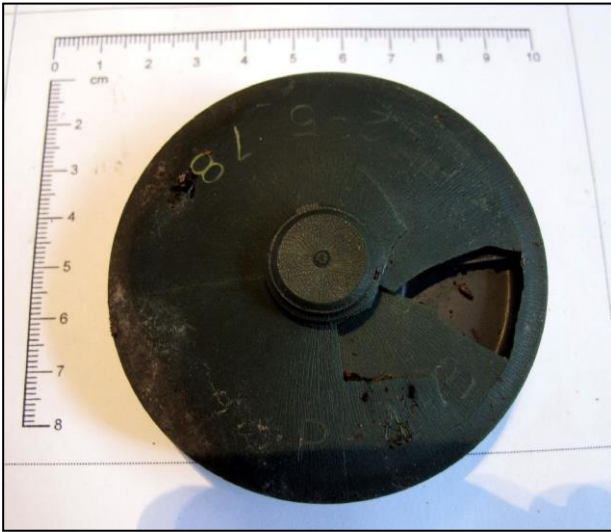
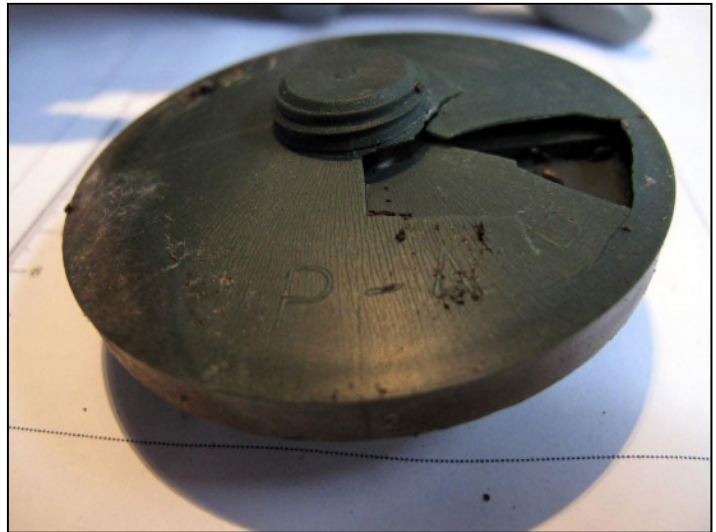
The P4B pressure plate shown in Figures 4 and 5 shows the type of long-term deterioration expected in ABS plastic. Increasing brittleness has caused fine cracks where the plastic is under stress; this has led to eventual failure, permitting the ingress of water. In most samples examined, cracking was not immediately visible; however, it is evident that the plastic is becoming more brittle and that all casings would eventually reach this stage. Previous studies have shown that such deterioration accelerates, since the effects (such as increasing the exposed surface area) make the material even more vulnerable to further degradation. Extensive tests would be required in order to assess the rate of degradation.

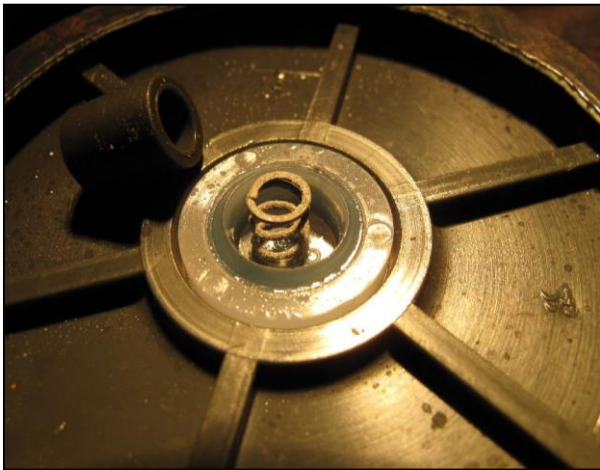
Figure 6

Even where water had penetrated the fuze assembly, the firing spring (Figure 6) was in remarkably good condition and remained fully functional. This was surprising, although, had the mines been nearer the coast, salt-water would probably have caused more extensive rusting. This would further degrade the detection signal from the small metallic mass.

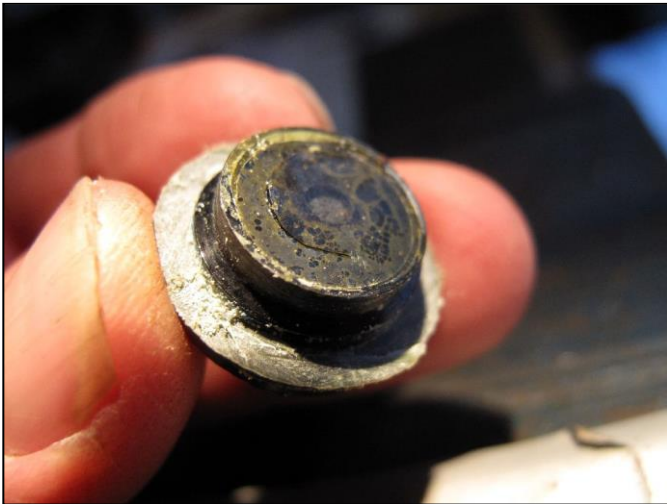
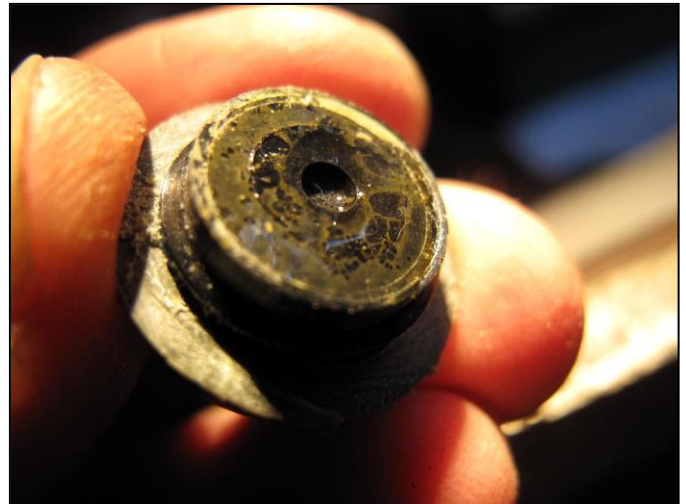
The detonator assembly is bonded into the fuze body and has to be cut from the mine, as shown in Figure 8. The stab-sensitive receptor in the centre is covered by a thin plastic film (seen here having been cut using a scalpel) to keep it dry. A similar assembly, shown in Figure 9, was full of water.

The presence of water might prevent the stab receptor from initiating, since water-soluble compounds are used within the composition. This is likely to be the primary cause of failure for P4B mines in the near term.

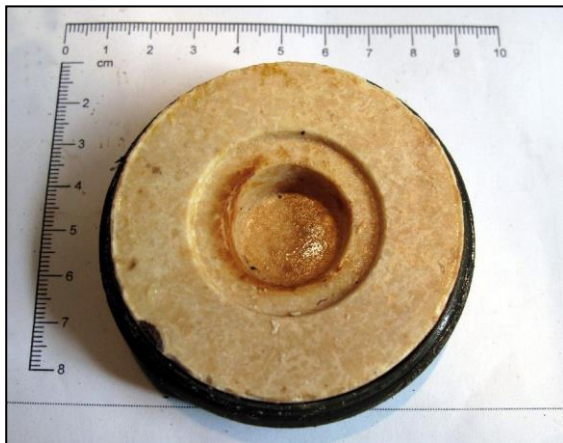
Figure 10

As expected, the pressed TNT charges (Figure 10) were in good condition, despite many being wet. TNT is relatively stable, especially when protected from sunlight. This High Explosive (HE) content is likely to remain functional for the foreseeable future.

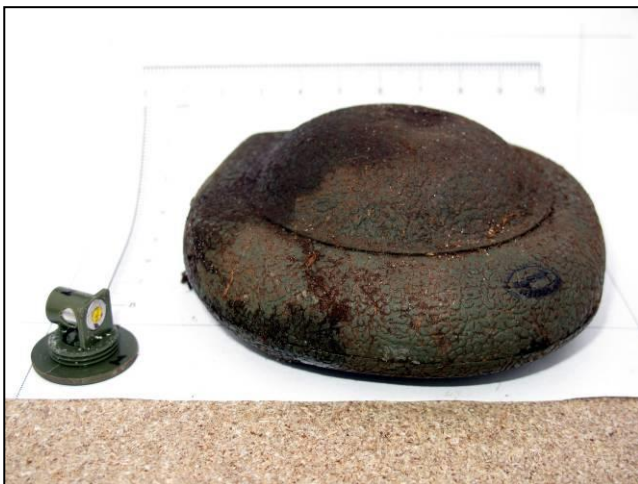
Seventeen SB-33 mines were recovered from a mixture of dry and wet sites (Figures 1 and 2). None of the SB-33 mines examined showed signs of significant external degradation, other than a notable increase in the profile of the rubber pressure plate; this is clear from Figures 3 and 4.

Figure 3: An SB-33 recovered from the Falklands; note the domed profile of the pressure plate

Expansion of the rubber appears to be due to the material softening when wet, although it continued to be waterproof. As the rubber dried, the height of the dome reduced noticeably, but not to the original profile.

Examination of the casing and pressure plate showed that the upper sections of all of the mines had remained watertight. Where water had penetrated, this appeared to be because the detonator plug (to the left in Figure 3) had not been tightened sufficiently.

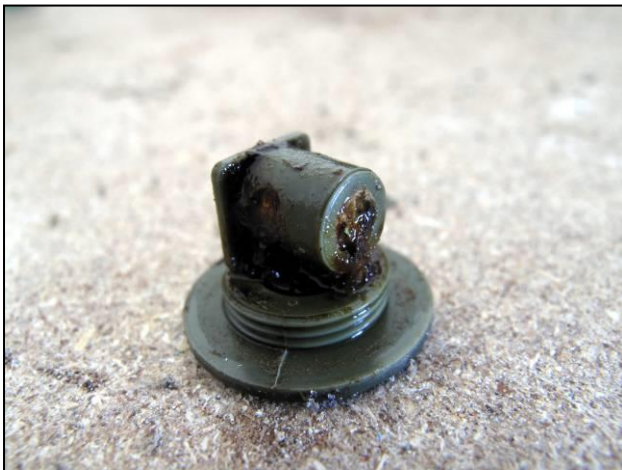
Figure 10: Some detonator capsules did show significant signs of degradation

There was obvious degradation where detonator capsules had been exposed to water for prolonged periods. It is likely that this had breached the seals of the capsule, particularly the thin yellow membrane covering the stab receptor. This is significant because the stab-receptive composition is likely to be affected by water, which may cause the mine to malfunction.

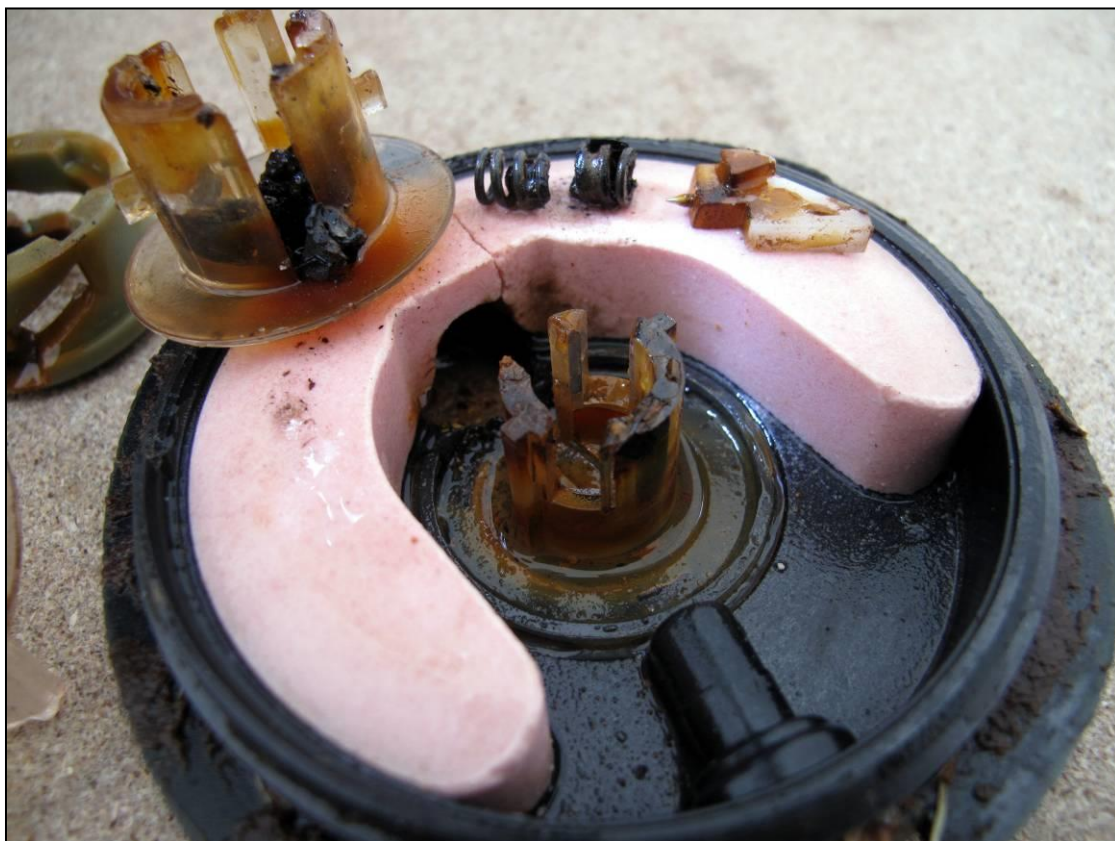
Only one of the recovered SB-33 mines contained a significant quantity of water; this was caused by the detonator plug not being screwed into place sufficiently tightly. The most obvious result of the water ingress was the disintegration of the striker spring, which would probably prevent the mine's fuze mechanism from actuating and might also make the mine more difficult to detect. The detonator capsule was also substantially corroded and possibly non-functional.

The badly corroded mine (shown in Figure 12) demonstrates the longer-term fate of all SB-33 mines, as rubber seals gradually deteriorate and permit water to enter the mine.

Figure 12: Inside an SB-33 which had been penetrated by water. The most likely cause of failure would be the disintegration of the striker spring, although degradation of the detonator capsule might also prevent the mine from operating. Note that the stainless steel firing pin is virtually unaffected

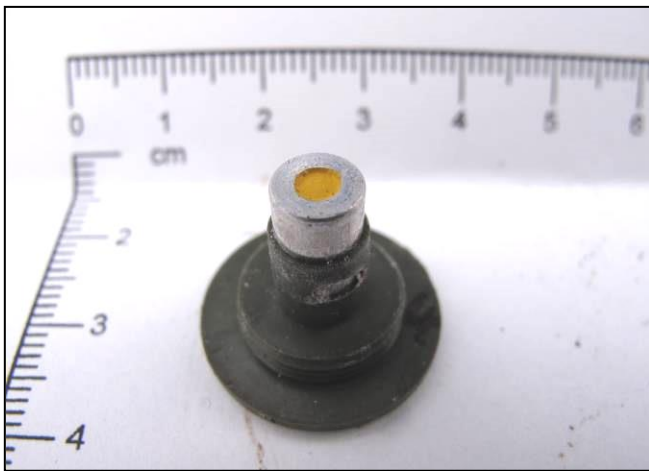
Figure 10: Some detonator capsules showed significant signs of degradation

The SB-81 uses the same detonator capsule as the SB-33, albeit in a different holder (Figure 10). Most were in good condition, but some, such as the one shown in Figure 11, showed obvious signs of degradation where they had become damp. It is possible that, in some cases, this had breached the seals of the capsule, particularly the thin yellow membrane covering the stab receptor. This is significant because the stab-receptive composition is likely to be affected by water, which may cause the mine to malfunction.
