Operational Evaluation Test Report on Beaver Micro-Vegetation Cutter

April 2005

Institute for Defense Analyses 4850 Mark Center Drive Alexandria, VA 22311-1882

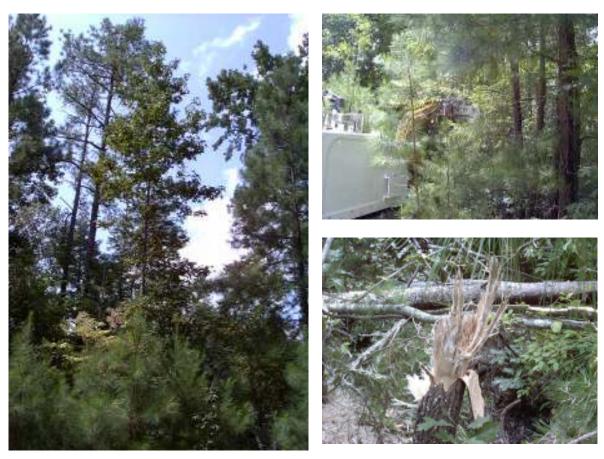
Figure 17: Tree to be Cut (left), Cutting (top right), Stump (bottom right)

A Category 4 deciduous, maple variety tree, 12 to 14 meters high and 15.4 cm in diameter, was selected for the Category 4 cutter operational evaluation test. The procedure followed with this tree was slightly different than followed with the two smaller trees in the Category 2 and 3 test. The tree was topped by cutting through the tree with the cutter at a height of 3–4 meters. The top fell behind the tree and the portion of the trunk left standing was then chewed down to ground level. Total time for this operation was 10 minutes. See Figure 17.

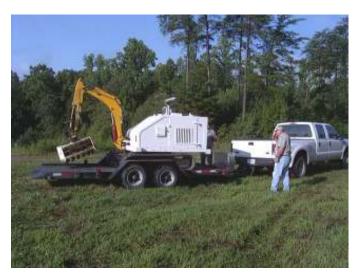
Figure 24: Beaver on Trailer

Local transporting (to and from a staging area) of the Beaver and Duck vehicles, as well as the three attachments (cutter, electromagnet, and bucket shovel), is most easily accomplished with two four-wheel automobile trailers each pulled by a pickup truck. Since the Beaver weighs almost 8,000 pounds (3,629 kg), a heavy truck capable of towing 8,000 pounds will be needed. The Duck, with attachments and tools, weighs about 5,000 pounds (2,268 kg), and may permit the use of a truck with a lower towing capacity. However, if any off-road or unimproved secondary road travel is anticipated, a truck with a towing capacity similar to that used for the Beaver is recommended. Figure 24 is a picture of the Beaver being loaded for movement at the test site.
