DDASaccident825

HD-AID Humanitarian DeminingAccident and Incident Database

DDAS Accident Report

BOARD OF INQUIRY (BOI) INVESTIGATION REPORT, Ref No. 11/2016

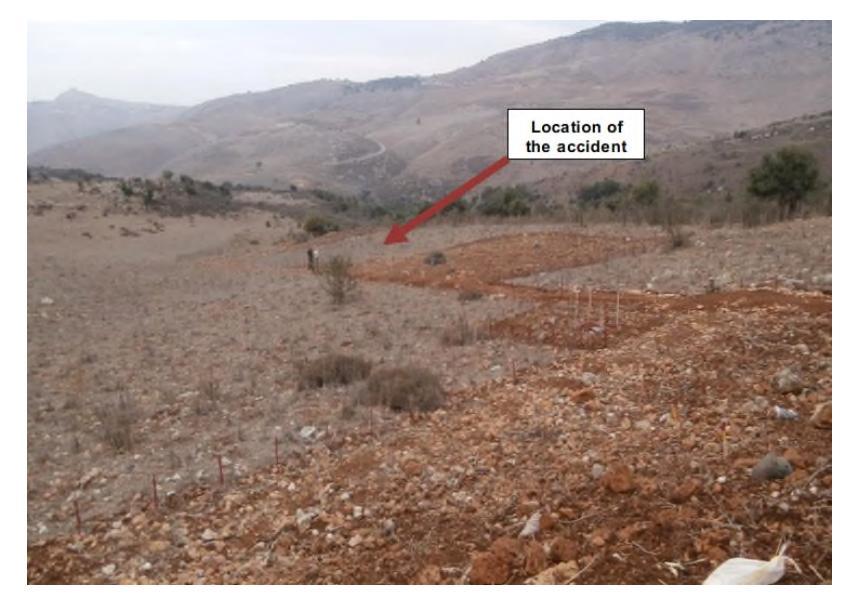
Location of the accident

The location of the accident was in the beginning of the lane being cleared by the deminer [the Victim] conducting manual full excavation technique.

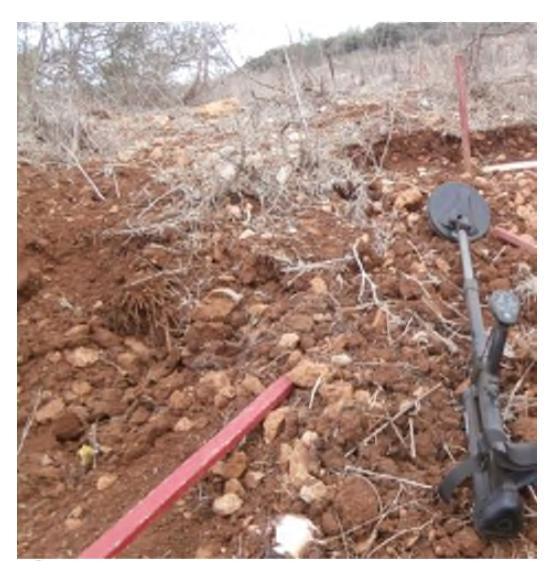
Marking in general on the task was in accordance with NMAS and [International demining organization] SOP, except for [the Victim]'s lane where it's obvious that the base stick was put

there right after the accident (the base stick is not broken, has no scratches even no dust from the explosion on it).

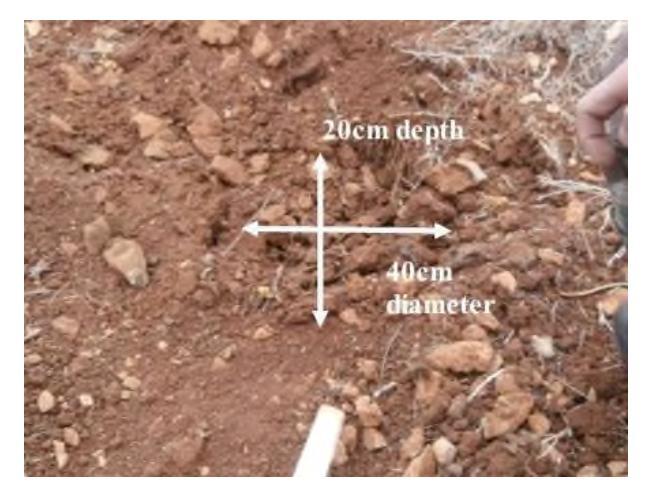
Crater

The crater [was] located just following the base stick and at the left side next to the detector.

The crater created by the explosion is about 20 cm depth and 40 cm in diameter as shown.

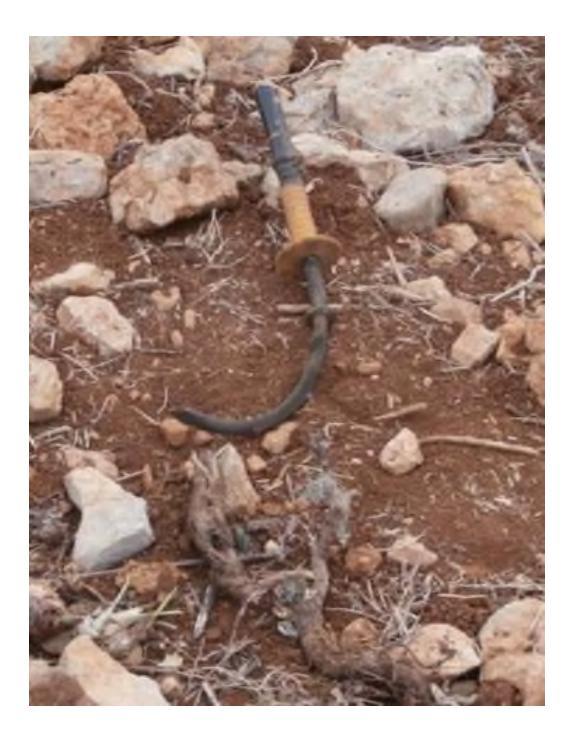
Items damaged

The excavating tool (prodder) was found 12.5 m away from the explosion place.

The excavating tool (prodder) which was found 12.5 m away from the explosion location was severely bent as shown.

The tool used for excavation was long and malleable and appears to have been made for the purpose, but it does not appear to be an ideal tool for area excavation or for the cautious excavation of a metal-detector reading in hard ground with many stones. No other tools are shown in the photographs. If this was the only excavation tool issued to the deminer, the provision of tools was inadequate.

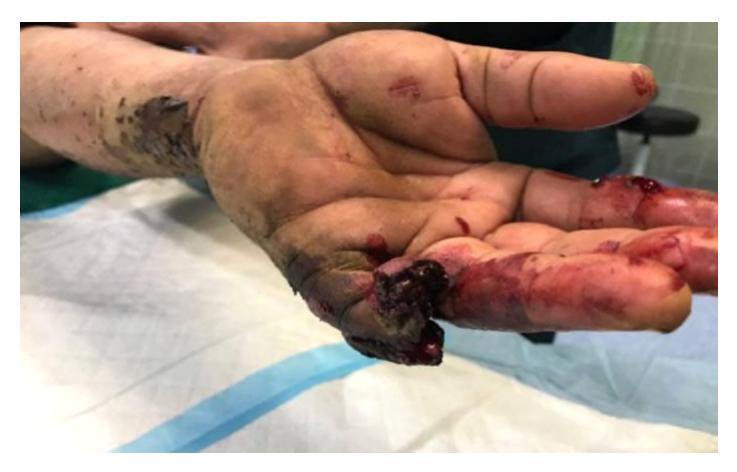
Description of Injuries

- Amputation of his left pinky finger at the middle bone level.
- Severe wound in his left index finger.
- Burns in his left wrist.
- Wound in his right forearm.
- Minor wounds and scratches in the front thighs area of both of his legs.
