MineWolf Flail and Tiller Machines: Testing the Differences between two Demining Technologies

MineWolf is the first demining concept, manufactured in Germany by *Arthur Willibald Maschinenbau GmbH (AHWI)*, that overcomes the limitations of flail and tiller machines by combining the advantages of both systems. Extensive tests with live anti-tank and fragmentation mines were carried out at the German Army proving ground to determine whether the MineWolf meets the operational requirements for humanitarian demining. The aim was to discover the effects of detonations on the operator, MineWolf, clearing tools and cabin, and to work out instructions for reparability.

by Heinz Rath and Dieter Schröder [MineWolf Systems GmbH]

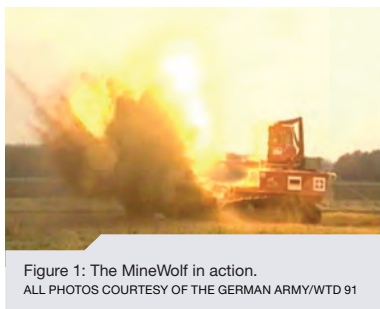
Figure 1: The MineWolf in action.
ALL PHOTOS COURTESY OF THE GERMAN ARMY/WTD 91

The MineWolf is a mine-clearing device developed especially for humanitarian mine-clearance. It is used for area clearing and clears up to 2,800 square metres per hour (3,349 square yards/hour), allowing for fast quality control on a demined area. The MineWolf system consists of a fragment-proof AHWI crawler tractor, a protected driver's cab and a mechanically driven mine-clearing device. Both a flail device and a tiller are available.

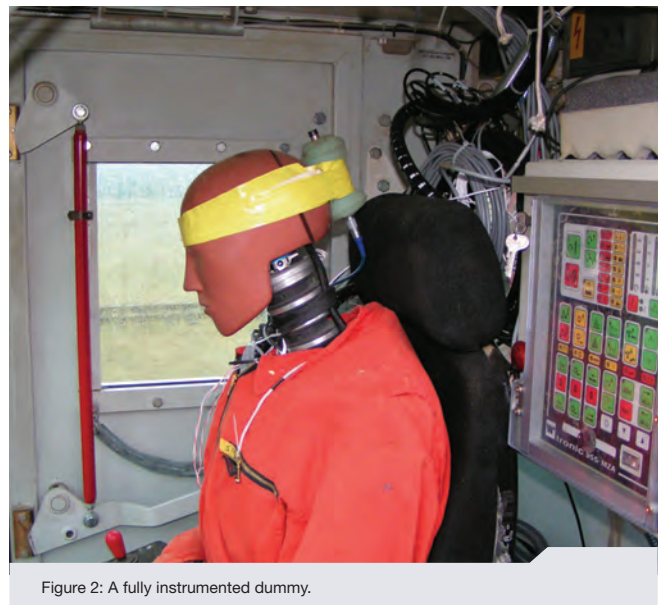
Figure 2: A fully instrumented dummy.

To record the measured values, an ATD was placed on the driver's seat and was fitted with various sensors to measure human-relevant impact information.

The results of the biomechanical measurements with the fully instrumented dummy were within a very acceptable range. This statement applies to the examined AT mine types DM 21, TM 57 and TM 62 and refers to mine detonations that occurred in the area of the clearing device.

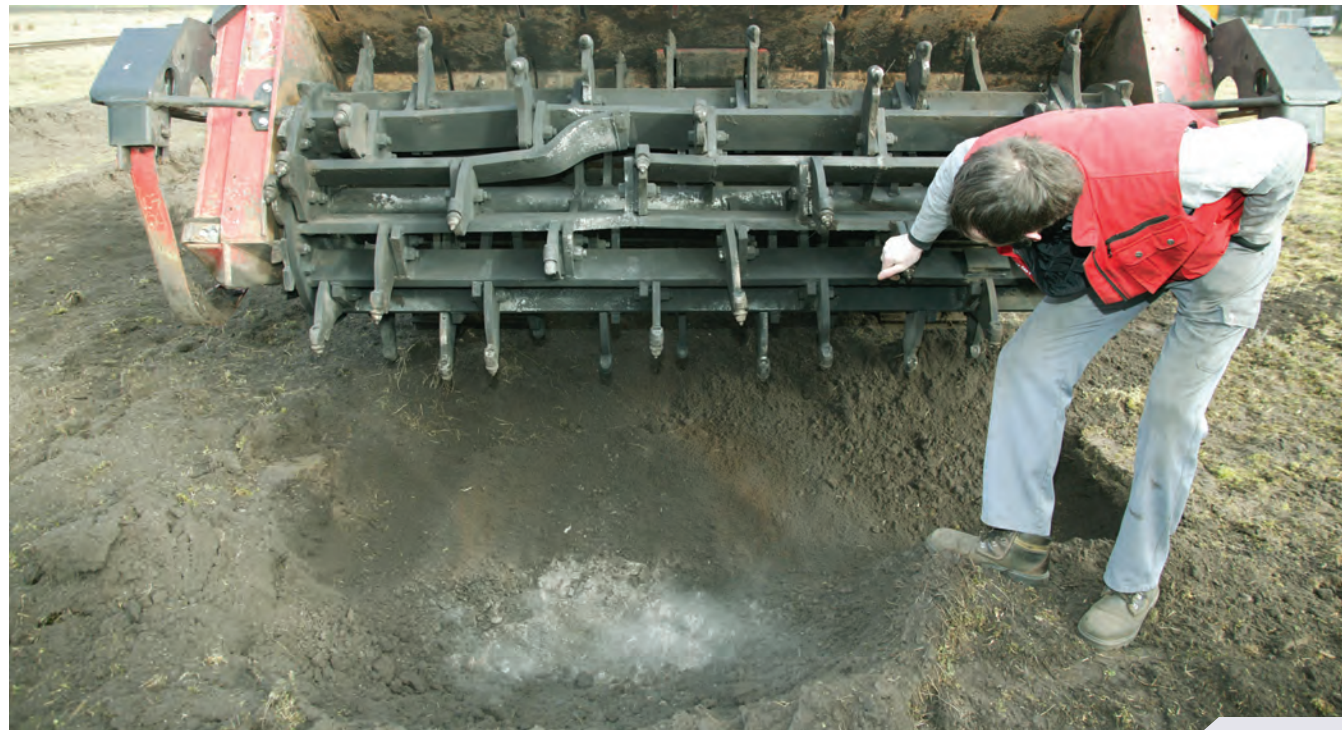
Figure 3: A typical mine crater after clearing a TM 57 or TM 62 AT mine.

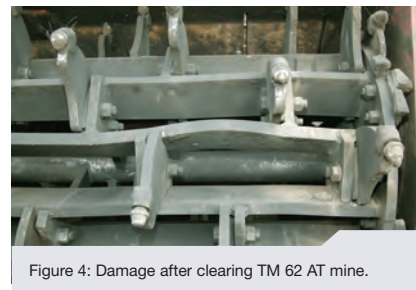
Figure 4: Damage after clearing TM 62 AT mine.

A total of six remote clearing tests were conducted against live AT mines. Four of these tests led to the detonation; two of the mines were crushed. Little or no flail repair work was necessary after the unmanned test. Damage to the tiller device is shown in Figures 4 and 5. The repairs shown in

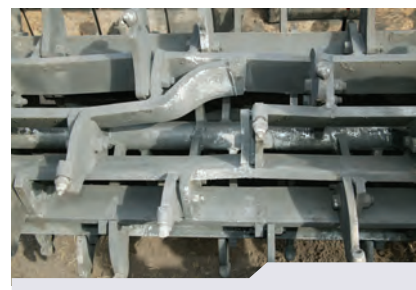
Figure 5: Damage after clearing TM 57 AT mine.

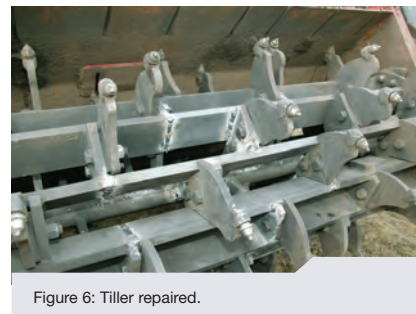
Figure 6: Tiller repaired.

Figure 6 are mainly welding work, which could be performed on-site the same day.

The mine-clearing MineWolf system with both accessory devices is suitable for clearing live anti-tank mines. The use of the flail device for clearing live anti-tank mines caused only minor damage that could be repaired with a limited effort or did not necessitate any repairs at all. The use of the tiller against live anti-tank mines, however, resulted in considerably greater damage, which could only be repaired with a substantially greater effort than those caused with the flail. The repairs, mainly welding work, could be performed on-site that same day.

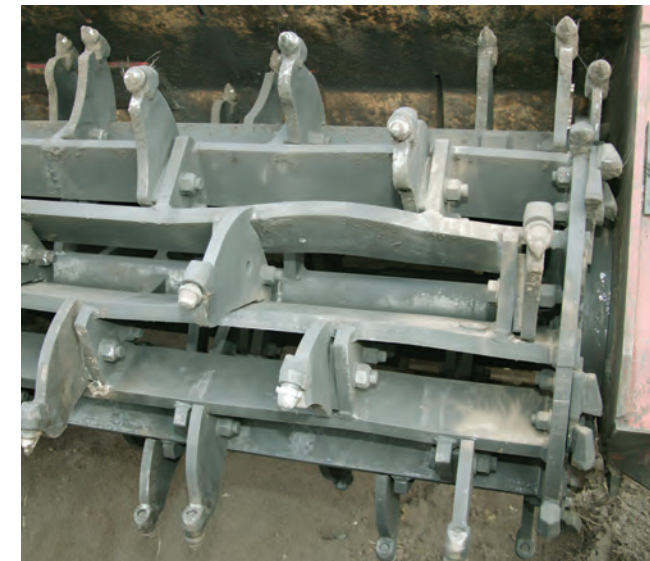
Figure 7: Damage after clearing a TM 62 P3 AT mine.

The AT mine TM 62 P3 detonated on-site upon contact with the mine-clearing device. The hit occurred approximately 0.5 metre (1.6 feet) off the left-hand side of the device.

Damage to the clearance machine included one worn chisel and two bent cross-spars (the cross-spars, or strut braces, were deformed by an area of 30 by 130 centimetres [11.8 by 51.2 inches]). The damage seemed to be minor as compared to the previous tests with the TM 57. The mine crater in the ground was of normal size. The machine could continue clearing despite the damage it suffered.

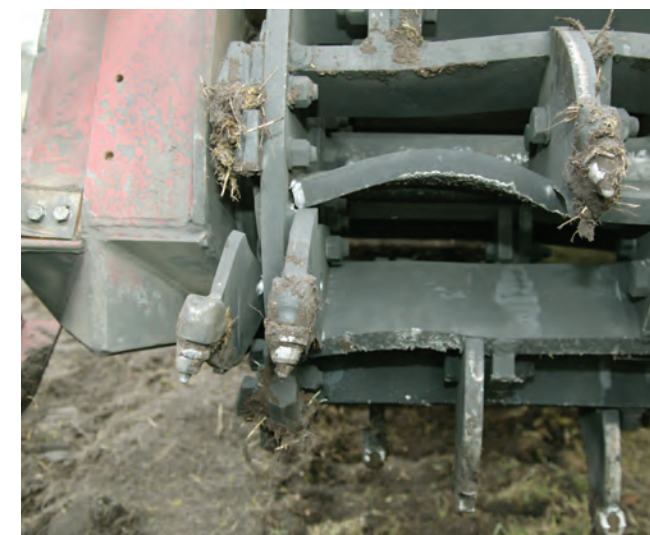
Figure 8: Damage after clearing a TM 57 AT mine.

The TM 57 also detonated on-site upon contact with the mine-clearing device. The hit occurred approximately 0.2 metre (0.66 foot) off the right-hand outer edge of the tiller.

Damage to the Minewolf included one outer tooth that was bent outwards and four cross-spars that were deformed by an area of 30 by 130 centimetres (11.8 by 51.2 inches). Two cross-spars were torn off at the end of the weld seam. The depth-control device was bent outwards but still functioning. After some provisional work lasting about 15 minutes, a test run with the tiller was performed. The tiller performance was still sufficient. The mine-clearing tool and drive train with power bands were still in repairable condition. The clearing quality was still good as shown by the ground appearance.

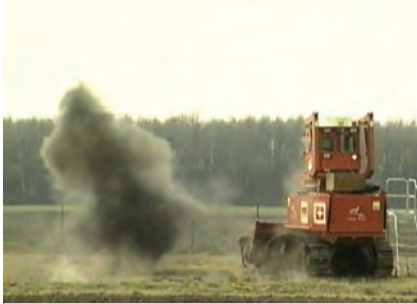
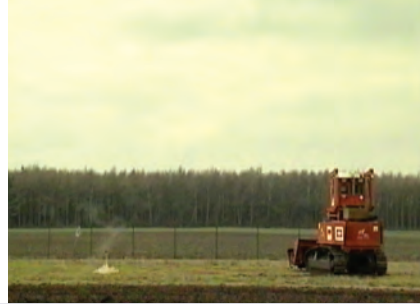
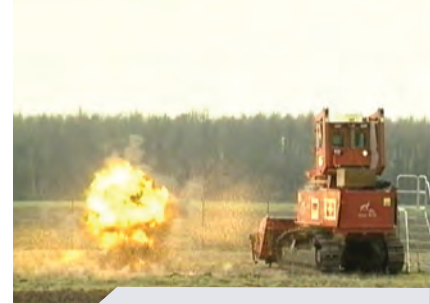
Figure 9: The operability of the MineWolf was not affected by fragment hits from the AP fragmentation mine DM 31.

Two contact detonations with AP fragmentation mine DM 31 were performed. The mines were placed on solid ground 10 metres and five metres (32.8 and 16.4 feet) from the tiller on the left-hand (fully armoured) side of the mine-clearing vehicle and the mine fuze DM 56A1B1 was initiated by a detonator placed on top of it. After approximately two seconds, the explosive device of the mine jumped from the launch box and detonated about one metre (3.3 feet) above the ground.

At a 10-metre (32.8-foot) distance, there were only a few fragment hits on the equipment. There were only small marks on the six-millimetre (0.24-inch) armour plates; there were two dents in the three-millimetre (0.12-inch) instrument box, one hit was found on

the cabin glass. At a five-metre (16.4-foot) distance, the fragment hits were more severe: slight dents in the six-millimetre (0.24-inch) armour plates. No fragment penetrations through the protected operator cab were detected. The operability of the MineWolf was not affected by the fragment hits.
