RHINO in Cambodia

RHINO, a large and powerful demining tool geared towards large clearance operations, has been put to the test—both on testing grounds and in the field. The result: a level of performance and operability that alleviates the concerns of critics.

By **Manfred Joehnk**, *Program Manager*

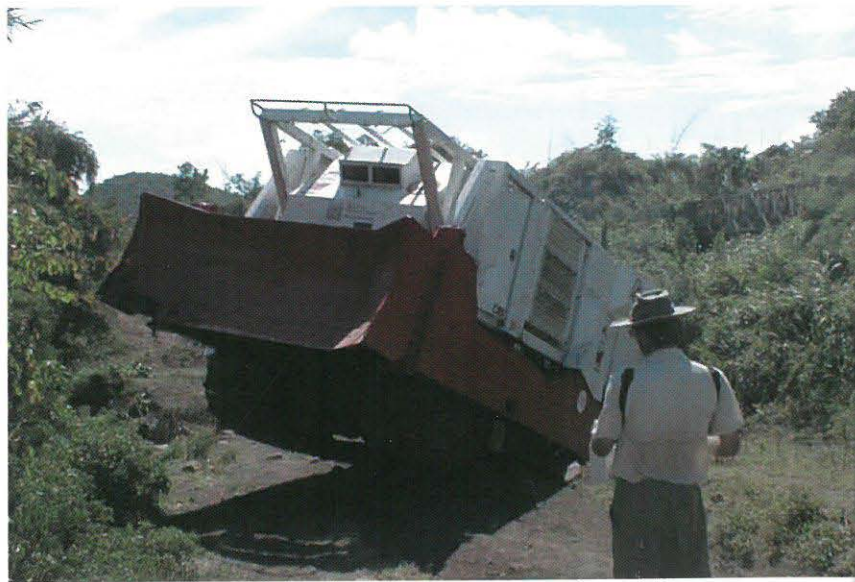
■ RHINO with dozer blade is transported to the test area, just bypassing a bailey bridge.
c/o RHINO

The infrastructure of Cambodia is especially weak from our point of entry (Sihanoukville) to the test area (approximately 600 km) and another 80 km to the operational site. The vehicle made the trip to the test area mostly on board a trailer and by rail. The critical parts of the roadway and undersized bridges were by passed through use of the Cambodian railway and by driving the vehicle under its own power. RHINO traveled some 140 km of the trip at about 4 km per hour. The tiller unit, which weighs 14 tons but is easy to remove, was replaced by the dozer blade. As a result, the trip was made without damage to roadway and bridges. RHINO was

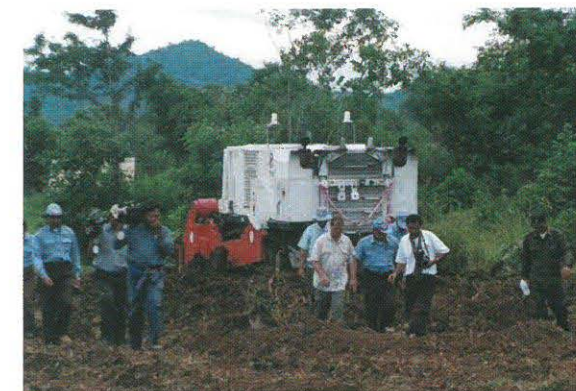
■ RHINO and crew emerge from typically dense vegetation found in Cambodian mine fields.

RHINO was designed to operate in a tropical environment, so the high temperature and humidity, dust and very heavy rain in Cambodia did not have an adverse impact on it. RHINO proved its ability to work through huge termite hills as well as dense vegetation including any kind of bamboo. Trees up to 20 cm in diameter were processed by RHINO. All materials are ground between the two tilling drums. Some of the vegetation was worse than anticipated, almost inaccessible due to thick vines and trees up to 30 cm in diameter. RHINO was slowed down but not stopped. The grinding process continued. While our customer in Croatia clears 20,000 m² per day, RHINO was able to clear 4,000-6,000 m² per day in a very challenging environment. This is significantly more than a platoon of manual deminers can clear in a week. We learned that RHINO's level feelers, which control the clearing depth, needed stronger protection for driving in reverse in such a challenging environment as Cambodia.

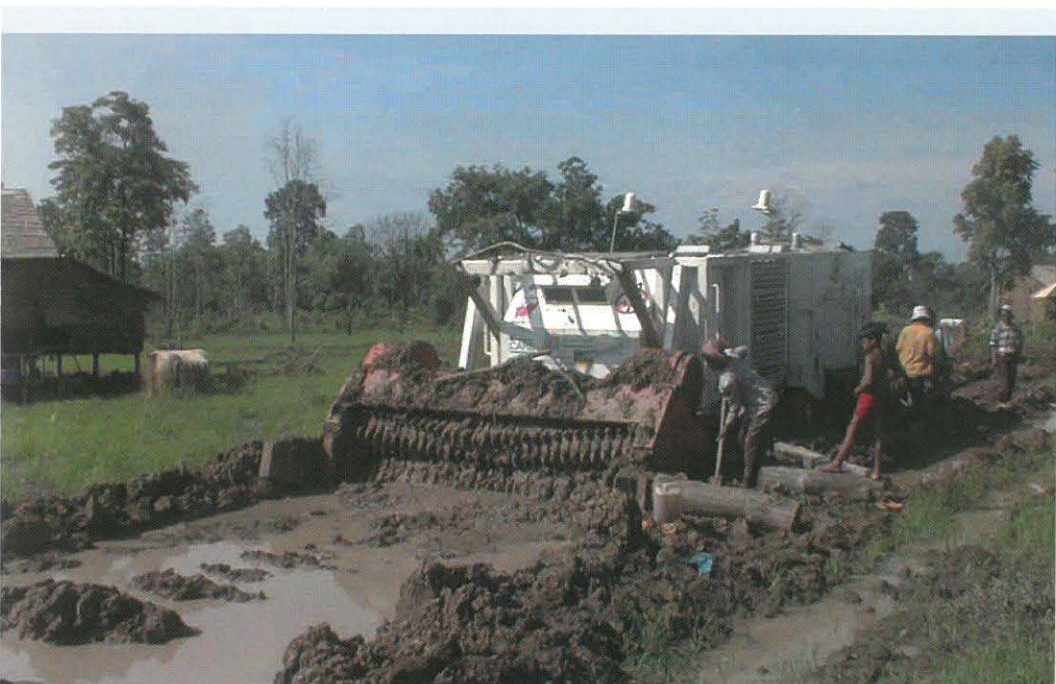
■ RHINO bogged down before self-recovery.

RHINO was bogged down twice in muddy, swampy terrain. Two methods of self recovery were:

- In the first case, the vehicle was bogged down in a mine-infested area. In accordance with regulatory procedures, two manual deminers had to clear the surrounding area before the recovery work could commence. An anchor was built by means of a steel plate and long iron rods. A rope was fixed on the anchor as well as on an iron bar, which was fixed to the track plates at the rear of each track. With this arrangement RHINO was able to tow itself out of the mud.
- In the second case, the tiller unit was forced downwards in the ground to elevate the system while the rear of

RHINO track formed the second base of the vehicle. Stones and wooden blocks were placed underneath to provide RHINO with traction to allow it to be driven out of the mud.
