Summary Report 910 Mechanical Clearance Device

Planned object: Mechanical Mine clearance device

Model: 910 MCV

Task: Establishment of mine test lanes in two distinctly different types of soil and execution of clearance trials.

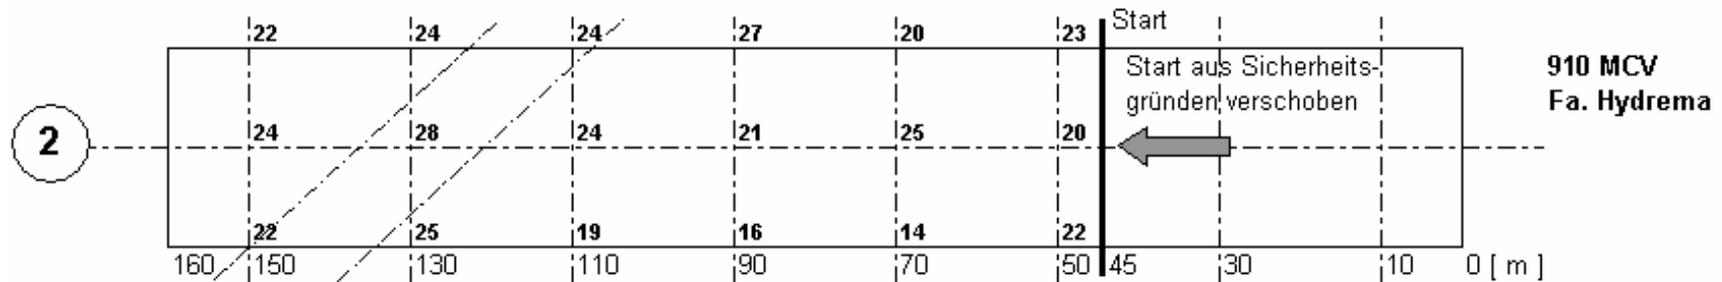
Vergleichserprobung Minenräumgeräte Schmidtenhöhe Koblenz
Vorversuche: Frästiefen in cm

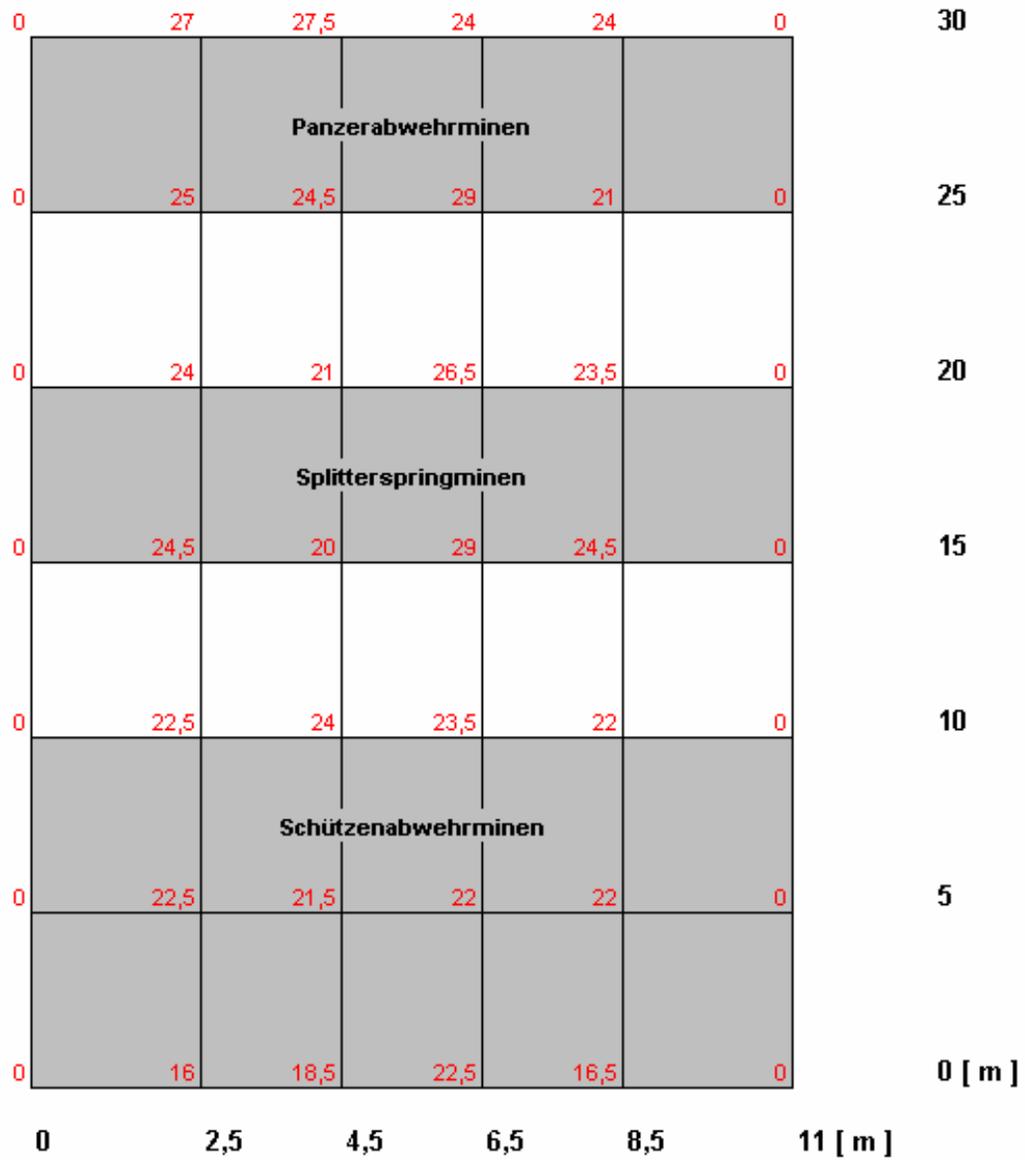
Nivellement des Minentestfeldes

910 MCV; Fa. Hydrema

Höhenangaben in [cm]

The topography along the test lane on the StÜbPI Schmidtenhöhe is visible in [Annex 6](#) and the crosswise slope in the context of the mine test fields amounts to:

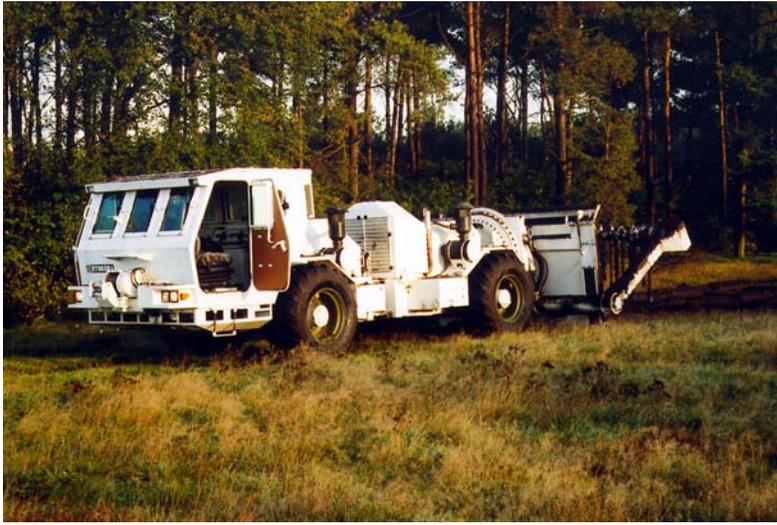
Picture 1 910 MCV working position overall view, front left

The MCV 910, designed for clearing surfaces is a mobile mine clearance device accredited also for the public road traffic. On the rear part it presents a special rotating

clearance device, hydraulically operated. The clearance takes place through the rotation movement of the flail, which should, through this action, detonate the mines. When working, the vehicle moves in the opposite direction to road movement and it can be either operated through a computerized automatic pilot steering system or manually using a joystick.

([see Annex 15 picture 1 to 6](#))

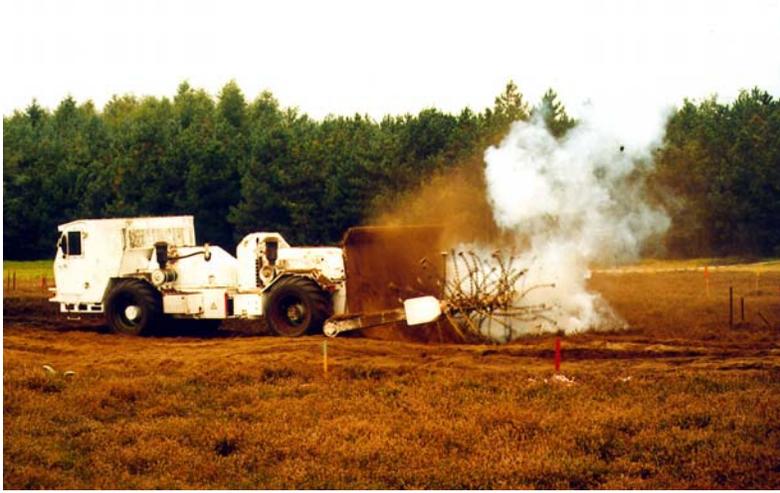
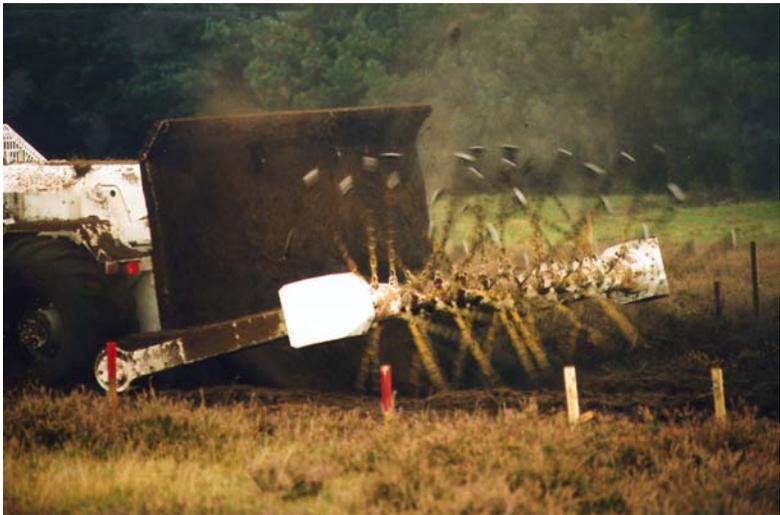
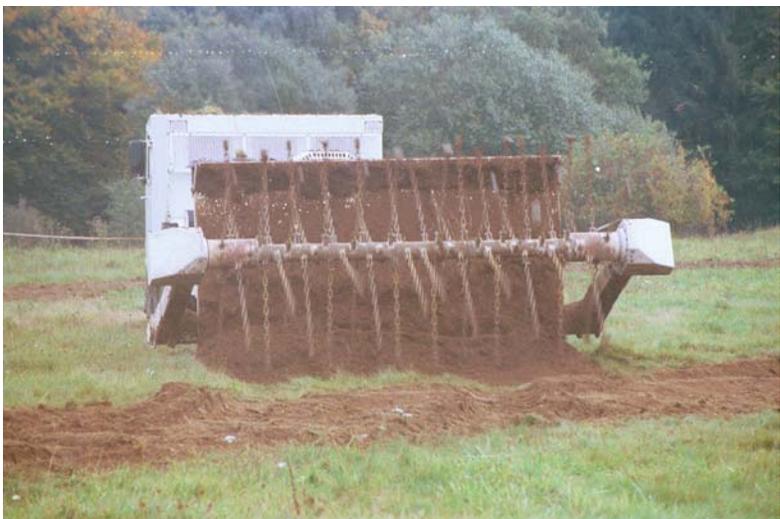
<p>Picture 4</p> <p>910 MCV during the clearance process</p>

<p>Picture 5</p> <p>910 MCV during the clearance process</p>

<p>Picture 6</p> <p>910 MCV during the clearance process</p>

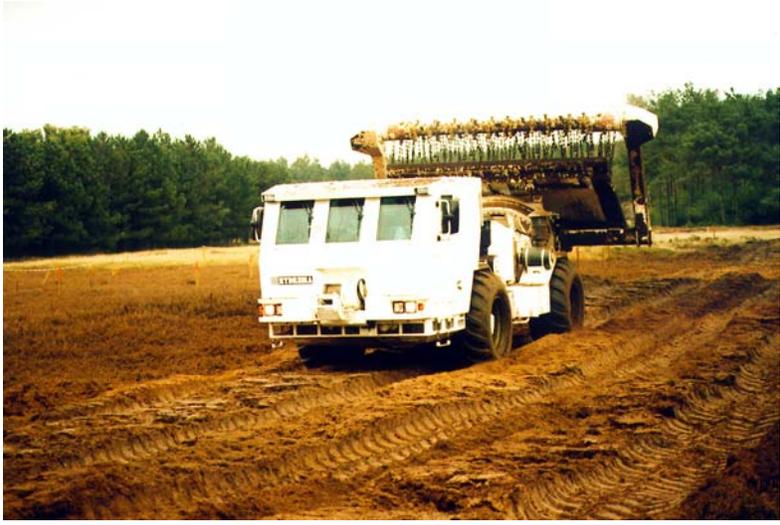
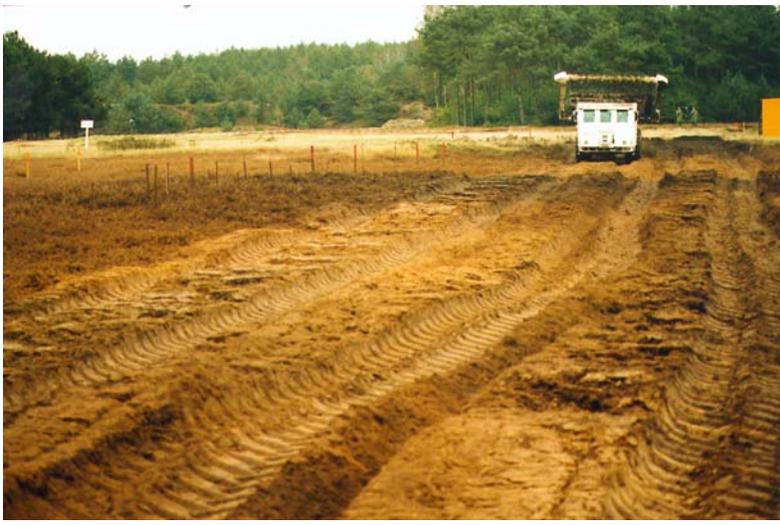
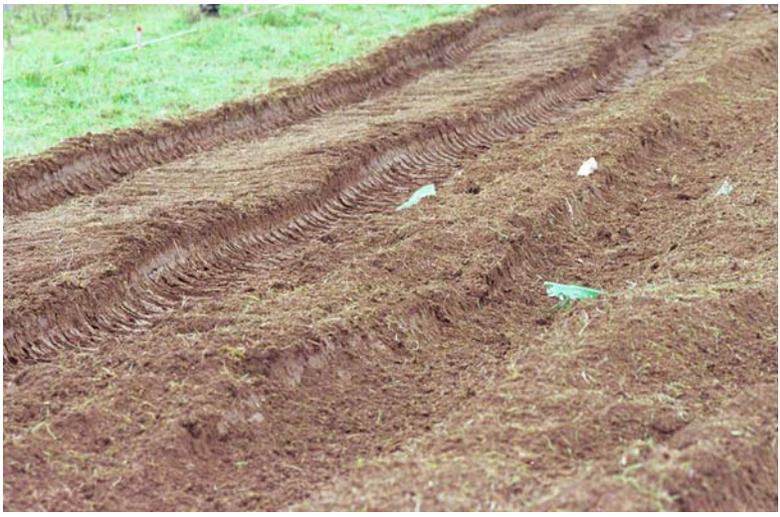
Picture 7 Moving tracks of the 910 MCV

Picture 8 Moving tracks of the 910 MCV

Picture 9 Moving tracks of the 910 MCV

The condition of the test lanes and moving tracks after the clearance trials are presented in the pictures hereafter:

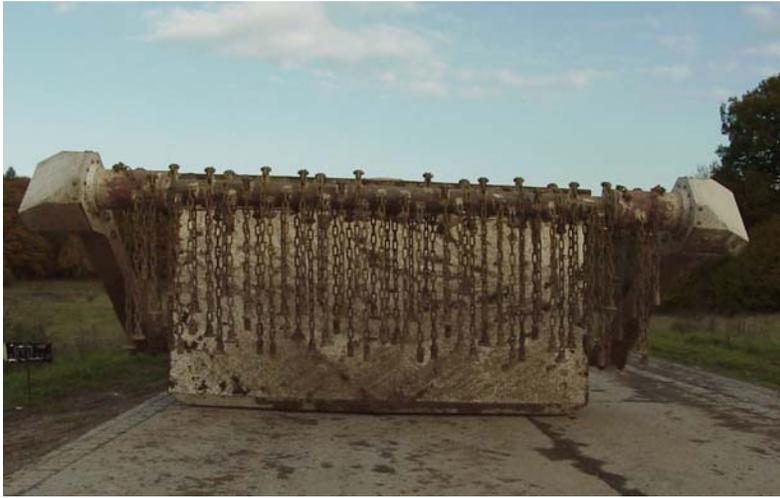
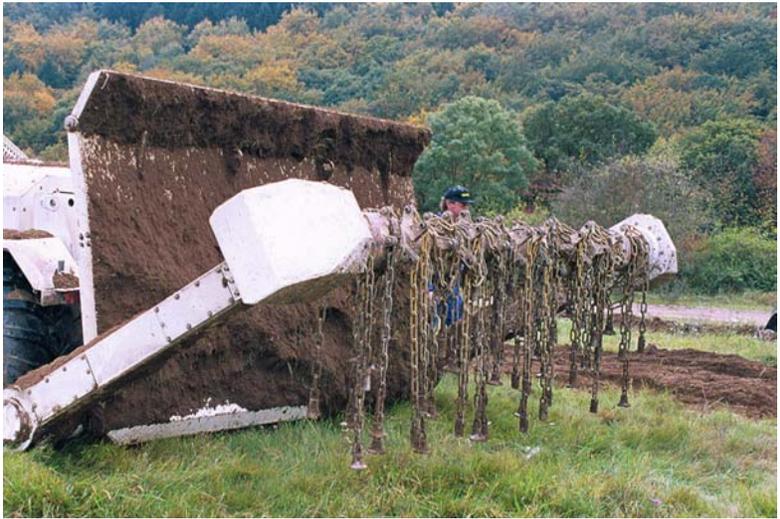
Picture 10 910 MCV Condition of the flails after the trials on Schmidtenhöhe

Picture 11 910 MCV Condition of the flails after the trials on Schmidtenhöhe

The condition of the clearance equipment after the trials on the Schmidtenhöhe, Koblenz test field is illustrated in [Annex 15 picture 10 and 11](#).

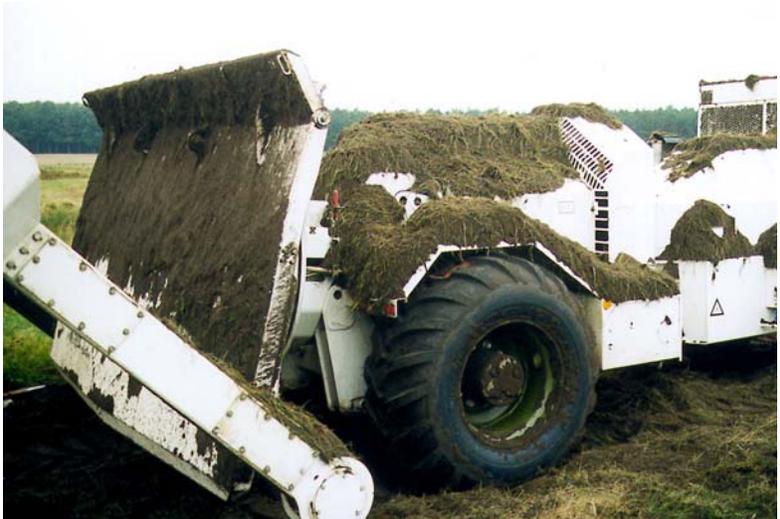
Picture 12 910 MCV Condition of the vehicle after the pre-trials on WTD 91

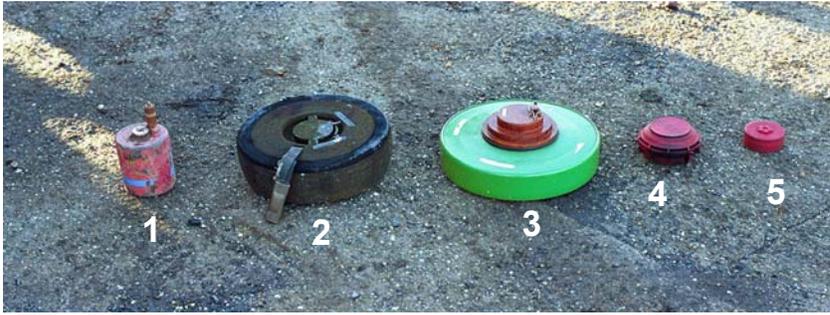
<p data-bbox="212 659 646 814"> 1 DM 31 Splitterspringmine 2 DM 21 Panzerabwehrmine 3 TM 62P3 Panzerabwehrmine 4 PPM-2 Schützenabwehrmine 5 DM 18 Schützenabwehrmine </p>		<p data-bbox="1141 302 1287 331">Picture 13</p> <p data-bbox="1141 371 1300 401">Used mines</p>

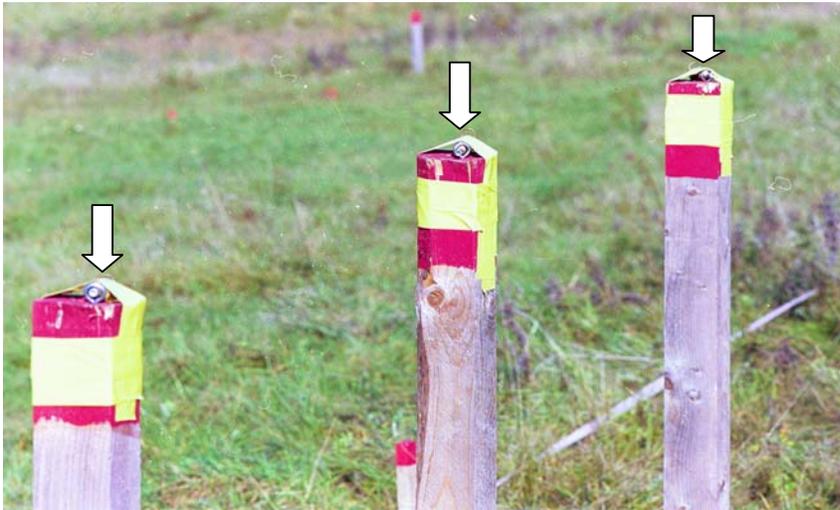
<p data-bbox="1141 835 1287 865">Picture 14</p> <p data-bbox="1141 905 1370 968">Mine fuses MIZ DM 56 A1B1</p>

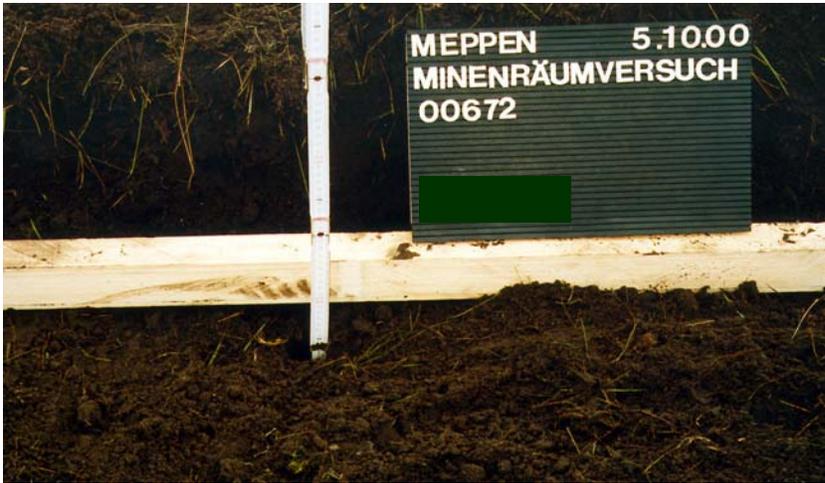
<p data-bbox="1141 1409 1287 1438">Picture 15</p> <p data-bbox="1141 1478 1365 1541">Clearance depth measurements</p>

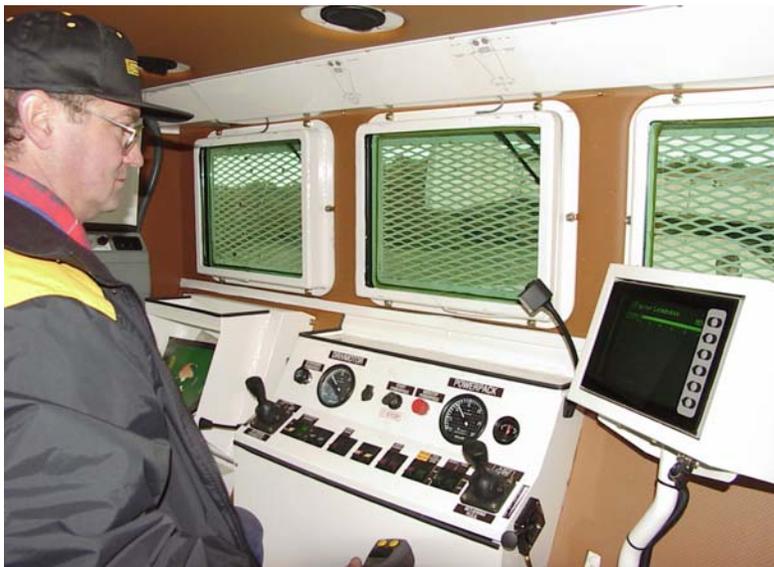
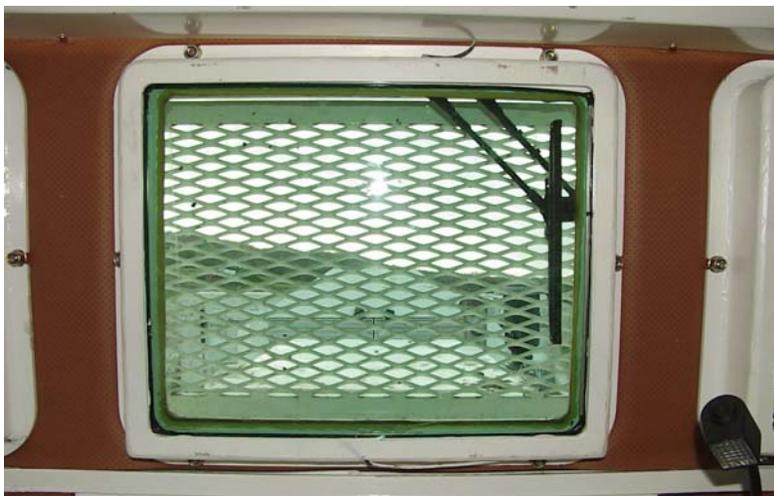
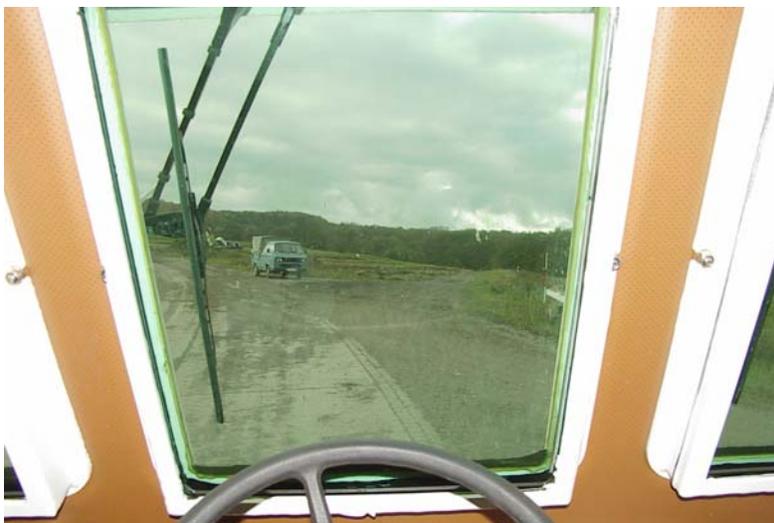
910 MCV
Window alignment during
the clearance process

910 MCV
View during the
clearance process

910 MCV
View during front drive

Operation: The operating of the machine from the driver cabin created no problems, notwithstanding the view conditions ([see Annex 15 picture 16 to 18](#)) being very limited due to the protection blade. The programming of the soil characteristics in the on-board computer requires however much experience.

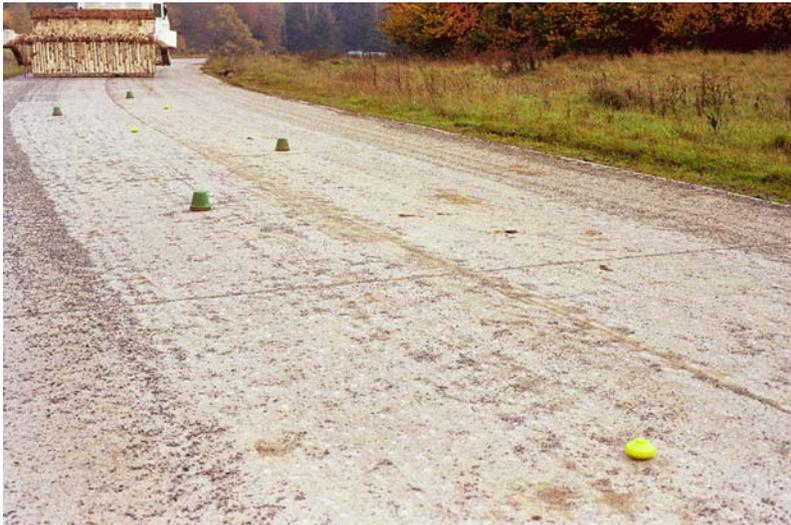
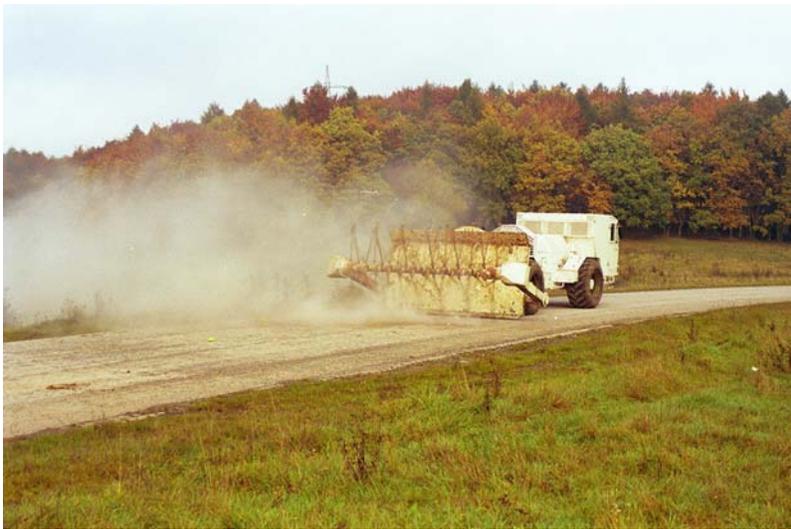
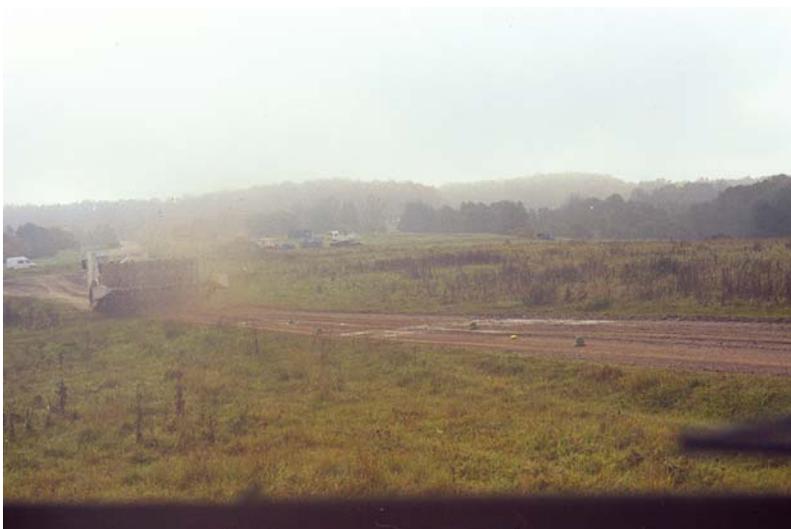
<p>Picture 19</p> <p>910 MCV Dummy mines distributed on paved roads</p>

<p>Picture 20</p> <p>910 MCV Clearance of mines on a paved road</p>

<p>Picture 21</p> <p>910 MCV Clearance of mines on a paved road</p>

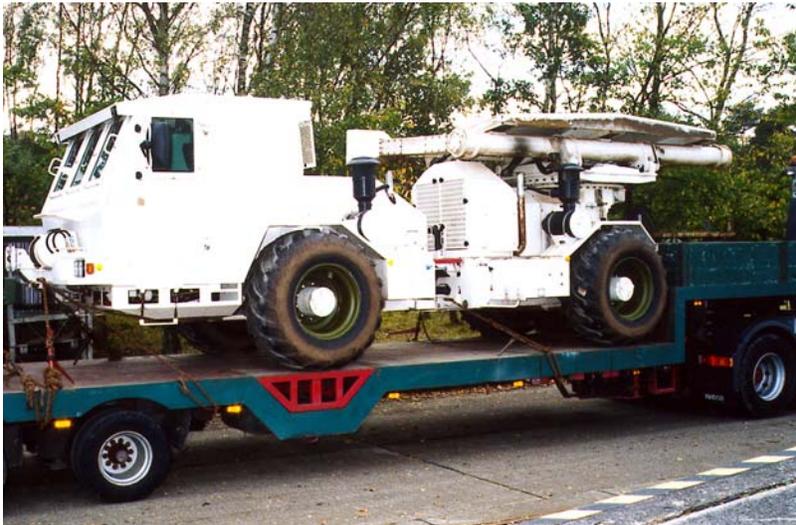
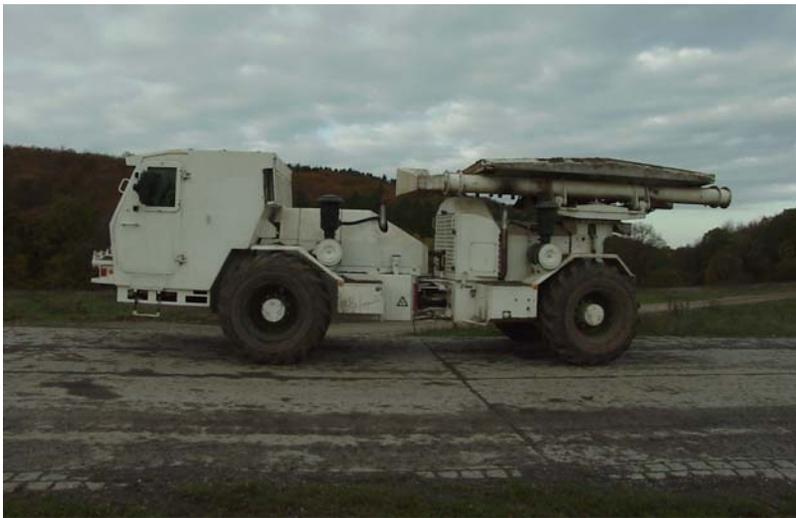
Picture 22 910 MCV Mounted on a trailer

Picture 23 910 MCV Road transport position

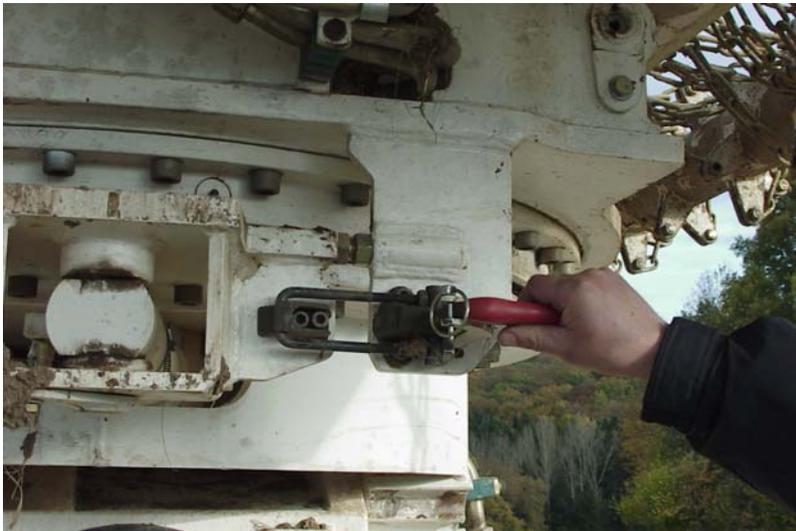
Picture 24 910 MCV Loosening of the fuse of the rotating assembly

2. Loose the fuse of the rotating assembly on the vehicle's tail ([see Annex 15 picture 24](#)).
3. Loose the screw fuse on the rear handle bar ([see Annex 15 picture 25](#)).
4. Rotate flail pushing frame and blade of 90° ([see Annex 15 picture 26](#)).
5. Flap flail pushing frame and blade to the stop position ([see Annex 15 picture 27](#)).
6. Lower flail pushing frame to the clearance position – starting position is reached - ([see Annex 15 picture 28 and 29](#)).
7. For road clearance the blade will be lowered until the rollers touch the ground.
For terrain clearance the rollers have to be dismantled first.

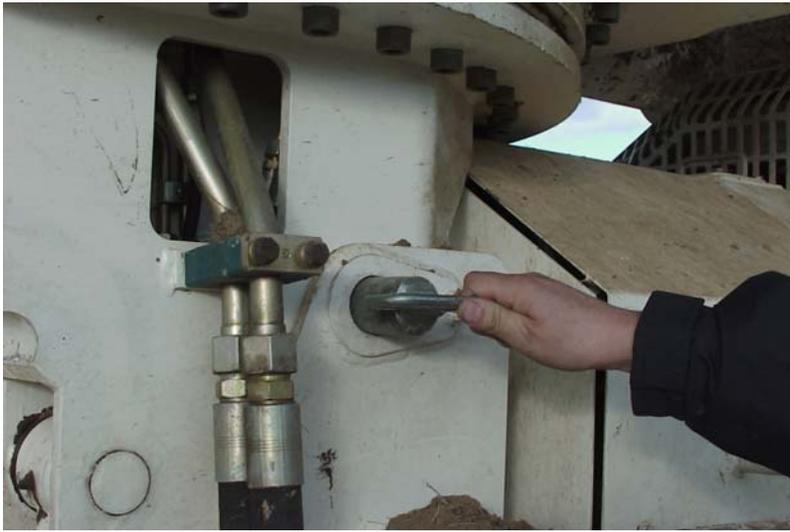
<p>Picture 25</p> <p>910 MCV To loose the screw fuse on the rear handle bar</p>

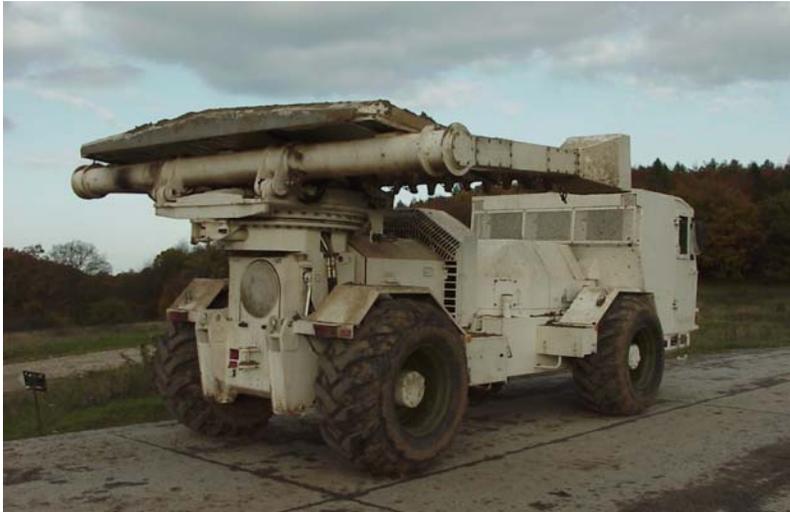
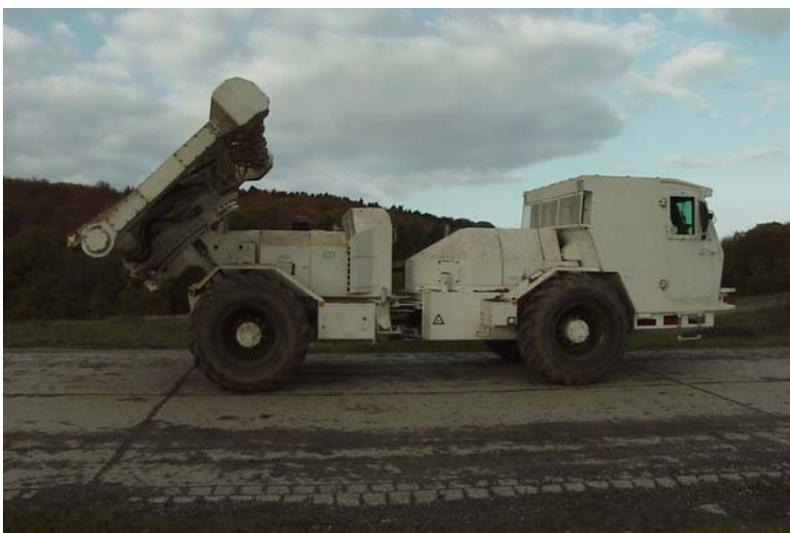
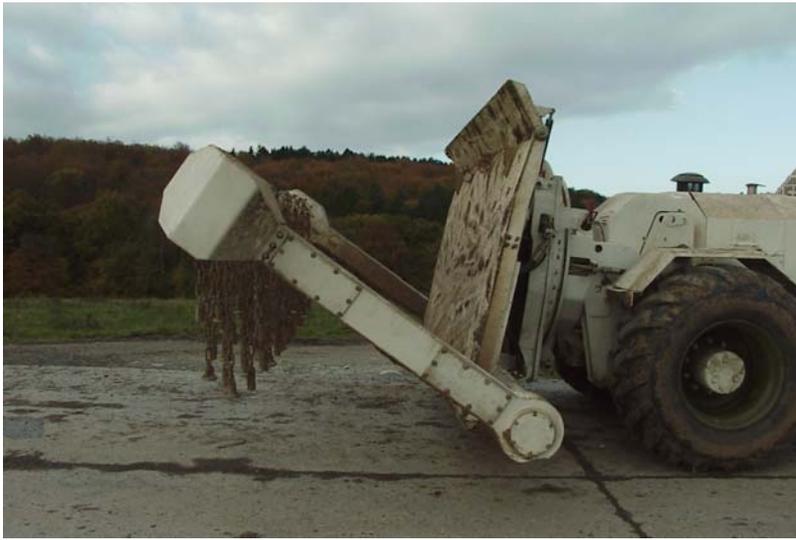
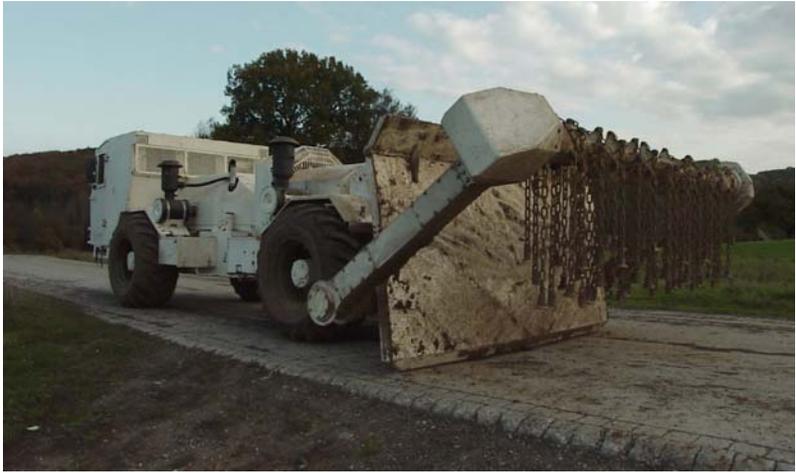
<p>Picture 26</p> <p>910 MCV Rotation of 90° of the flail pushing frame and blade</p>

<p>Picture 27</p> <p>910 MCV Flail pushing frame and blade flapped to the stop position</p>

<p>Picture 28</p> <p>910 MCV Flail pushing frame lowered to the clearance position</p>

<p>Picture 29</p> <p>910 MCV Clearance position</p>

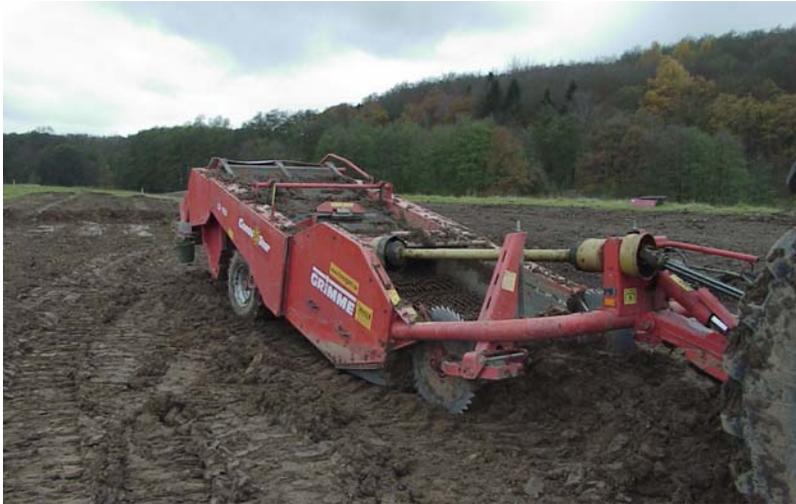
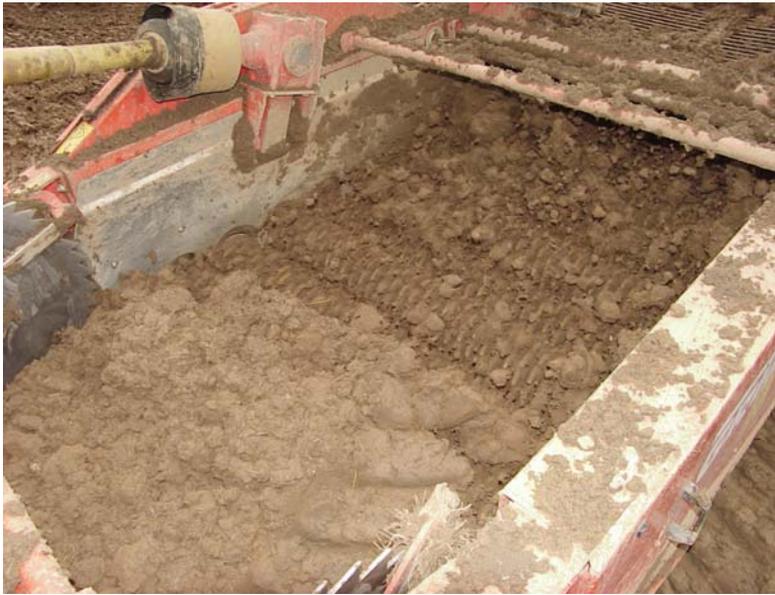
<p>Picture 30</p> <p>Searching for remaining mine fragments with the rock collector</p>

Picture 31 Searching for remaining mine fragments with the rock collector
