HD R&D Field Evaluation: Multi-Tool Excavator

DEVELOPMENT AND TEST OF THE HUMANITARIAN DEMINING SIFTING EXCAVATOR

Christopher Wanner
Night Vision and Electronic Sensors Directorate
October 2003

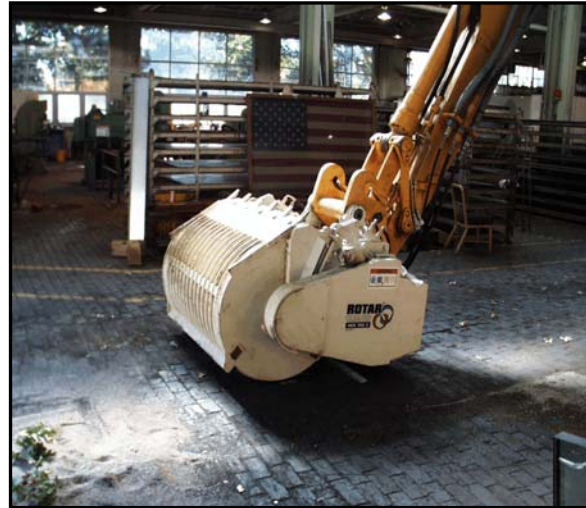
Figure 3. Rotar Sifting Bucket

The primary sifting tool for the excavator is the Rotar sifting bucket (see figure 3). The Rotar is basically a drum shaped cage. The drum can be opened to allow the operator to scoop loosened soil into the cage, then closed and spun at speeds up to 30 RPM. Soil will crumble and pass through the cage walls, dropping to the ground. Mines and other large objects are retained and emptied for inspection at the end of the sifting cycle. The Rotar is a commercially available attachment built and sold by Rotar International b.v. of Genemuiden, Netherlands, for separating debris from soil in trash areas. It was first adapted for mine clearing by MGM of Namibia.

The HEX 700 model used on the Sifting Excavator has a capacity of 650 liters and fully loaded weight of 1850 KG. The Rotar hydraulic system was custom designed for this application by Rotar Inc. according to Night Vision specifications to make the system compatible with the Shinn HPU and Liebherr controls. The Rotar is manipulated with the existing Liebherr controls; in addition, the mechanical locks which control the opening and closing of the bucket are integrated with the Liebherr control system and operated from buttons on the operator’s left joystick. The power for spinning the cage is supplied by the Shinn HPU and rotational speed is controlled from the Shinn system joystick on the operator’s right side. The mechanical interface with the excavator will permit the Rotar to be mounted for either forward scooping (away from the vehicle) or rearward scooping (toward the vehicle). For use consistent with the operation concept, the Rotar faces away from the cab, and the operator uses a forward stroke to pick up the residuals in the bottom of the trench against the trench wall.

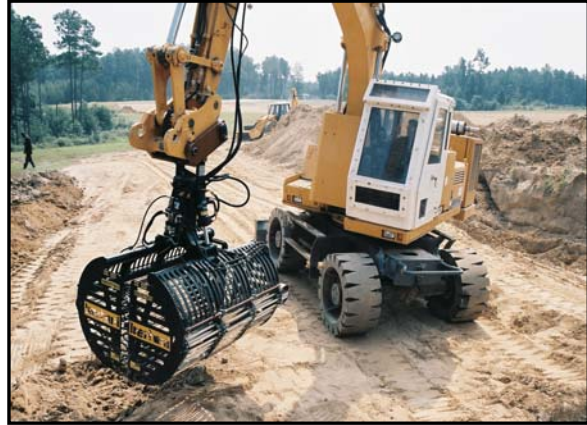
Figure 4. Bertani Sifting Bucket

The second sifting implement for the excavator is the Bertani Bucket, originally designed and sold commercially by Bertani & Donelli of Castelnovo Sotto, Italy for harvesting beets. The Bertani Bucket hangs from the end of the excavator boom and opens like a clamshell bucket for picking up loosened soil in a pile (figure 4). When the clamshell is closed, the operator activates the sifting action which consists of moving, slotted belts in the bottom of the bucket. Soil passes through the slots in the belts and mines and other large objects are retained and emptied in an inspection area (figure 5). The Bertani FBS 1500 used on the Sifting Excavator has a capacity of 1500 liters and weighs fully loaded 1770 KG. Because of the larger volume and the more aggressive sifting action, the Bertani is capable of reducing piles faster than the Rotar, however it does not pick up material as cleanly, nor does it have provision for retaining all materials inside the bucket until the sifting action has begun. This can be a problem when trying to clean the trench completely and when moving from the excavation location to the sifting location. The Bertani Bucket is manipulated with the existing Liebherr controls, and the opening and closing of the clam is integrated with the Liebherr control system and operated from buttons on the operator's left joystick. The power for running the sifting belt is supplied by the Shinn HPU, and belt speed is controlled from the Shinn system joystick on the operator's right side.

The Bertani Bucket is a lighter and simpler design than the Rotar Bucket. It has a larger volume and very aggressive sifting action. For these reasons it is capable of sifting through a pile more quickly. The scooping action is not as clean as the Rotar, nor is the construction as robust. The Bertani tends to leave a 0.1 meter high trail of soil where the jaws come together and for this reason, the operators tend to dig a little deeper with the Bertani in order to ensure that all mines have been picked up. In the dry, powdery conditions prevalent during the practice operations, there was no method of retaining all the soil in the bucket until the sifting action was started. Although no mines would be lost, the spilled residuals can create uncertainty for the operator and observers as to where the sifter has been when a small pile is left at the pickup location. The Bertani Bucket was originally designed for harvesting beets from cultivated soil. Thus the construction is somewhat fragile and the drive motors lightly powered. One or two back and forth

movements of the sifting belt are sometimes needed before continuous sifting action is sustained in heavy, wet, or heavily rooted soils. The sifting bars on the belt are constructed of 22 mm nylon bars. The bars are somewhat pliant and can be sprung from their mounting pins on the drive chains. On average 1 bar dropped out for every 8 hours of operation. Although losing 1 bar is not a crisis, each lost bar must be replaced eventually. A tool will have to be designed to assist with this, as few people possess the strength needed to deform the bars enough to spring them back into place.

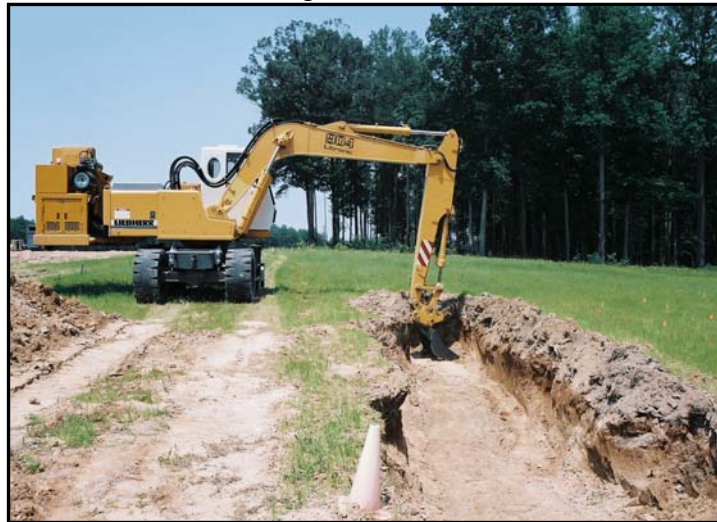
Figure 7. Working Across Trench

After completion of the starter trench the excavator was positioned adjacent to the trench on the “safe” side. The operator would reach across the open trench and down into the hole to perform the excavation (figure 7). The undercarriage was positioned parallel to the long dimension of the trench so the excavator could continually drive straight along the wall of the trench as the operator progressed down the length of the hole. The digging was performed with the undercarriage positioned approximately 1.2 -1.4 meters from the edge. Multiple passes made in this manner widened the trench to 5-6 meters at which point the excavator could no longer reach across.

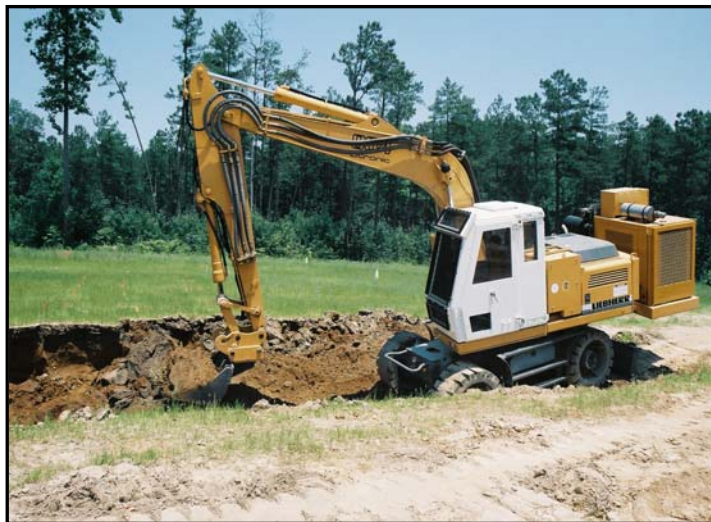
Figure 8. Working Inside Trench

The digging bucket was again used to further excavate the safe side until the trench width was 7.5-9 meters and the excavator could drive down in the trench and have sufficient

width to pivot the upper carriage 360 degrees (figure 8). As it turned out this width left insufficient room to adequately maneuver the excavator. Considerable time was wasted repositioning the excavator each time the machine needed to move, as just a little bit of drift in the positioning of the carriage as the operator moved along the trench would result in his becoming “tangled” with a wall. As the clearing operations widened the trench to 10 meters, the maneuver room was no longer an issue.

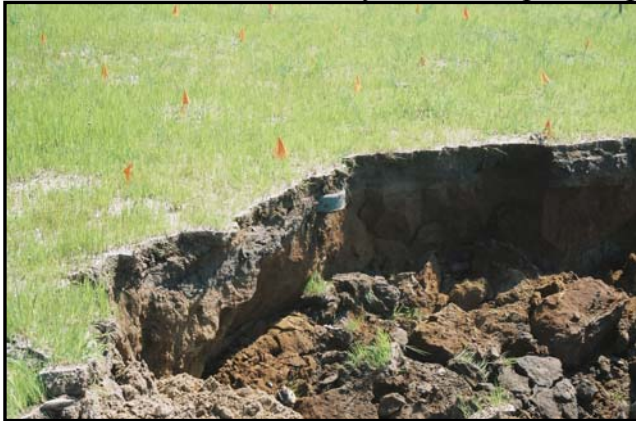
Figure 9. AT Mine Exposed In Bank

Appendix 1 maps the location of each mine and records the observations made as each mine was excavated, retrieved, and examined/tested for functionality. In the operational procedure planned for the Sifting Excavator each mine encountered would have 3 separate opportunities to be visually detected and recovered. The first is when the face of the trench is excavated and the mine is left exposed in the face as in figure 9. The second is when a portion of the bank collapses and the mine is visible in the spoils at the base of the mined face. The third opportunity is when the pile is picked up by one of the sifting buckets. Best practice would demand that a given mine be recovered at the first opportunity at which the mine was visually detected. For the purposes of gathering information on the efficiency of each step in the process, AT mines which presented themselves visually in the bank were not recovered, but instead were permitted to stay in the process and be detected again in the pile. At the point at which each AT mine had fallen into the spoils, each AT mine was recovered and examined to determine whether or not the fuze had functioned in the excavation process. AT mines which appeared not to have triggered were set aside and sufficient pressure was applied to the pressure plates to cause triggering and verify that the mine was in fact able to function.

themselves visually in the bank were not recovered, but instead were permitted to stay in the process and be detected again in the pile. At the point at which each AT mine had fallen into the spoils, each AT mine was recovered and examined to determine whether or not the fuze had functioned in the excavation process. AT mines which appeared not to have triggered were set aside and sufficient pressure was applied to the pressure plates to cause triggering and verify that the mine was in fact able to function.

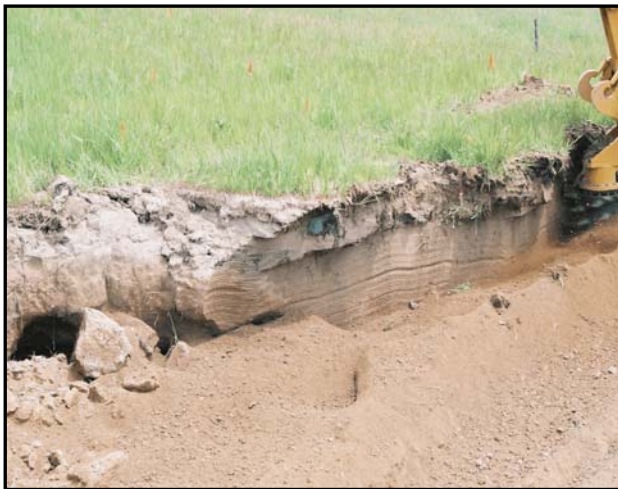
Figure 11. Mine Exposed in Bank with Vertical Mill

The Vertical Mill was perhaps the most operator skill intensive tool developed on this project. With additional practice time it is believed that the 88.9% bank exposure efficiency in table 2 could be made to approach 100% in homogeneous soils without large rocks or tree roots. As it was, 2 of the 18 mines encountered were excavated from the bank without first becoming visible. Structural damage to mines still embedded in the bank but visible on a side was light to moderate, and in normally oriented mines safely isolated from the fuzing portions of the mine. One such mine is pictured in the center of figure 11. All mines were

base of the trench. The structural damage to the mines after extraction from the bank was in most cases moderate to substantial. Again, most of the damage was on the sides and bottom of the mine, away from the fuze. 1 of the 18 mines did trigger upon extraction from the bank with the Vertical Mill. Acknowledging the statistical problem of reporting efficiencies to two or three significant digits on the basis of 18 test objects, we expect the Vertical Mill to eject 11.1% of the mines from the trench wall without first exposing them. 5.6% of those mines which are ejected may be expected to function, giving a theoretical ability to safely detect 99.4% of the all AT mines and trigger the remaining 00.6%. Again with the low number of test objects in this test, the composite score for all of the AT mines being safely recovered was 100% (because the 1 mine that was triggered was visible and recoverable when it first appeared in the bank before being triggered).

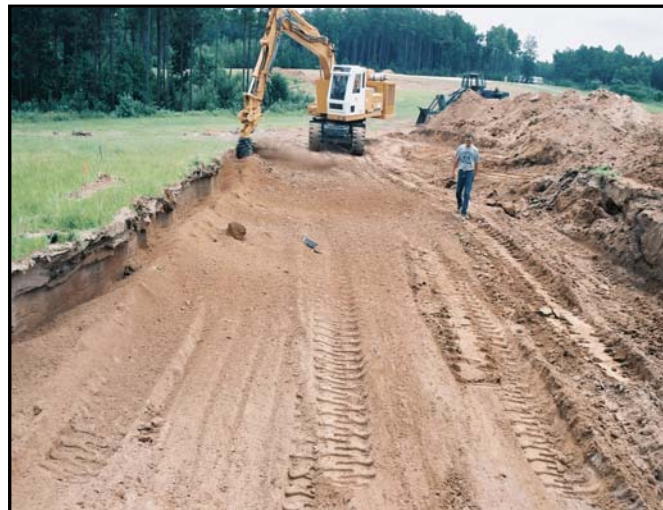
Figure 12. Vertical Mill Completing a Rearward Pass

A rearward stroke, that is moving the mill against the direction of spin produces a very aggressive cutting action. It is believed to be gentler on the mine cases because the maximum angle the mine must be transported through the soil is 1/4 of a rotation before reaching a free surface. Unfortunately this direction also produces a wide dispersion of materials coming off of the wall (see figure 12). The excavated soil layer although thin (<0.1 m beyond 1 m from wall), extends to 4.5 m from the wall and overlaps with the path of the excavator. A forward stroke, on the other hand, produces a very well behaved pile which lays in tight against the wall. The disadvantage to moving in this direction is a slower cut and a perceived rougher treatment of the mines since they must be pushed deeper into the bank for 1/4 of a revolution before movement toward the free surface for another 1/4 of a revolution. Mainly owing to the better dispersion of excavated soils, the forward stroke was chosen as the preferred direction for the majority of the testing. It is possible to envision a usage SOP with very tight monitoring of the

vehicle path which would make the rearward stroke more attractive, however, the secondary problem of picking up the thinly dispersed soils spread far from the wall for sifting represents another inefficiency which would need to be overcome.

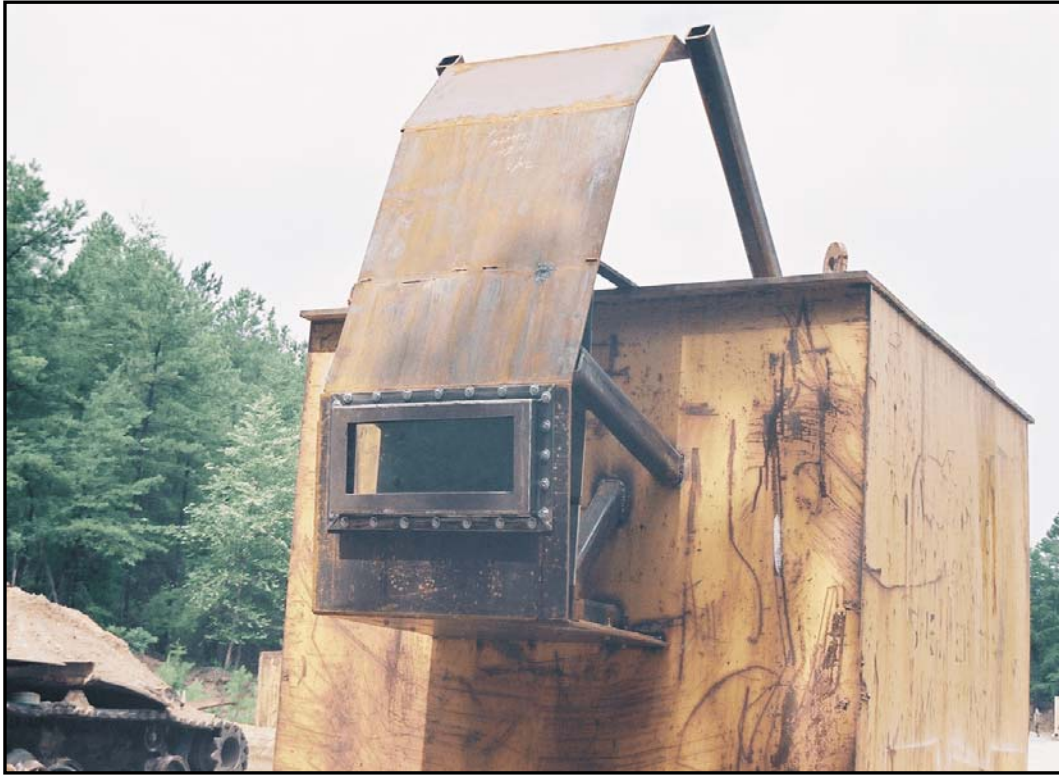
Figure 13. Blast Shield

As described in the introduction to the equipment, the vehicle cab was developed previously to provide protection for the operator from AP mine blast and bounding mine fragments. It is constructed of 0.5 inch 6066 hardened aluminum. It has been successfully demonstrated stopping fragments from the M16 bounding fragment mine detonated 1 meter from the cab. In order to enhance the blast survivability of the operator an additional layer of protection was designed and added to the front of the cab. The blast shield is intended to deflect heavy blast loading from reaching the aluminum cab coming from the forward direction. If the excavator is always kept on cleared ground, reaching into the hazardous areas to work, the shield will always be between the operator and the most likely sources of heavy mine blasts encountered during the initial excavation of the mines. The technical goal of the shield, then, is to ensure the aluminum cab remains fully intact when subjected to the blast of a large antitank mine detonated in the working zone around the end of the bucket positioned at minimal working distance. The minimum working distance was chosen at 4.0 meters, which is the location of the tine tips on the Vaned Bucket when the bucket is lying flat on the ground and the stick is vertical.

For the purposes of conducting the tests a simplified replica of the blast shield was constructed. The test shield had the same geometry and materials as the actual shield; however, only one of the three windows in the shield was installed (see figure 13). The actual shield has three windows stacked in a column on the shield face. Only the lowest window (which is closest to the blast site) was in place on the replica. Placed on vertical columns approximately 0.25 meters behind the shield were 4 aluminum witness plates of varying strength. The plates were bolted at each end to the columns and spanned a

distance approximately 1 meter. The lowest plate on the columns was 0.5 inches thick (12.7 mm), the second plate was 0.25 inches thick (6.4 mm), the third plate was 0.125 inches thick (3.2 mm), and the top plate was 0.0625 inches thick (1.6 mm). The purpose of the plates was to provide evidence of the destructive strength of the blast behind the shield as well as any fragmentation penetrating or spalling on the interior of the shield.

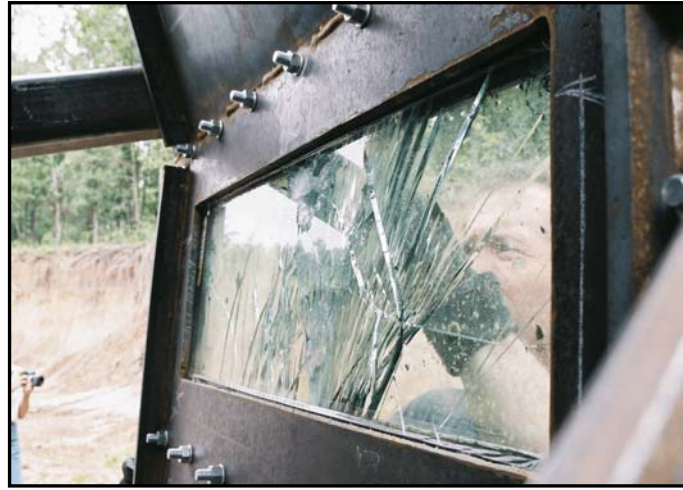
Figures 15 and 16 show the effects of the blast on the shield. The outer surface of the shield was pitted with impact marks from flying debris but none of the fragments penetrated the thickness of the metal more than 0.5 mm. There was no perceptible deformation to the shield structure or cracks visible in the surfaces. The glass cracked extensively and two rock fragments embedded in the outer surface. No evidence could be found of any materials penetrating through the glass. An icecube sized chunk of glass did spall on the inner surface; however the evidence suggests that it came off at low velocity. There were no scratch marks on the soft aluminum witness plate directly behind the glass surface, less than 0.2 meters away. The glass chunk itself was lying intact about 0.1 meter from the spot where it originated.

The shield performed well and is believed to be capable of adequately protecting the structures behind it from blasts originating in front of the cab, provided the minimum 4.0 meter standoff from potential mine hazards is maintained. The cab construction of 12.7 mm 6061 aluminum plate has over ten times the strength of the thinnest witness plate (6.4 mm) which did not deform in the blast test. The blast protecting glass also performed well and did not permit any through penetrations when twice blasted.

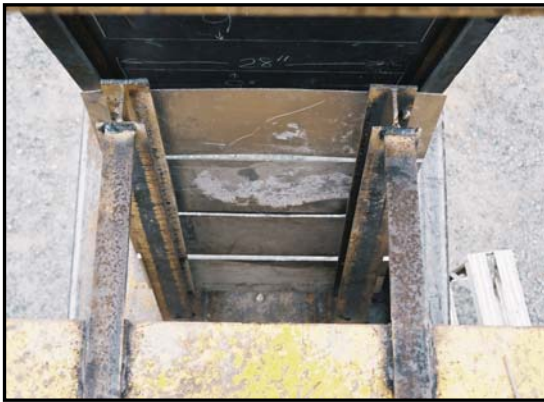
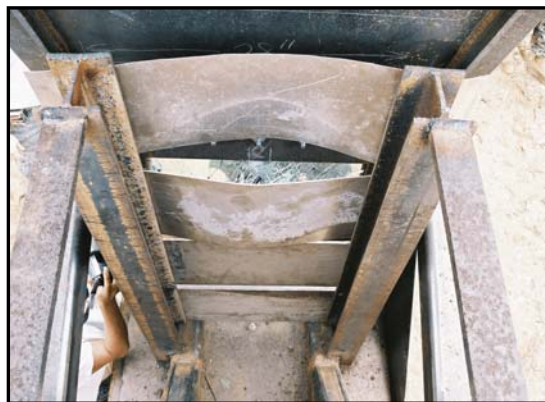
Figures 17 and 18 provide an overhead view of the witness plates standing behind the shield before and after the blast. As commented above, no scratches or impact marks of any kind were found on any of the witness plates. The 1.6 mm plate did deform significantly as did the 3.2 mm plate below it. No perceptible deformation occurred to either the 6.4 mm or 12.7 mm plates.

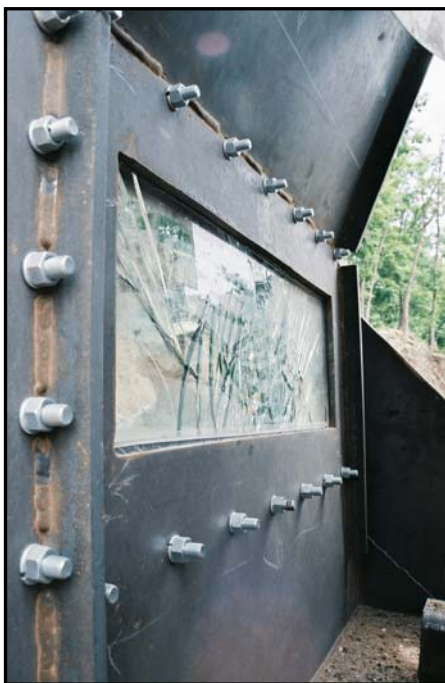
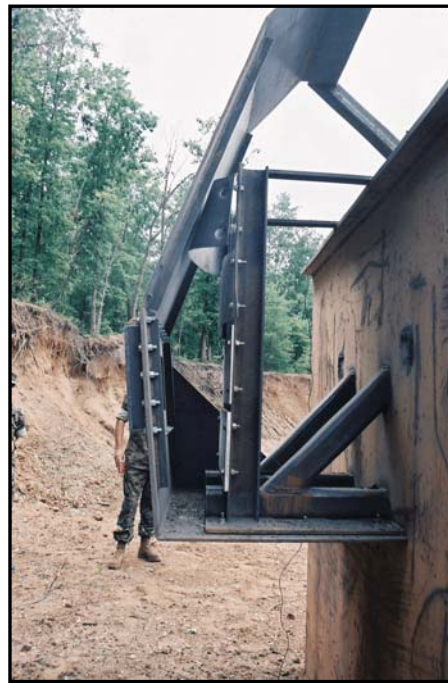
The shield was blasted a second time with conditions identical to the first. As can be seen from figures 19 and 20 no further damage was done to the shield beyond additional cracking of the glass and further bending of the 1.6mm and 3.2 mm witness plates.

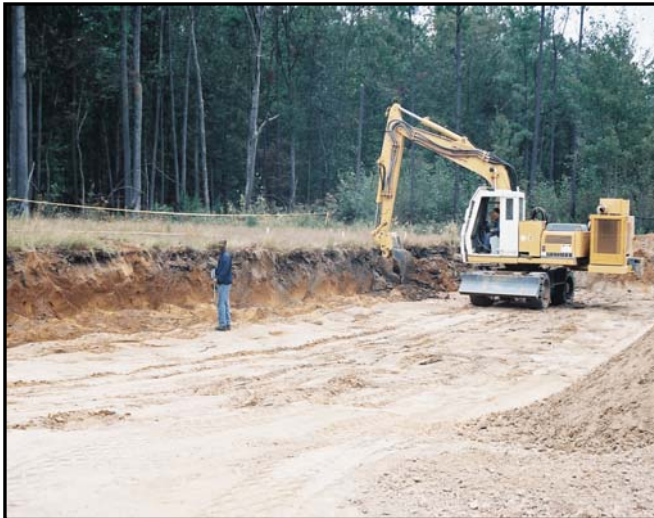
Figure 22. Blind Test - Excavation

The tools chosen to use to perform the test were the Vaned Bucket and the Bertani sifter. The Vaned Bucket was chosen as the faster more robust approach for safely excavating AT mines. The per pass cut from the Vaned Bucket is about twice the recommended cutting penetration with the Vertical Mill. In addition, the mill was judged to require additional practice time in order to develop sufficient confidence that operators could bring the detonation risk down to an acceptable level. In contrast, the Bertani Bucket was chosen mainly on the basis of speed. It is believe that either the Rotar or Bertani could

The starting trench was dug with the excavator immediately adjacent to the minefield boundary. The trench was dug 9 - 10 meters wide and 32 meters long. A drainage ditch was cut at one end 1 meter wide which ran down a slope. The other end had the entrance ramp. Excavating passes were made starting at the “far” end and working toward the ramp. Although test personnel were close by, they were not permitted to influence the operator and only observations made by the operator were recorded during the time the system was in operation. In between passes inspections of the area were made and additional observations

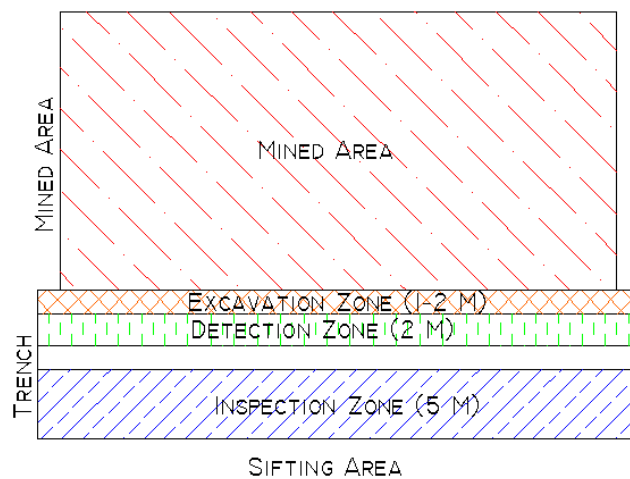
Figure23. Layout of Working Trench

When the digging pass was completed, the Vaned Bucket would be removed from the excavator and the Bertani Bucket would be installed. Soil which had accumulated at the base of the wall would be picked up with the Bertani. Use of the Bertani was determined to require the operator to run with the boom nearly perpendicular to the wall. Thus he could pick up soil from a zone approximately three buckets wide before having to move the excavator. After a load was picked up, the cab would rotate 180 degrees with the Bertani over the edge of the pile on the “safe” side. The rotation would always be done to the rear so that the Bertani Bucket never traveled over the path of escape for the

excavator. The sifting action would be started and would continue until only large solid materials (heavy soil clods, roots, mines etc) remained in the bucket. The sifting action required approximately 15-30 seconds. When the sifting was completed, the bucket was again swung in the rearward direction and the contents emptied in the trail behind the excavator. Initially we had hoped to confine the residuals to a narrow band following the excavator tracks; however, experience dictated a wider spread to the residuals to keep the layer thin. In the end the area from the wheel track on the mined side of the trench over to the base of the clean soil pile was used for inspection of residuals. When the sifting pass was completed, the inspection team would again enter the trench and inspect the residuals with metal detectors. In addition to inspecting the residuals pile, a 2 meter zone beginning 1 meter from the wall out to the 3 meter point would be given a final check with the metal detector to ensure no mines had slipped by the process. The overall layout of the working process is diagrammed in figure 23.

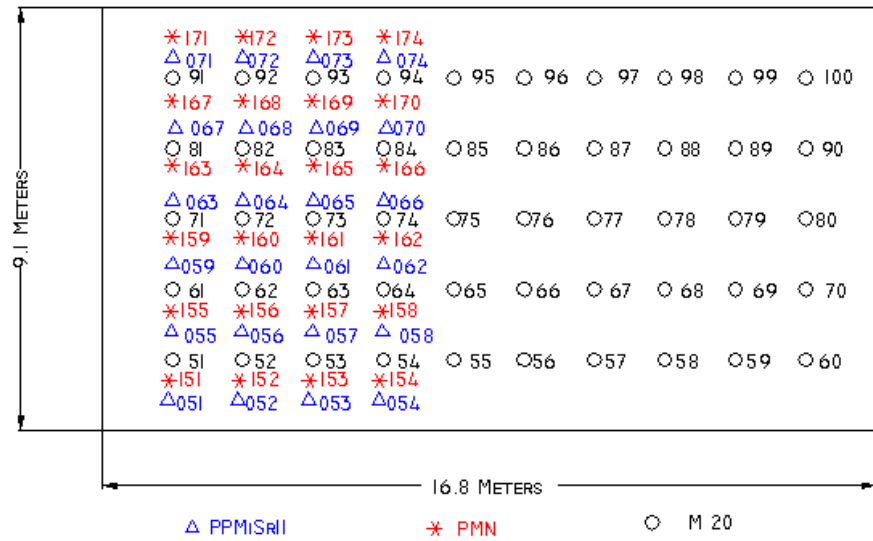
Layout and Mine Locations within Practice Area

AT Mines In Practice Minefield							
AT Mine Number	Burial Depth (cm)	Tool Used	Visible in Bank	Visible on Pile	Triggered in Recovery	Function Verified	Comments
51	10						Area Not excavated
52	10	Vaned	Yes	Yes	No	Yes	
53	10	Vaned	Yes	Yes	No	Yes	
54	10	Vaned	Yes	Yes	No	Yes	
55	10	Mill	Yes	Yes	No	Yes	
56	10	Mill	Yes	Yes	No	Yes	
57	10	Vaned	Yes	Yes	No	No	Mine was buried unarmed
58	10	Vaned	Yes	Yes	No	Yes	
59	10	Vaned	Yes	No	No	Yes	
60	10	Vaned	Yes	Yes	No	Yes	
61	20						Area Not excavated
62	20	Vaned	Yes	Yes	No	Yes	
63	20	Vaned	Yes	Yes	No	Yes	
64	20	Mill	Yes	Yes	No	Yes	
65	20	Mill	Yes	Yes	Yes	Yes	
66	20	Mill	No	Yes	No	Yes	
67	20	Mill	Yes	Yes	No	Yes

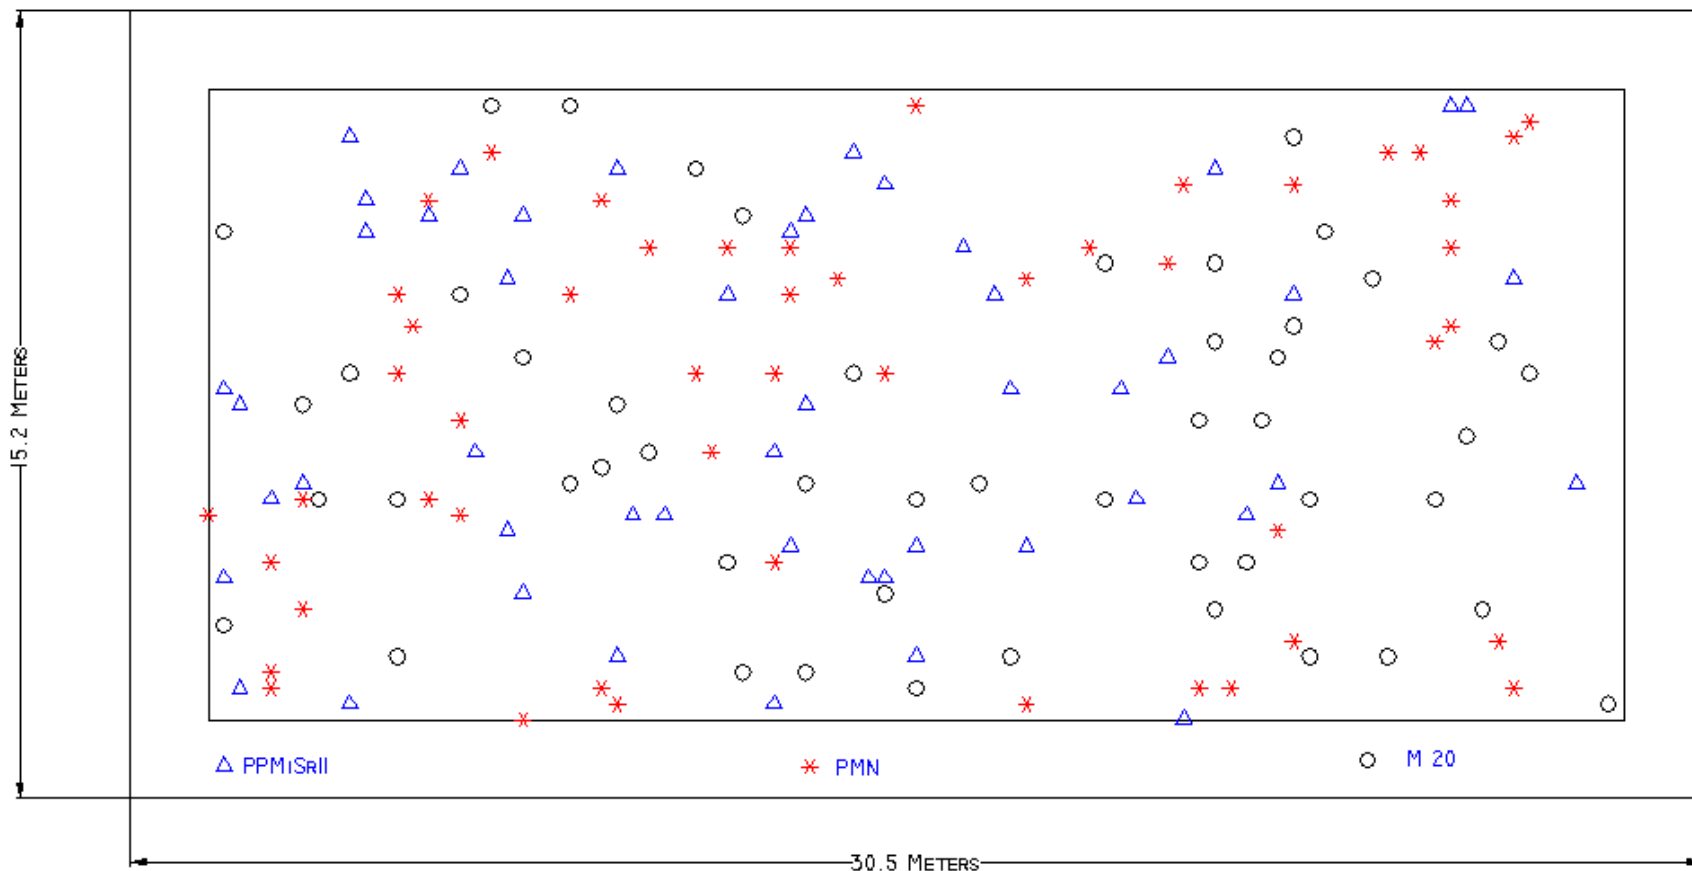
Mine Locations In Blind Minefield

AT Mines Blind Minefield					
Mine Number	Visible In Bank	Visible in Pile	Fuze Triggered	Function Verified	Comments
1	Yes 2:25 10/2/03	Yes 2:25 10/2/03	No	Yes 2:25 10/2/03	
2	Yes 2:00 10/2/03	Yes 2:00 10/2/03	No	Yes 2:05 10/2/03	
3	Yes 2:00 10/2/03	Yes 2:00 10/2/03	No	Yes 2:05 10/2/03	
4	Yes 2:00 10/2/03	Yes 2:00 10/2/03	No	Yes 2:05 10/2/03	
5	Yes 11:15 10/2/03	Yes 11:15 10/2/03	No	Yes 11:15 10/2/03	
6	Yes 2:00 10/2/03	Yes 2:00 10/2/03	No	Yes 2:00 10/2/03	
7	Yes 11:40 10/2/03	Yes 2:20 10/2/03	No	Yes 2:20 10/2/03

20% of the AT mines were buried 50 centimeters, 20% at 40 centimeters, 20% at 30 centimeters, 20% at 20 centimeters, and 20% at 10 centimeters. The AP simulants were buried one month in advance, approximately 10 to 20 centimeters. The minefield layout and mine locations are shown in appendix 2.
