Performance Evaluation Test of the Nemesis M3

September 2008

Prepared by
Institute for Defense Analyses
4850 Mark Center Drive
Alexandria, VA 22311-1882

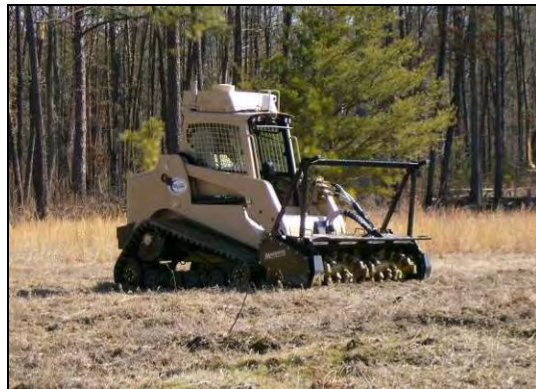
The Nemesis tracked vehicle (Figure 1) was assembled by Applied Research Associates, Inc., on an ASV SR-80 vehicle. It can operate a suite of area-preparation tools. The Nemesis hydraulic track-laying drive system gives the operator the ability to maneuver in all types of terrain, as well as perform 180-degree turns within its own length. Table 1 lists the Nemesis specifications.

Figure 1: Nemesis with Vegetation Cutter Attachment

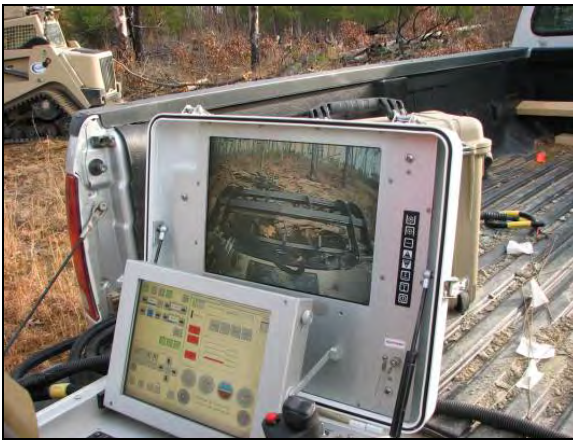
The Nemesis, which can also be controlled by an on-board operator, is fitted with the Modular Robotic Control System (MRCs), a remote-control system manufactured by Applied Research Associates, Inc. This system can provide up to 1.5 km line-of-sight control with video and up to 2.4 km without video. The remote system consists of a receiver antenna, a remote operator control unit, a battery, and the transmit antennas and cameras mounted on the Nemesis vehicle. The operator control unit gives remote operators the ability to fix vehicle speed, maneuver and perform operations with attachments, and view operations from a selection of four cameras (to include a pan/tilt camera that can be slewed by the operator to any desired forward-looking location) through the use of touch-screen and joystick controls (expandable up to eight cameras). In addition, the remote system is equipped with Global Positioning System (GPS) receiver to provide tracking, track mapping, and a record of the vehicle's current location. Figures 2–5 give images of the remote system components, and Table 2 lists specifications of the radio control system.

Figure 2: Remote Operator Control Unit with Battery Box

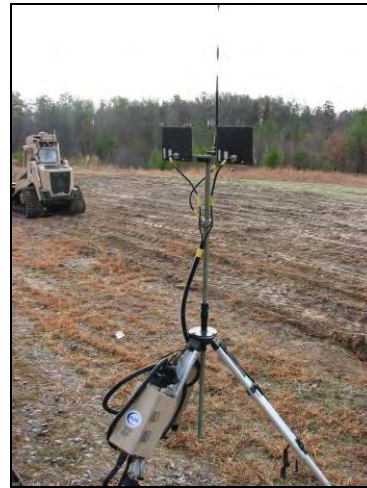
Figure 3: Remote Transmit/Receiver Antenna

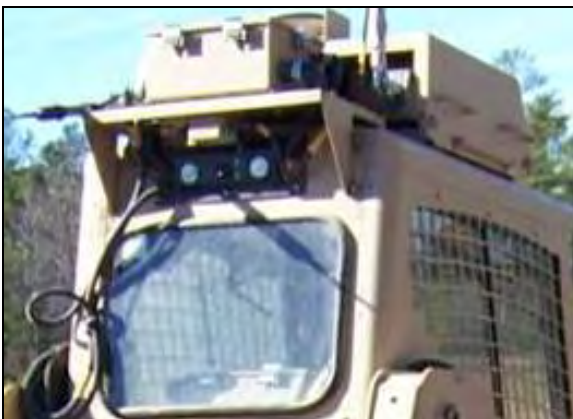
Figure 4: Vehicle-Mounted Remote Transmit/Receive Antennas and Electronics Box

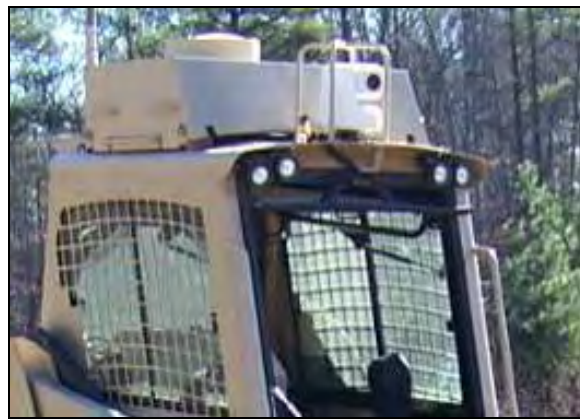
Figure 5: Vehicle-Mounted Pan/Tilt Camera

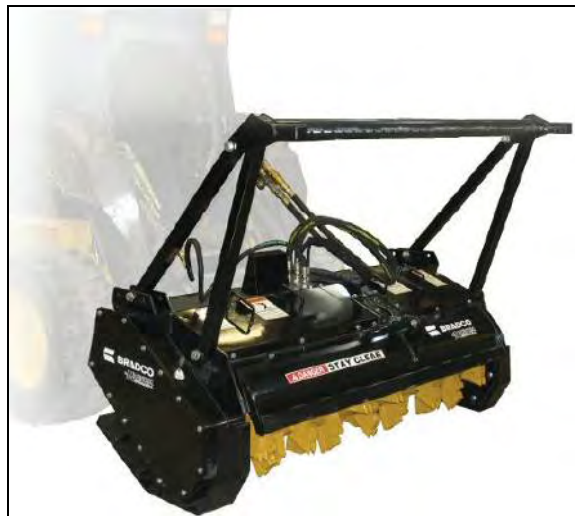
The set of attachments for Nemesis currently contains four skid-steer tools: a mulcher, grapple bucket, 4-in-1 bucket, and a cold asphalt planer. The primary tool is the heavy-duty Bradco Mini-Mag Mulcher brush cutter, capable of cutting heavy undergrowth and trees up to 20 cm (8 inches) in diameter. Figure 6 shows the mulcher, with specifications given in Table 3.

Figure 6: Bradco Mini-Mag Mulcher XL 165-6

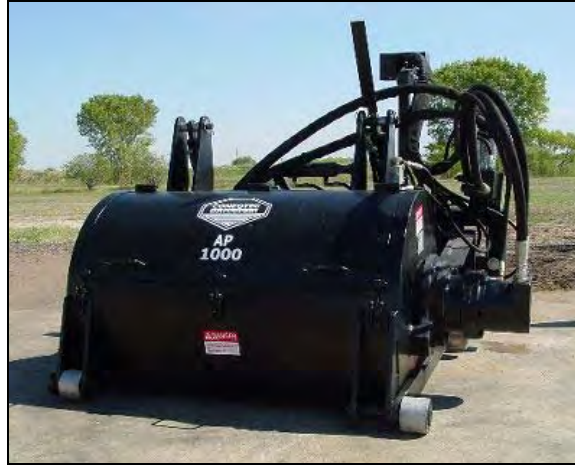
Adding the Coneqtec Corp. pavement planer to the Nemesis attachments tool box gave another dimension to the test program; namely, the ability to remotely control the tool versus the performance of the tool. In normal pavement planer operations, the cold planer is able to remove pavement to a depth of 15 cm (6 in.). Given this and the design of the planer, which is not unlike that of a very robust tiller, it was considered an ideal off-the-shelf tool for removal (including neutralization) of antipersonnel land mines and possibly for quality-assurance operations. Figure 9 shows the pavement planer, and specifications are given in Table 6.

Figure 9: Cold Planer

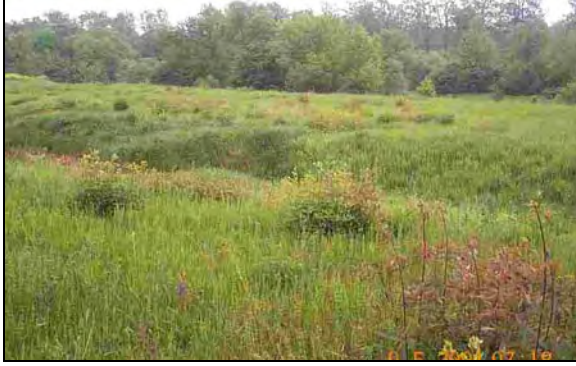
Figure 12: Category 1, Easy

Test Site B is an area comprising Category 1 – Category 4 vegetation. Figures 12–15 and Table 7 show example images and descriptions of vegetation categories, respectively.

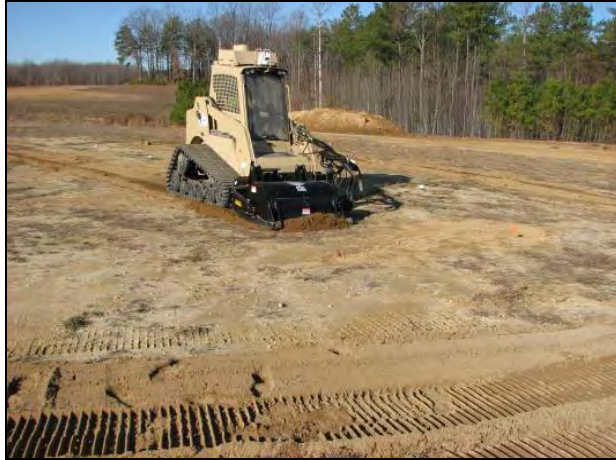
Figure 16 shows Test Site C, an area of little to no vegetation consisting of a clay and loam mix soil. Due to rain in the weeks prior to testing, the ground was relatively soft. Because this area was designated for planer testing, six antipersonnel mine simulants were buried at various depths, together with four 8 ft (length) × 1 ft (width) fiber witness boards. Figure 17 is a plan view of the layout. Use of the mines and boards during testing will be described in Section 5.6.

Figure 16: Test Site C

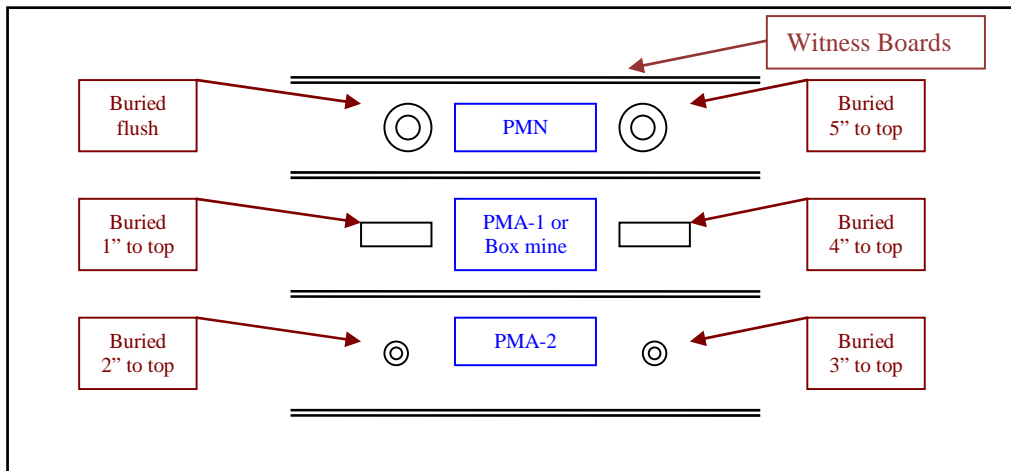
Figure 17: Test Site C, Mine Simulant and Witness Board Layout, Plan View

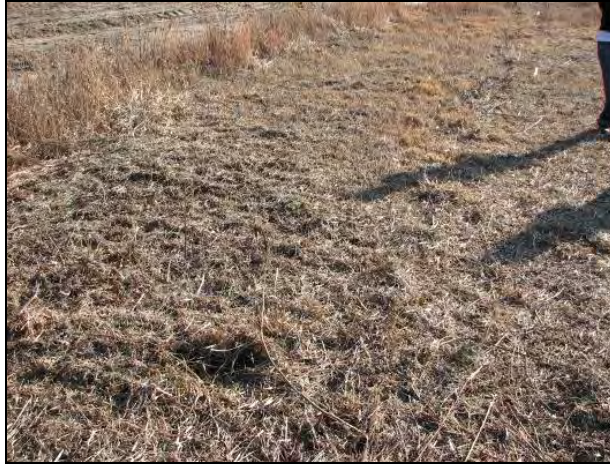
Test Site D was used for additional testing of the cold planer. The soil in Test Site D is a sandy loam consisting of a low, thick, grass-like vegetation with a heavy root system (see Figure 18). Like Test Site C, mine simulants and fiber boards were buried within the test area for the cold planer testing. Figure 19 is a plan view of the mine and board layout.

Figure 18: Test Site D

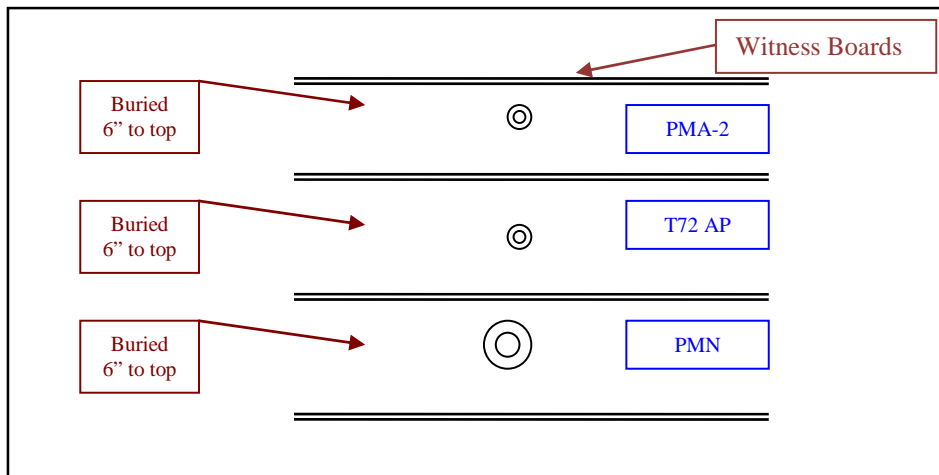
Figure 19: Test Site D, Mine Simulant and Witness Board Layout, Plan View

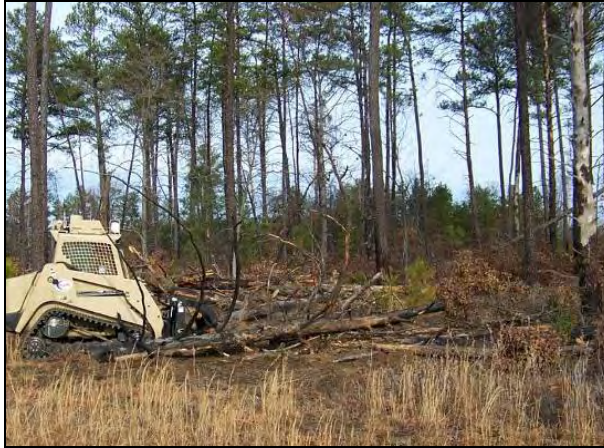
Figure 20: Test Site E

Test Site E was used to demonstrate the ability of the grapple and 4-in-1 bucket to clear an area of fallen trees and cut vegetation. Figure 20 shows the area chosen for Test Site E, which consisted of many large trees, as well as piles of cut vegetation.

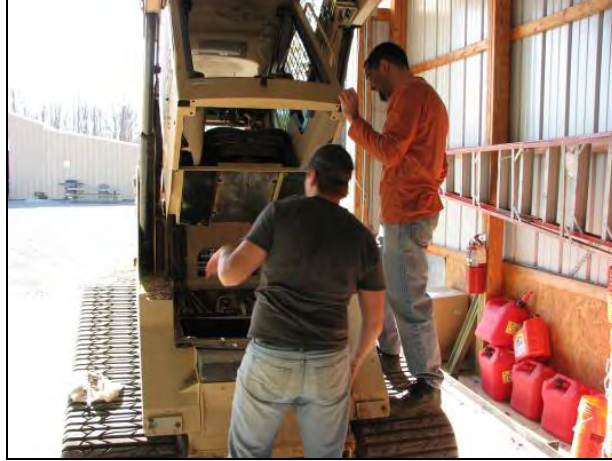
All maintenance and inspections, except those items requiring under-the-cab investigation, can be performed by a single trained person in less than 2 hours. For under-the-cab inspections, three persons are recommended to lift and lock the cab in its raised position (see Figure 21). Tools needed to perform maintenance inspections will be provided with the Nemesis.

Figure 21: Cab Raised for Maintenance Inspection

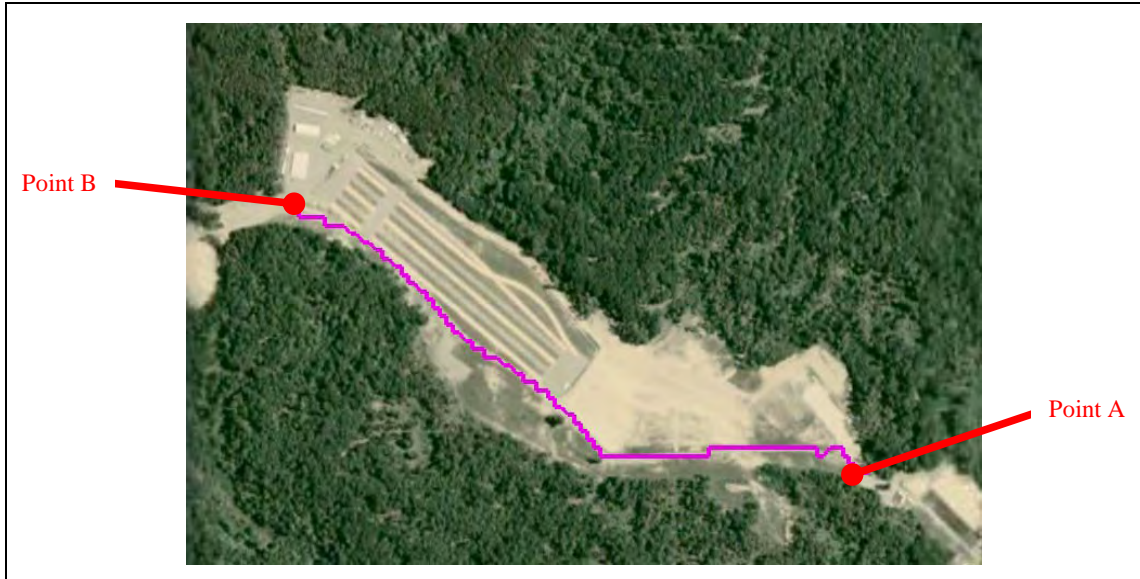
During the line-of-site test, the Nemesis passed by three GPS monuments located within the test site compound. Since a mapping of the vehicle's path and its current GPS locations are viewable on the operator control unit, the GPS monuments located within the test site were used to verify the accuracy of the system's GPS (latitude-longitude in degrees, elevation in meters). For each monument within the test site, the operator stopped the vehicle next to the monument location and the corresponding GPS coordinates were compared. In each case, the GPS coordinates of the remote guidance unit were identical to those of the GPS monuments.

Figure 22: Line-of-Site Test Route

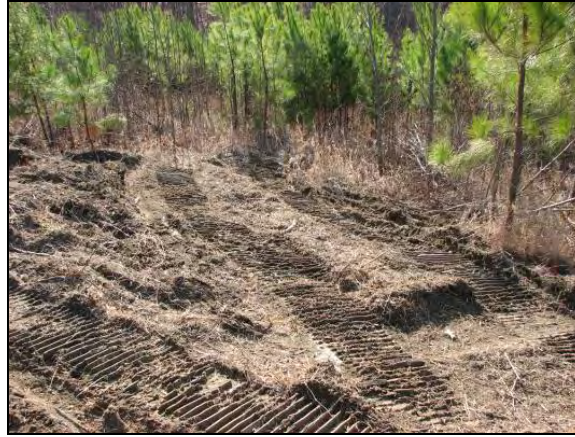
Figure 24: Vegetation/Dirt Mounds Created During Mulching Operations

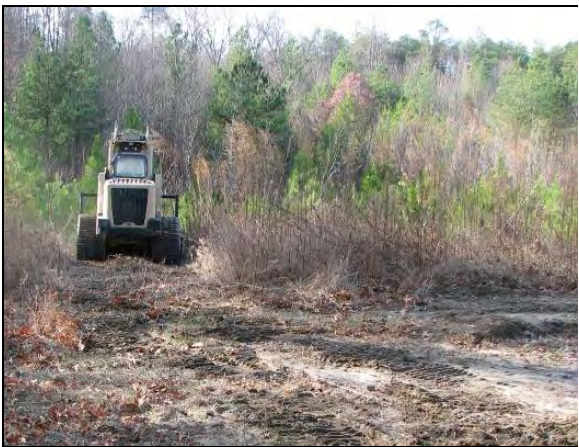
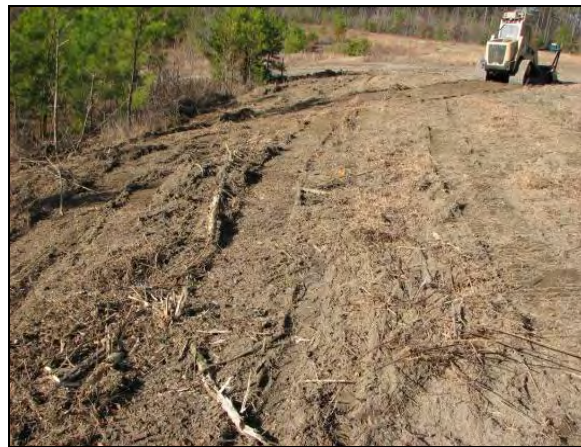
In total, the Nemesis with the attached mulcher was able to cut a 454.3 m² area in 21 minutes, a 1,298 m²/hour cutting rate for Category 1 vegetation. Figures 25 and 26 give before cutting and after cutting looks at the Category 1 test area.

Figure 25: Category 1 Vegetation, Before Cutting

Figure 26: Category 1 Vegetation, After Cutting

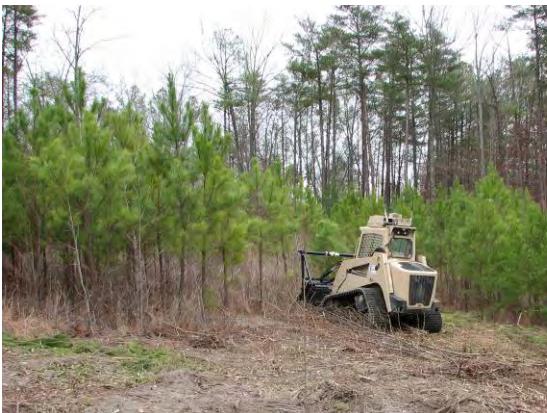
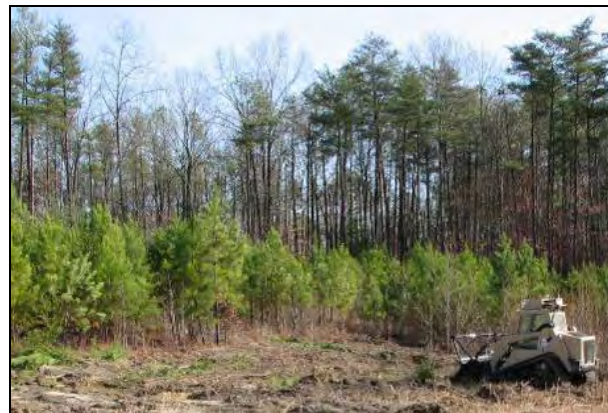
The second cutting performance evaluation included the remote cutting of Category 2 vegetation in Test Site B. Slopes within the Category 2 test area averaged 14 degrees, and cutting operations in this area were executed in with-slope passes to avoid the mobility issues caused by the vegetation and dirt mounds in Category 1 testing. This with-slope pattern appeared to alleviate some of the problems experienced earlier. In total, 240.8 m² of Category 2 vegetation were cut within 28 minutes, giving a cutting rate of 516 m²/hour. Figures 27 and 28 show the Category 2 test area before and after cutting operations.

Figure 27: Category 2 Vegetation, Before Cutting

Figure 28: Category 2 Vegetation, After Cutting

Continued passes over cut vegetation did not result in continued mulching of the cutting debris. Much of the debris was pushed into the soil loosened by the initial cutting pass and then passed over by the mulcher and vehicle. Where the debris was thick, it was

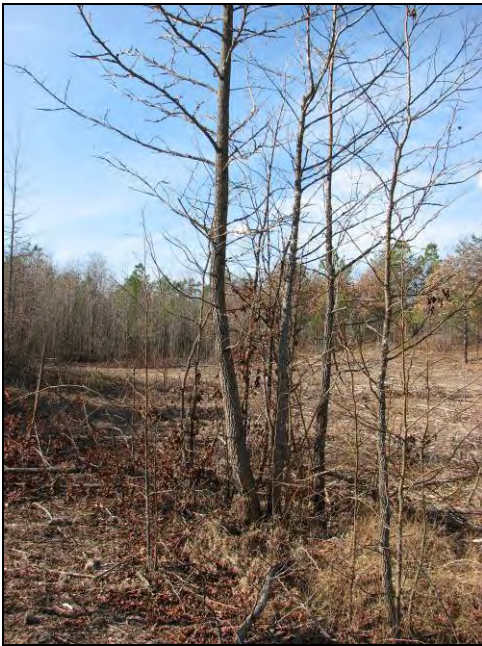
Figure 29: Category 3 Trees

Last, a test of the vehicle's ability to remotely cut a Category 3-sized (10 cm) tree was conducted. To cut any tree with the mulcher, the Nemesis must be able to push the tree slightly over using the mulcher's front bar to allow its cutting heads to reach (and cut) the tree. In soft soil, cutting Category 3 trees can be difficult because the vehicle's tracks may not have enough ground traction to force these trees to bend. This traction problem was occasionally observed during this test, but ultimately, the Nemesis and mulcher were able to cut and mulch the tree. Figure 29 shows the Category 3 trees, and Figure 30 shows the Nemesis cutting them.

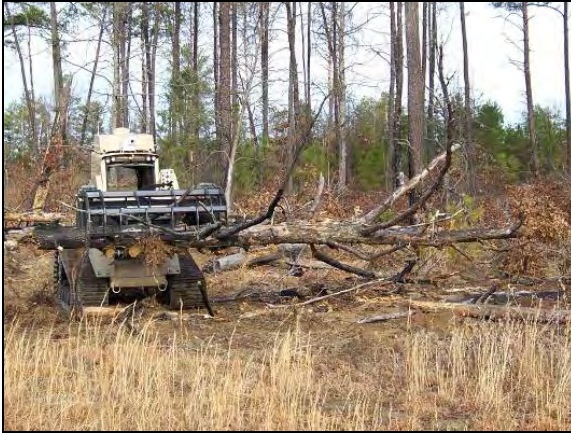
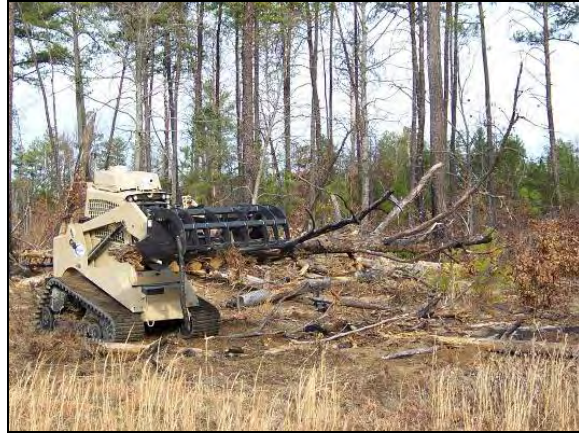
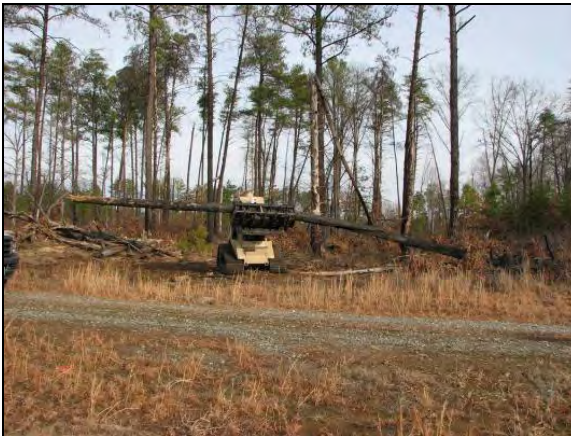
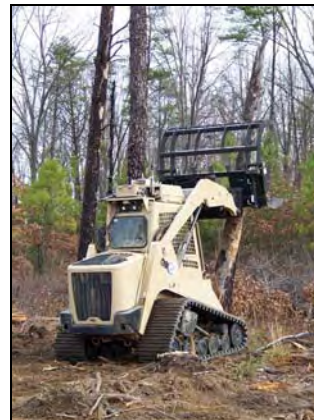
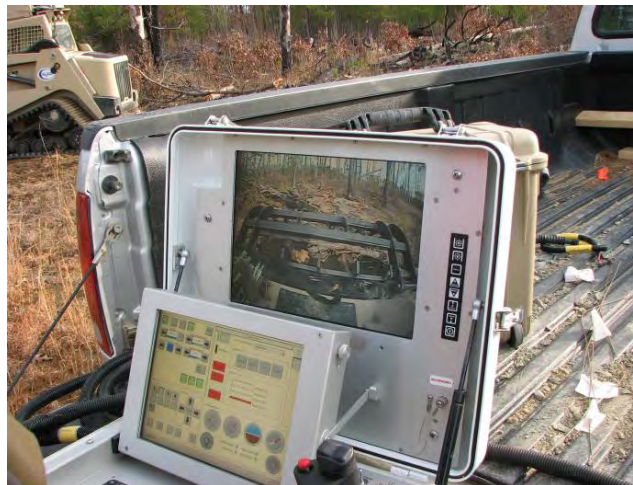
Testing began with the grapple. Clearance performed with the grapple included the removal of large trees, branches, and other debris, as well as the felling and removal of two large, dead trees. Remote operators remarked that the remote controls for the grapple were easy to use, but noted that smooth operating skills take time to develop (e.g., determining ground clearance and lift height necessary for transport). One of the major obstacles to successfully operating the grapple remotely is the inability to see the lifted objects in the camera's field of view. Operators cannot determine safe travel routes when grabbed objects are larger than the camera's field of view when the grapple is lifted, which obstructs the view of the forward-looking camera. Because of these issues,

remote operations were completed by allowing operators to physically watch the movements of the vehicle as opposed to using the limited camera views. Figures 31–35 are images of grapple operations.

Figure 31: Removing Large Tree with Branches

Figure 32: Removing Branches and Other Vegetation Debris

Figure 33: Removing Large Tree

Figure 34: Felling Large, Dead Tree

Figure 35: Remotely Controlling Nemesis with Operator Control Unit

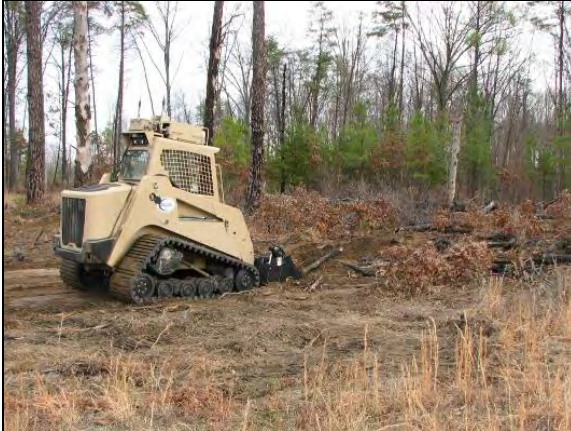
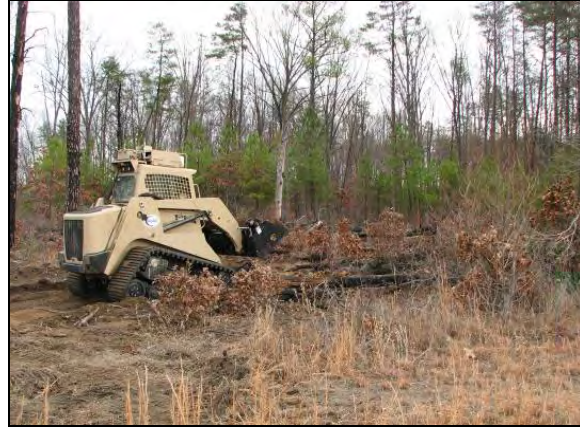
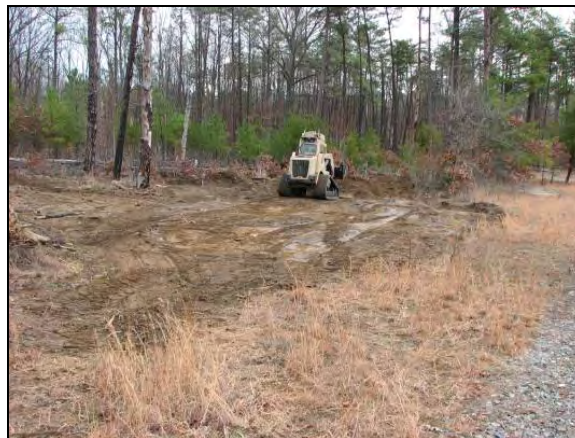
After the grapple completed the removal of medium- and large-sized vegetation debris, site-clearance operations continued with the use of the 4-in-1 bucket. The bucket was used to scoop up and remove smaller debris and grade the area after all removal operations had been completed. Figures 36–38 are images of the 4-in-1 bucket’s scooping and grading operations.

Figure 36: Scooping Small Debris with the 4-in-1 Bucket

Figure 37: Scooping Small Debris with the 4-in-1 Bucket

Figure 38: Grading with the 4-in-1 Bucket

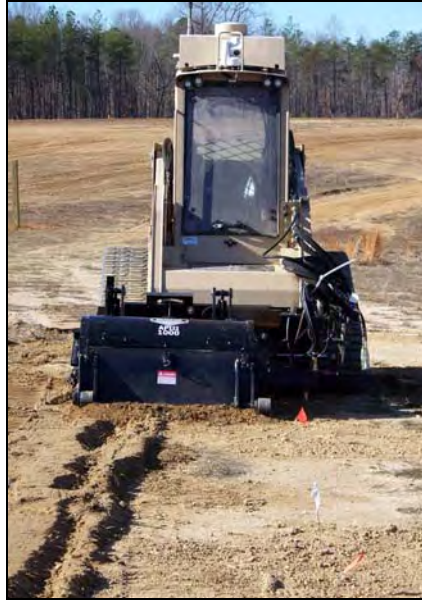
The cold planer is a 101.6 cm wide off-the-shelf asphalt planer that has potential for the removal or neutralization of small antipersonnel mines. Because the cutting width of the planer is less than the width of the Nemesis, the planer’s attached position relative to the vehicle will be offset to the right to cover the path of the right track (see Figure 39). This will ensure that the planer will engage threats before that side’s track overpasses them. The exposed left track will always operate in an area already cleared of mines to maintain its safety.

Figure 39: Cold Planer Attached to Nemesis

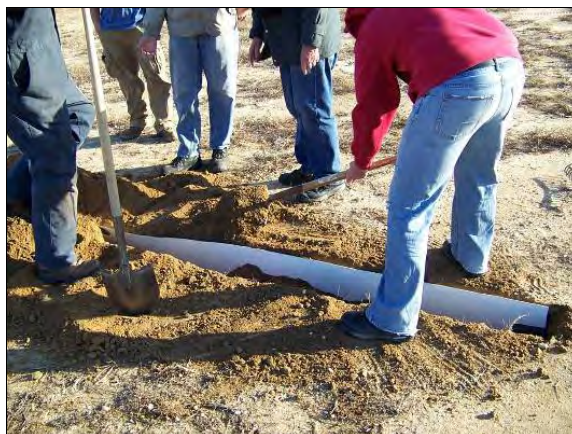
The cold planer was tested in Test Site C and Test Site D. For both tests, antipersonnel mine simulants were buried at various depths to assess the planer’s ability to remove and possibly neutralize small mine threats. In addition, at each site, four 8 ft × 1 ft fiber boards were buried on edge, flush to the surface, at a distance of 5 m apart, to determine the depth reached by the planer during normal operations (see Figure 40). (See Figures 17 and 19 for images of the surrogate mine and fiber board layout.)

Figure 40: Fiber Board Emplacement, Test Site C

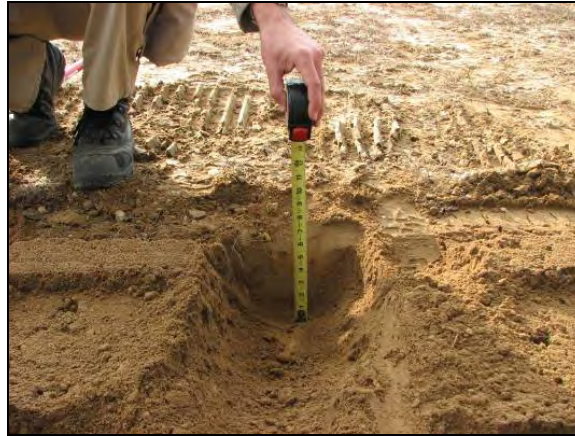
Before remote operations, the planer was manually operated within Test Site C. The purpose of this manual operation was to determine the ground-to-planer height that should be maintained for planing operations. During this test, it was observed that the weight of the planer caused the vehicle to rock while operating, stop abruptly when attempting to brake, and tilt forward when the planer was lifted off the ground. Also, due to the skewed location of the planer in relation to the Nemesis, the vehicle tended to drift to the right when forward operations straight ahead were attempted. The planer was able to penetrate 6 inches into the ground (see Figure 41), although buildup inside and in front

Figure 41: Penetration Depth of Planer in Manual Operations

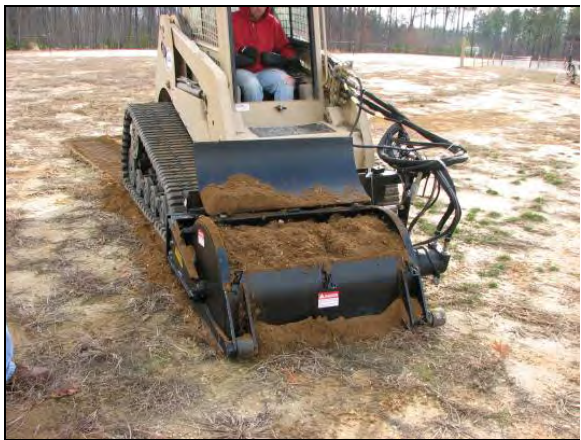
of the planer caused the vehicle's forward movement to slow or stop on many occasions. Figures 42 and 43 show dirt buildup inside and in front of the planer.

Figure 42: Dirt Buildup Inside Planer

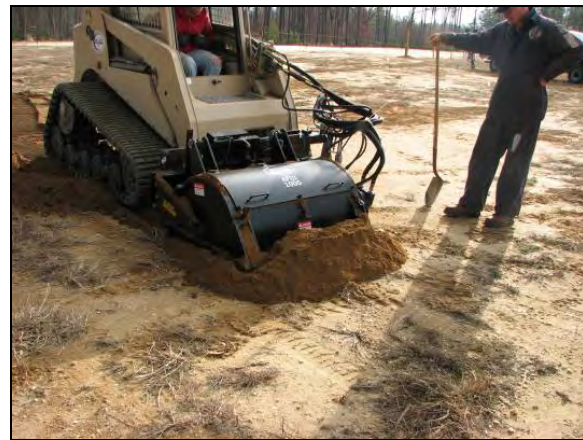
Figure 43: Dirt Buildup in front of Planer

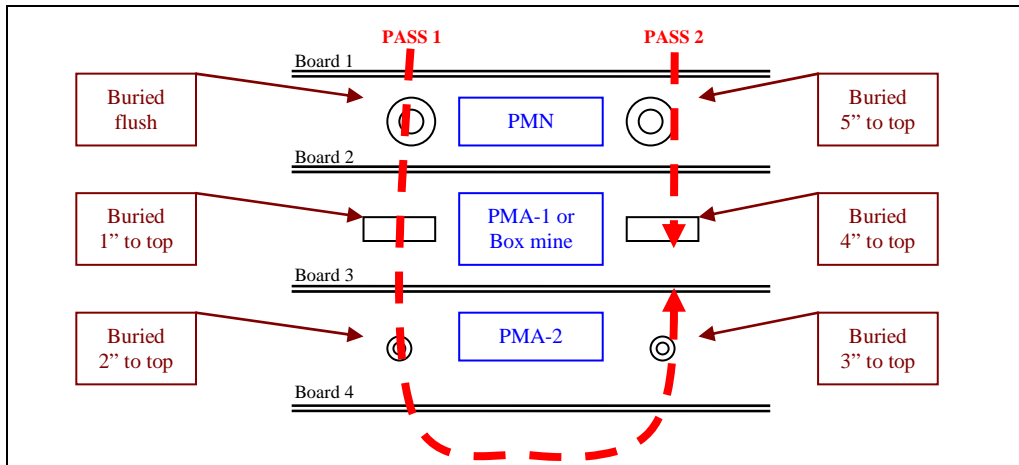
The first remote operation performance test of the Planer occurred at Test Site C. As described in Section 3.3, Test Site C consists of flat ground with clay and loam mixed soil and spotty amounts of low vegetation (e.g., grass, shallow roots). Simulated mines and 8 ft × 1 ft fiber witness boards were buried according to the layout in Figure 44. The dotted line represents the path forward by the Nemesis.

Figure 44: Test Site C, Vehicle Path

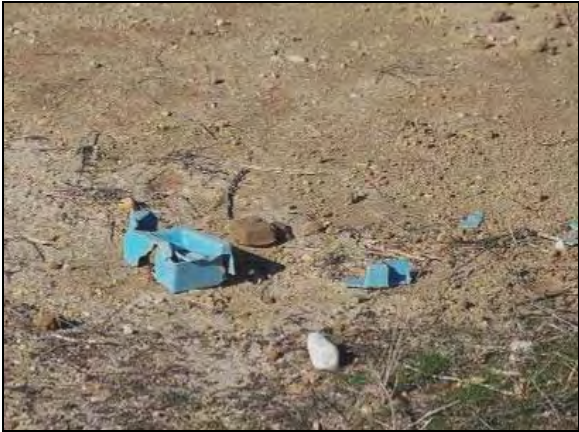
As this test progressed, the operator was better able to control the depth of the planer. (This was the first time the cold planer had been used on the Nemesis and operated by the operator on any piece of equipment.) By the time the system was tilling the soil to a constant depth of 15 cm (6 in), the backpressure of the soil buildup inside and in front of the planer became so great that the track on the Nemesis lost traction, and the vehicle came to a halt. To restore forward progress, the operator had to raise the planer, but in doing so, the planer missed board #3 and missed the surrogate mines buried at 4 in and 5 in. Table 9 shows the effect of the planer on the buried mine stimulants. The effects of the operator’s learning to control the depth of the planer and the raising of the planer necessitated by the buildup of dirt are reflected in the depths of cuts made in the witness boards (see Table 10). Note that the data in Table 10 correspond to Figure 44 in the following way: The top-most board in the layout is Board #1, the bottom-most board in the layout is Board #4. The “left-hand” side of the board is the left-hand side when looking at the layout drawing. Images corresponding to the data are shown in Figures 45–50.

Figure 45: Box Mine Broken in Pieces by Planer, Test Site C (Pieces Recovered by Test Personnel)

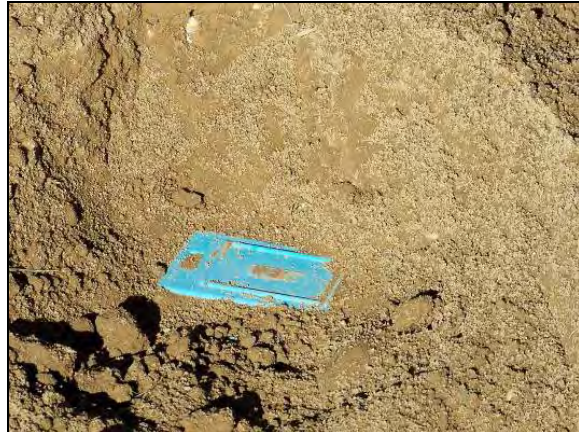
Figure 46: Box Mine Untouched by Planer, Test Site C (Uncovered by Personnel for Photo)

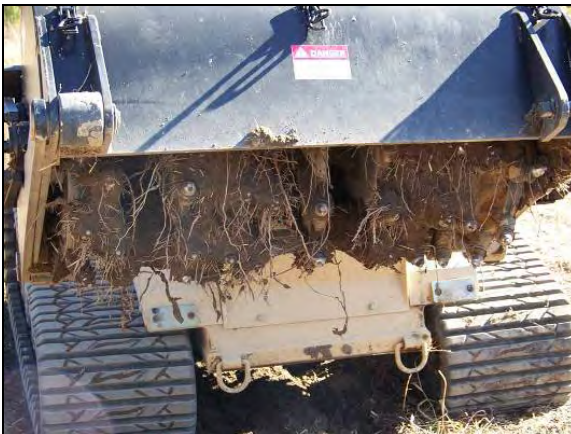
The vegetation present in Test Site D posed new challenges for the planer. Whereas in Test Site C the dirt accumulated within and in front of the planer, at Test Site D the density of the root systems and the moisture retained in the soil by the vegetation caused the dirt to pack in between the planer cutting tillers. Compounding this, the cutting tiller disks are canted to the mounting shaft to provide maximum coverage of the cutting teeth, but the variable separation between the tiller disks became traps for the roots and soil. This collection of dirt and roots was hard enough to require the use of picks and shovels for removal (see Figures 53 and 54).

**Figure 53: Dirt and Vegetation Accumulation
Inside Planer**

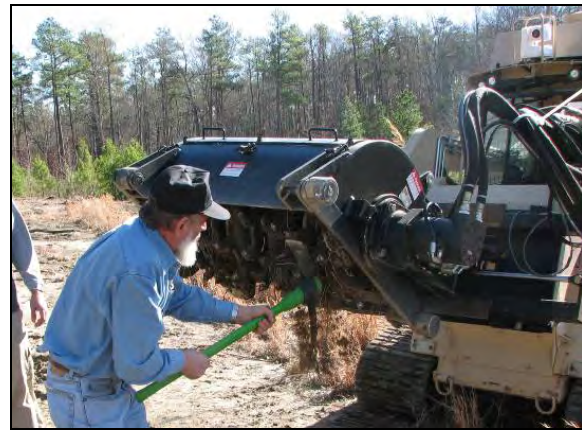
**Figure 54: Removal of Dirt and Vegetation
Accumulation**

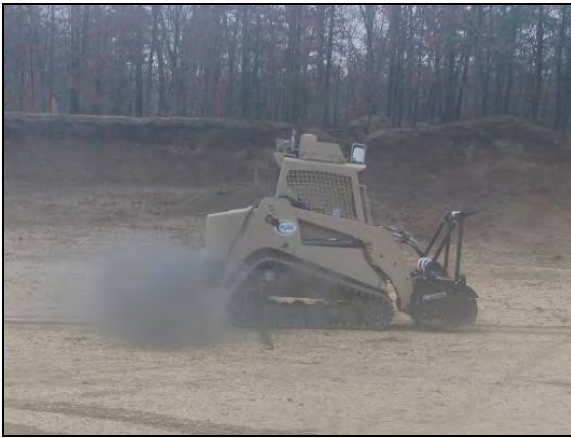
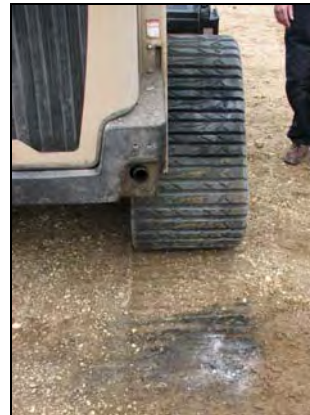
The first mine to be used for testing was Mine A, a small, round antipersonnel mine. Inspection of the vehicle after the blast showed damage to both the exterior and interior of the rubber track (see Figures 62–65). Exterior damage was limited to surface scarring, whereas interior damage resulted in a deep crack in one of the belt’s drive cogs. In addition to the track damage, the drive system encoder, which is located at the rear inside the loop of the track, sustained some damage. As a result of the damage, the vehicle veered slightly left during straight drives.

Figure 62: Mine A Blast

Figure 63: Vehicle after Mine A Blast

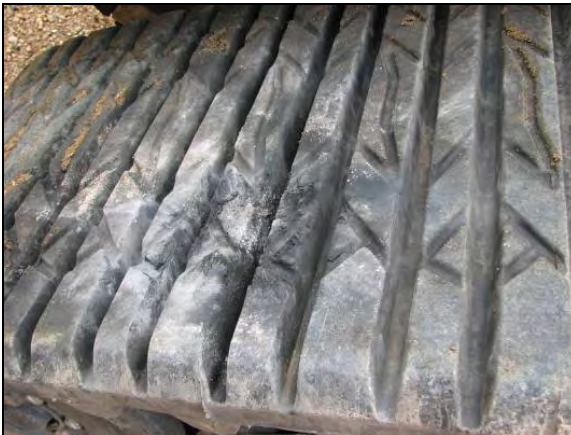
Figure 64: Damage to Track Exterior, Mine A

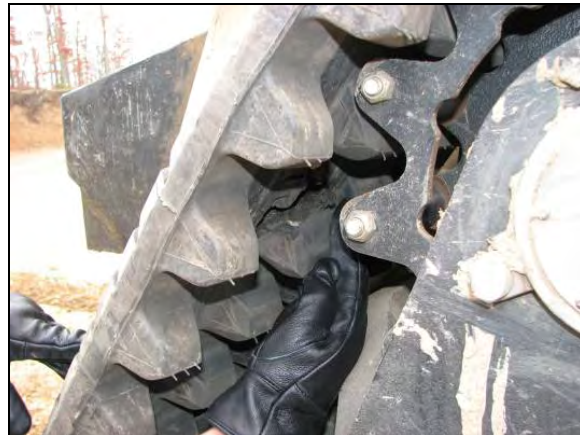
Figure 65: Damage to Track Interior, Mine A

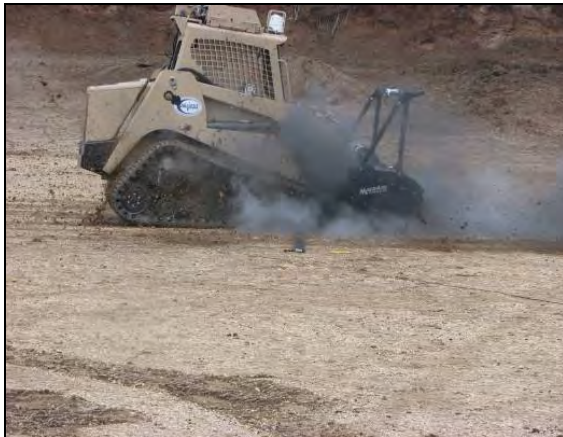
Figure 66: Mine C Blast

The last mine tested, Mine C, had the largest explosive (TNT) content of the three mines tested. The blast from this mine damaged both the exterior and interior of the rubber track, as well as two of the graphite composite wheels inside the track. Although the damage was more severe than the damage sustained from Mine A, the vehicle was still able to function and could safely move both forward and backward after the blast. In fact, the Nemesis traveled approximately 200 m from the blast test site to a maintenance garage. Figures 66–69 are images of the blast and damage incurred from Mine C.

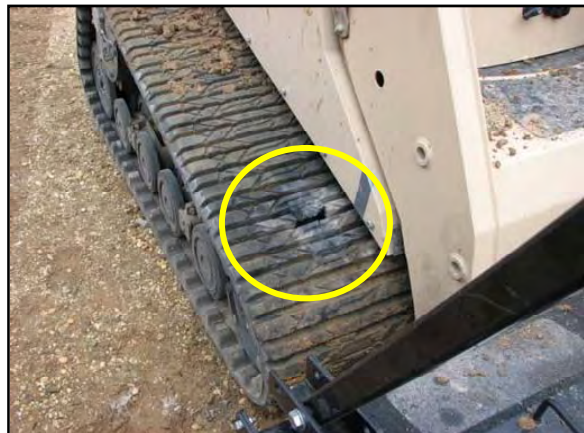
Figure 67: Damage to Track Exterior, Mine C

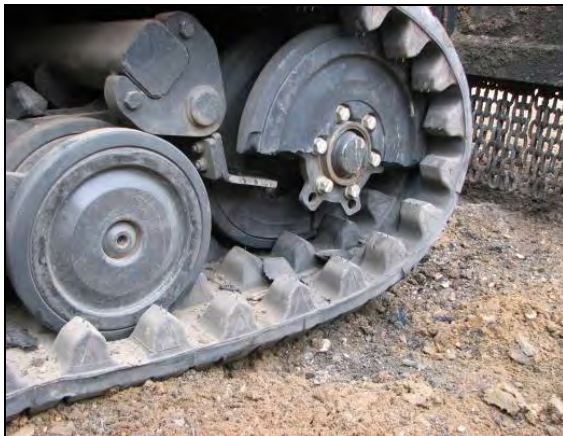
Figure 68: Damage to Outer Wheel, Mine C

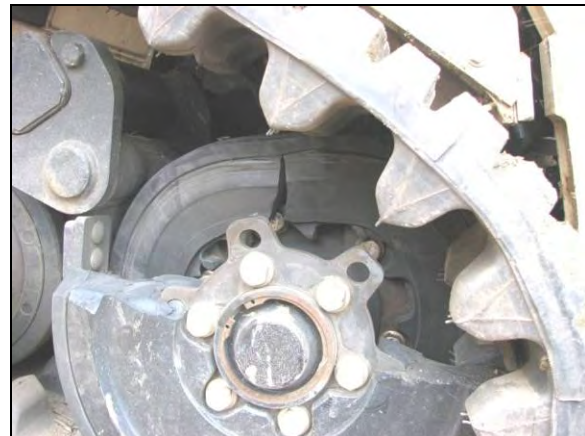
Figure 69: Damage to Outer and Inner Wheel, Mine C

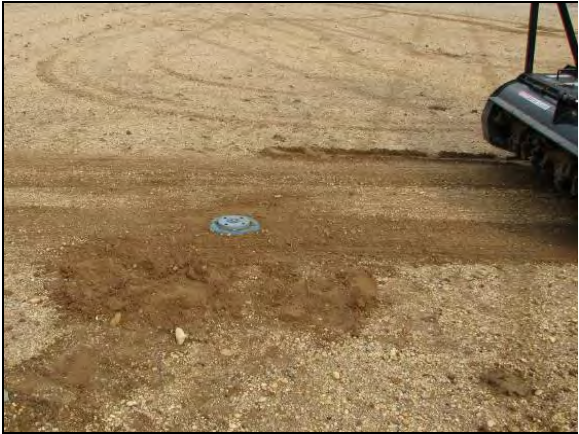
To perform the test, the smoke-fused antitank mine was buried flush to the ground's surface, as shown in Figure 69. The Nemesis was remotely driven over the mine without activating the fuse (Figure 70). The Nemesis then backed over the mine, again without setting the mine off. The mine was lifted and reburied with the fuse at one inch above the ground. The Nemesis again drove over the mine without detonating the fuse. To ensure the fuse was functioning properly and that the Nemesis had indeed demonstrated an overpass capability, test personnel drove a pickup truck over the mine. This set off the smoke fuse (see Figure 71), thus verifying that the Nemesis has a potential antitank mine overpass capability.

Figure 70: Emplaced Smoke-Fused Antitank Mine
