Performance Evaluation Test of the Peco Tracked Brush Blazer

January 2008

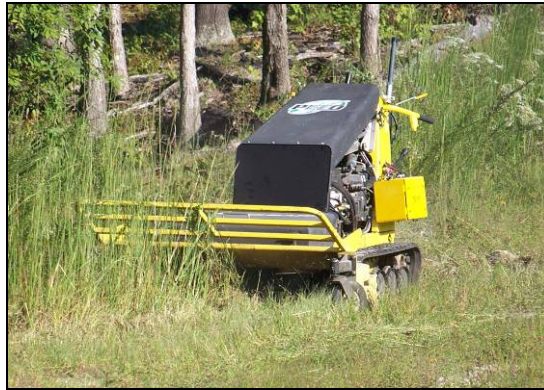
Figure 1: Peco Tracked Brush Blazer TBB-2001

The Peco Tracked Brush Blazer TBB-2001, referred to as the Peco Cutter, shown in Figure 1, is a heavy-duty brush cutter advertised as capable of cutting heavy undergrowth and trees up to 10 cm in diameter. It is equipped with a hydraulic track drive that gives the operator the ability to maneuver in all types of terrain, as well as perform 180-degree turns within its own length of 2.4 meters. Safety features of the Peco Cutter include a chain-guarded deck (Figure 2) and a front safety bar (Figure 3) to push over vegetation to be cut.

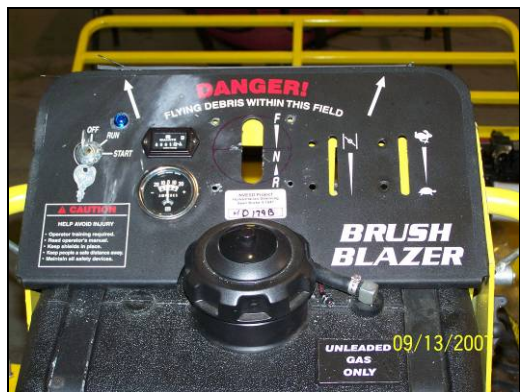
Figure 6: Instrument Panel Before Modifications (Note: Panel Levers Are Removed)

Modifications to allow for push-button manual operations as well as remote operations were made by the Humanitarian Demining Program Office's vehicle fabrication shop at Ft. Belvoir. The Peco Cutter remote-control system enables operators to start and shut off the Peco Cutter engine remotely, enable and disable the cutter remotely, and continue line-of-sight operations for distances up to about 400 meters. Photos of the modifications can be found in Figures 4 through 10. Table 1 lists specifications for the Peco Cutter.

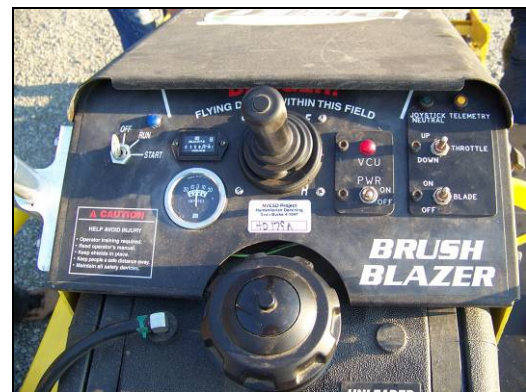
Figure 7: Instrument Panel After Modifications

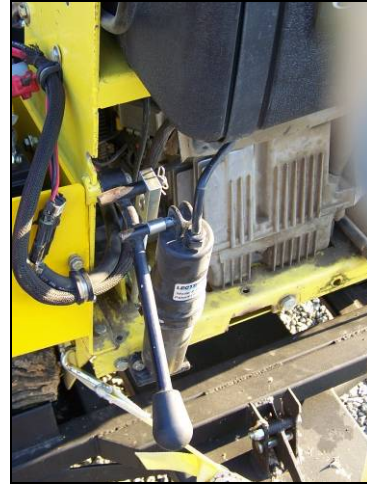
Figure 9: Cutter Engaging Lever After Modifications (Hydraulic Addition allows Operator Push-button Cutter Engagement)

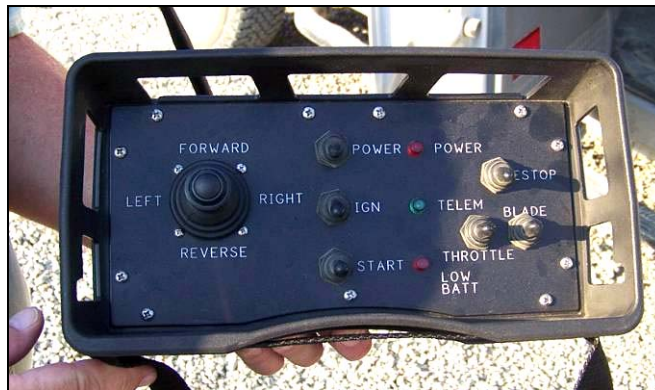
Figure 10: Hand-held Remote Control Device

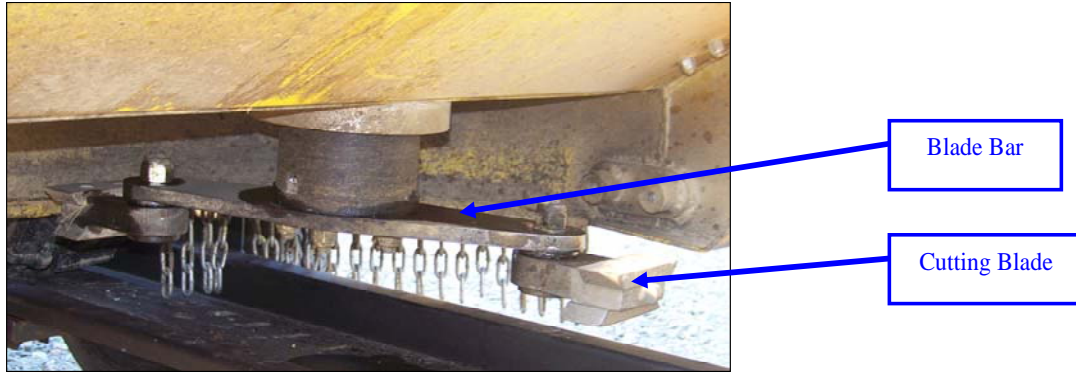
Figure 11: Blade Bar and Cutting Blade (Photo Taken from under the Cutting Deck)

Peco Cutter TBB-2001 Brush Blazer	Measurement Dimension
Height, overall	1.1 m / 3.6 ft
Width, overall	1.4 m / 4.6 ft
Length, overall	2.4 m / 7.8 ft
Length, blade bar (see Figure 11)	45.1 cm / 17.75 in
Length, cutting blade (see Figure 11)	10.8 cm / 4.25 in
Length, cutting deck	1.0 m / 3.4 ft
Width, cutting deck	1.4 m / 4.6 ft
Cutting Height / Ground Clearance	12.7 cm / 5 in
Cutting Width	1.2 m / 4.0 ft
Weight, without remote system	499 kg / 1100 lbs
Weight, with remote system	626 kg / 1380 lbs
Fuel Capacity (Unleaded)	18.9 L / 5 gal (US)
Hydraulic Fluid Capacity	9.5 L / 2.5 gal (US)

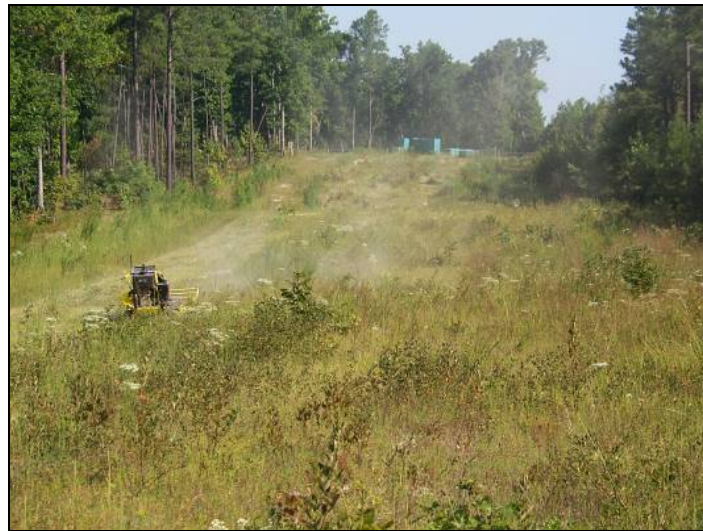
Test Site A consisted of Category 1 vegetation within a 350 m × 60 m area, as shown in Figure 12. Category 1 vegetation is described as light vegetation with saplings up to 3 cm in diameter within level to slightly rolling terrain.

Figure 12: Test Site A, Category 1 Vegetation

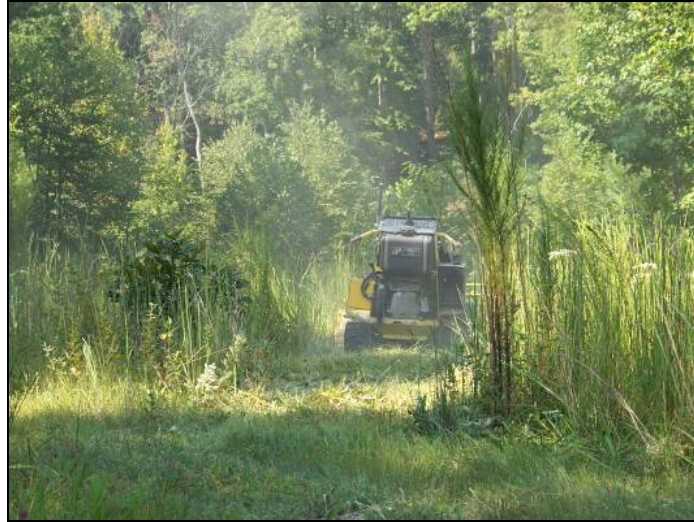
Test Site B included Category 2 vegetation within a 30 m × 20 m downward sloping area, as shown in Figure 13. Category 2 vegetation consists of moderate vegetation with sparse brush and saplings up to 6 cm in diameter, within level or lightly rolling terrain with minimal ruts. The slope within Test Site B measured as a 10 degree angle of descent. Slight bumps were present throughout the area, and a 6.5 m × 0.5 m gully, with a depth of 26.7 cm, was discovered during testing.

Figure 13: Test Site B, Category 2 Vegetation

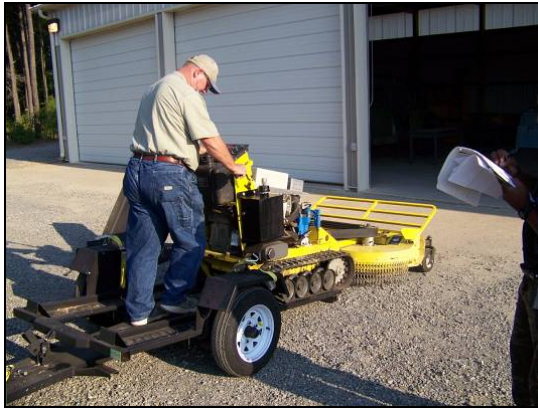
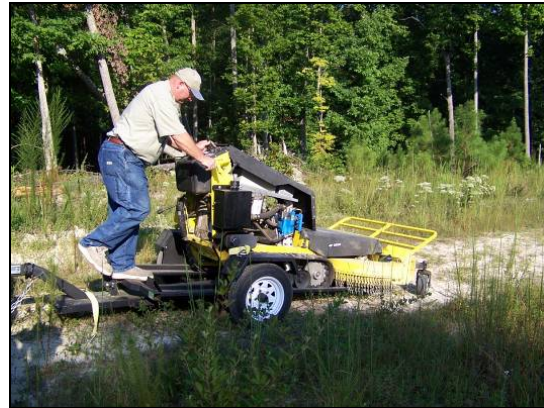
Manual operation of the Peco Cutter is necessary when loading and off-loading it from its travel trailer, as shown in Figure 15 and 16. Modifications to the Peco Cutter's manual driving mechanism include the addition of a driving joystick to make it possible for any operator to control movement of the Peco Cutter. Throughout the test, manual operators were able to successfully load (and off-load) the Peco Cutter in less than 1 minute.

Figure 15: Off-Loading Peco Cutter

Figure 16: Loading Peco Cutter onto Trailer

Movement of the Peco Cutter onto and off the trailer is performed manually by the operator as shown previously in Figures 15 and 16. The Peco Cutter was modified to include joystick-guided steering, making it possible for persons of all heights and physical strength to operate the Peco Cutter manually.

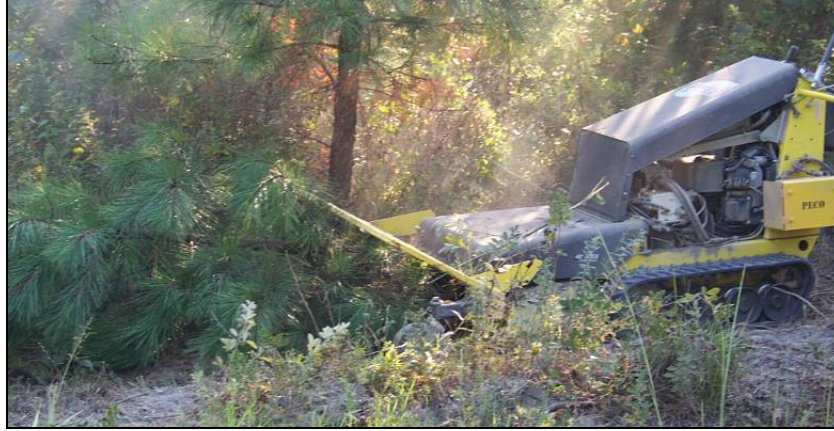
The Peco Cutter is designed to cut vegetation and trees up to 10 cm in diameter with a “push and cut” technique that uses the front safety bar and the cutting heads. When the Peco Cutter approaches trees, saplings, or brush, the front safety bar pushes those items over until the cutting heads are able to reach the vegetation's base. At this time, the cutter cuts the vegetation from the ground and will cut the remainder of it as the Peco Cutter drives over the fallen item (see Figure 17).

Figure 17: Cutting Heads Engaging Tree After Being Pushed by Safety Bar

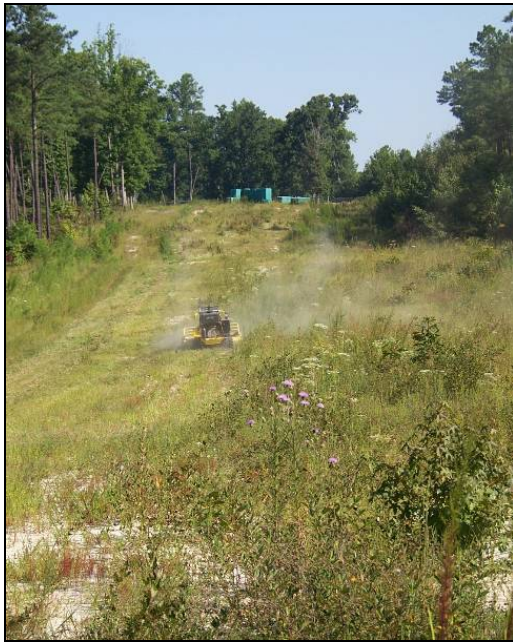
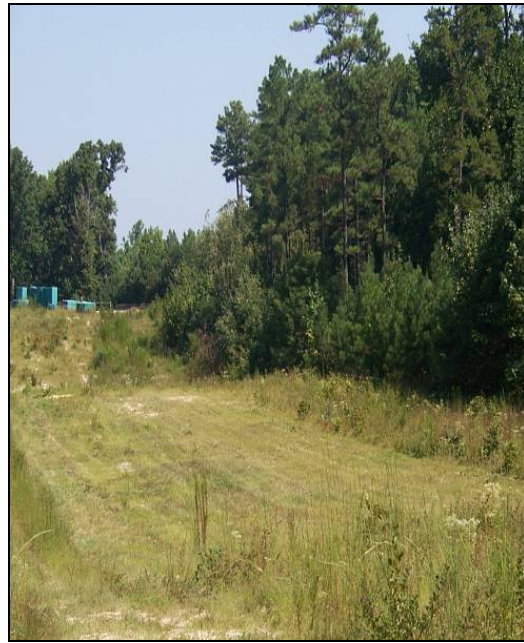
The Peco Cutter's cutting ability was tested against Category 1, Category 2, and Category 3 vegetation within Test Sites A, B, and C, respectively. In Test Site A, approximately 2,000 m² were cut, with no mobility or operational issues. Figures 18 and 19 show before and after cutting views of Test Site A.

Figure 18: Cutting Operations, Test Site A

Figure 19: After Cutting, Test Site A

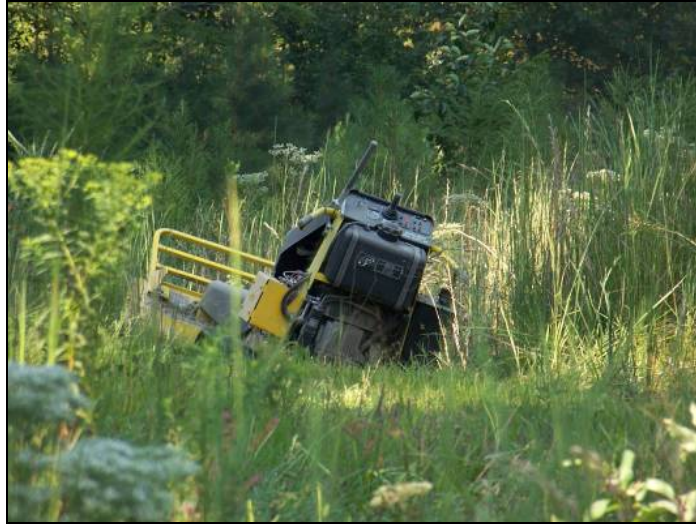
Operational cutting on the downward slope of Test Site B was separated into two timed tests. For the first test, the cutter was operated for 40 minutes. This resulted in a cleared area of 29.3 m × 9.4 m (6.9 m²/min, or 413.1 m²/hr) over ground with an average slope of 6.5 degrees. During this test, the gully described in Section 3.2 was encountered, requiring the operator to perform special maneuvers to continue cutting operations around and through the rut (see Figure 20). The heaviest vegetation cut in this area was an 8 cm diameter tree.

Figure 20: Peco Cutter Encountering 26.7 cm Deep Gully at Test Site B

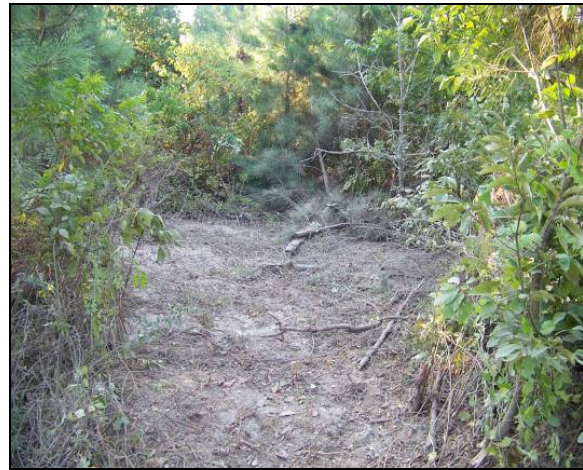
Test Site C operations were conducted to determine the capabilities and limitations of the Peco Cutter within Category 3 vegetation. In a 30-minute timed test, the Peco Cutter was able to successfully cut a 12 m × 3.4 m area (1.36 m²/min, or 81.6 m²/hr), which included two 10 cm diameter trees, several saplings, and dense vegetation. Before the start of the timed test, the Peco Cutter was not able to cut down a 10 cm tree because the soil around the tree was powdery and soft, with no vegetation or brush covering. This prevented the Peco Cutter from getting enough traction to push over the tree. Figures 21 and 22 show Test Site C operations.

Figure 21: Peco Cutter Entering Test Site C

Figure 22: Test Site C, Cutting Complete

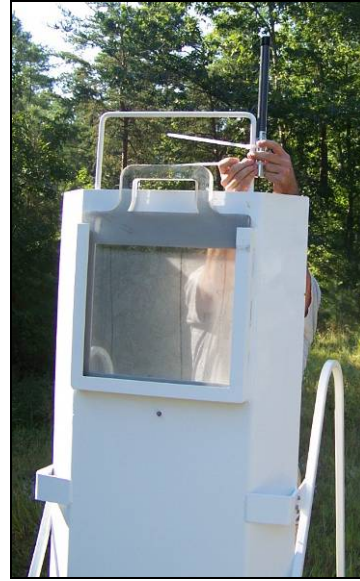
Figure 25: Mounting Remote Antenna to Operator Shield

The remote antennas were initially mounted on the Peco Cutter and on the operator's remote-control device. As the operator stood behind and close to the shield, as shown in Figure 24, radio transmissions were blocked. The Peco Cutter's remote system was designed to shut down the vehicle if the communicating signal was lost. Thus, there were several instances when the Peco Cutter shut down due to interference from the shield. To remedy this problem, the remote control unit's antenna was removed and mounted on the top of the mobile shield (see Figure 25), and a connecting cable was run between the antenna and the remote-control unit as shown in Figure 26. Also, a hook was mounted to the inside of the shield, so the operator could continue operations without having to hold the remote device. With this configuration, remote operations were

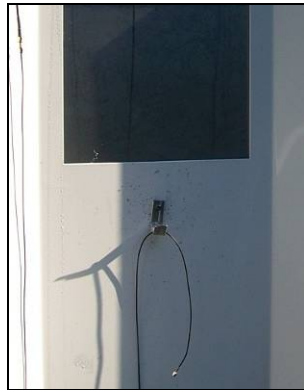
Figure 26: Remote Device Hook and Antenna Cable

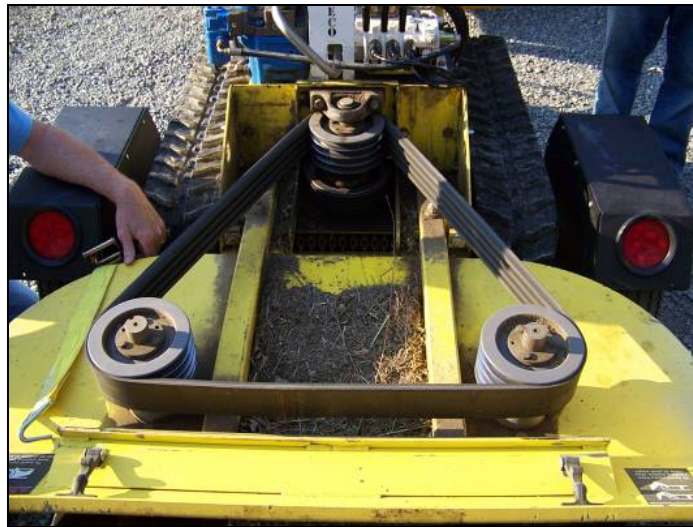
During the test, one maintenance issue arose. It was noticed that although the Peco Cutter's cutting blades seemed to be rotating, the vegetation was not being cut. An inspection of the problem showed that the wide belt responsible for turning the blades was loose (see Figure 28). A quick adjustment to the tension rod was made, and the Peco Cutter resumed cutting. This repair took only a few minutes and required no tools.

Figure 28: Cutting Blade Belt (Top Cover Removed for This Photo)

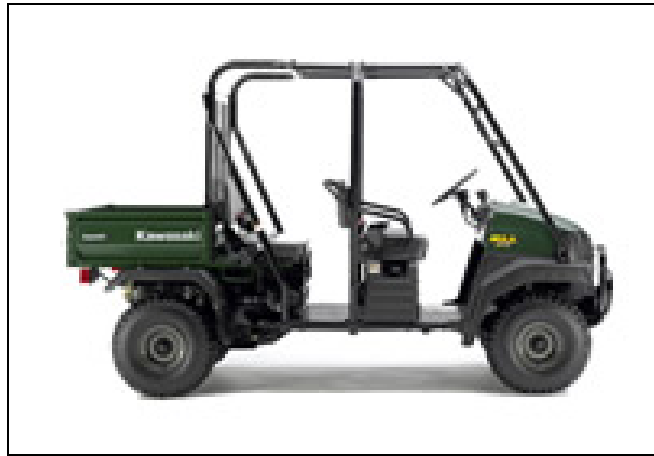
In addition to the manual recovery of a disabled vehicle, recovery by a small vehicle was also tested. A 4×4 utility vehicle, like the one shown in Figure 29, weighing 693.5 kg (1,528.9 lbs) was used to tow the Peco Cutter from its location. Although the utility vehicle was very close in weight to the Peco Cutter, it was able to successfully drag it several feet.

Figure 29: 4×4 Utility Vehicle, Used in the Damaged Vehicle Recovery Test

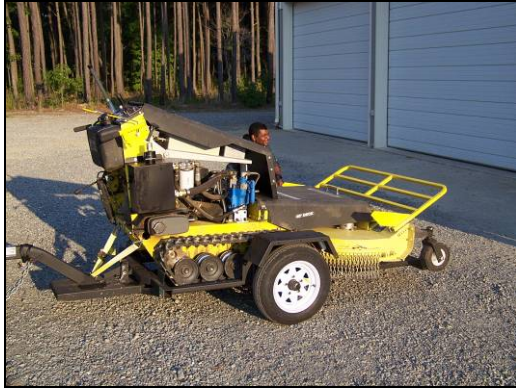
The Peco Cutter, its on-road traveling trailer, the operator's shield, and all mechanical and electronic spare parts are stowed in a 10 ft (3 m) shipping container. The Peco Cutter is shipped strapped to its trailer (Figure 30), and metal ramps are used for loading and off-loading the duo (Figure 31) into the container. A removable handle (Figure 32) is used to assist personnel in maneuvering the trailer into and out of the shipping container.

Figure 30: Peco Cutter, Strapped to Trailer

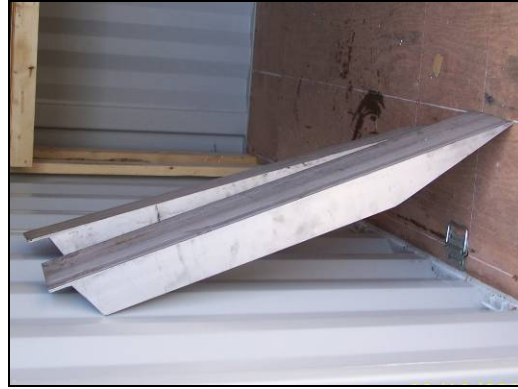
Figure 31: Metal Ramps

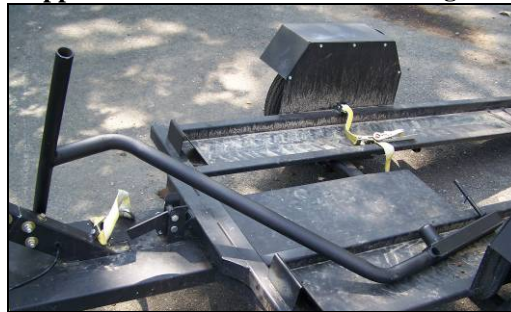
Figure 32: Trailer with Removable Handle (Handle is Lying on Trailer, Not Connected)

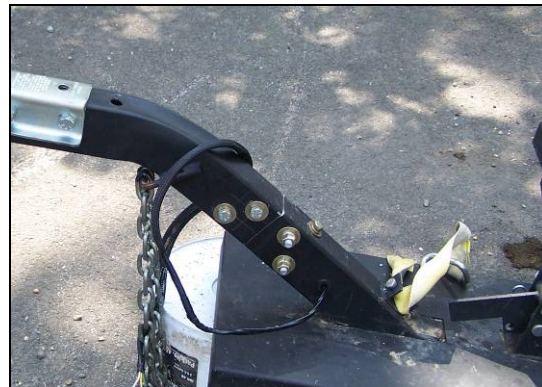
To ensure that the trailer would fit into the container, a modification was made to the trailer's connecting end (as shown in Figures 33 and 34), making it removable. Table 3 shows specifications for the trailer.

Figure 33: Trailer Connecting End, Before Modifications

Figure 34: Trailer Connecting End, After Modifications
