Report on the Mine Clearing Rake Test

October 2006

**Operational Evaluation Test Report
on the
Mine Clearing Rake**

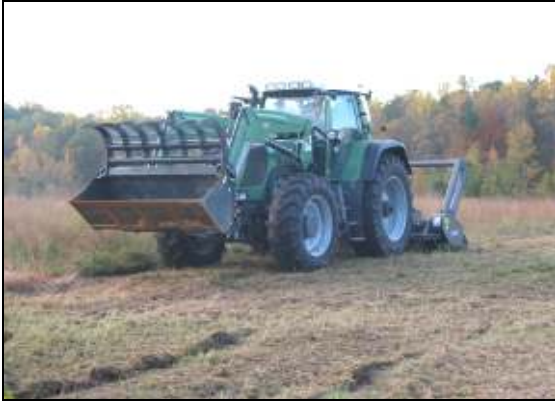
Figure 2. Fendt 918 Tractor

MCR while towing and turning. The tools used in the MCR test were a Fendt 918 Vario tractor (Figure 2), a Loftness 918 Timber Ax Extreme vegetation cutter (Figure 3), a Krause 4830-730F Chisel Plow (Figure 4), an Unverferth Perfecta II Spring Cultivator (Figure 5), and the MCR (Figure 6).

Item	Measurement / Dimension
Max Height, to top of cab	10.15/3095 ft/mm
Min Working Clearances under axles	1.98/605 ft/mm
Max Width	8.17/2490 ft/mm
Max Length	16.2/4938 ft/mm
Max Shipping Weight	17945/8138 lbs/kg
Fuel Capacity	530 liters
Oil Capacity	24 liters
Hydraulic Fluid Capacity	65 liters

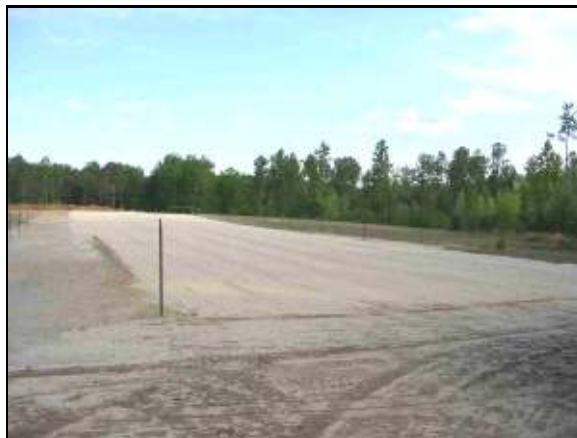
Figure 13. Test Site 2 (Sand Test Site)

There was no need for any preparation of the sand test area (see Figure 13).

Test Site 2, the sand soil test area, required no preparation before MCR testing. While there was spotty evidence of wild grass seed having germinated in the sand, the lack of nutrients in the sand caused the grass shoots to quickly die.

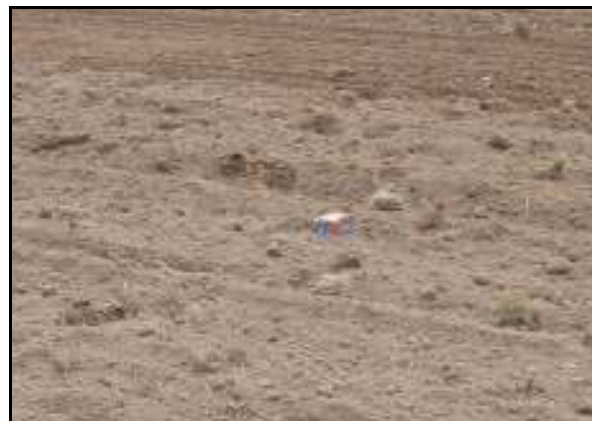
Figure 21. Surface-Laid Mine

After testing the MCR on buried mines, a test of surface-laid anti-personnel mines was performed within the Test Site 1 field. Two mines were laid on top of the prepared field and within the path of the MCR, cleaned of debris prior to this test. The mines were placed at a point 40m and at 50m from the start of the MCR run. Figure 21 shows the condition of the field and the placement of the mines in the field.

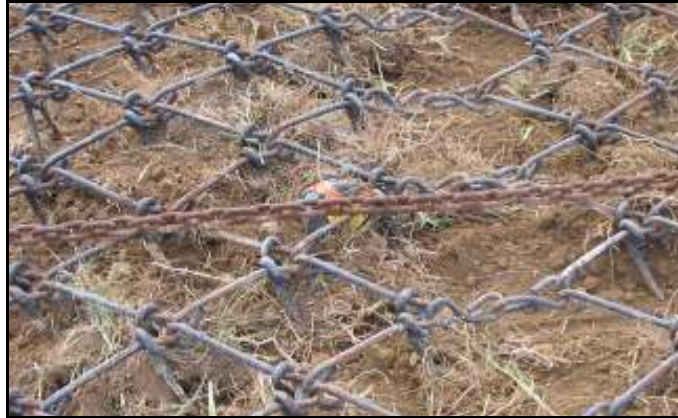
Figure 22. Surface-Laid Mine Remaining on Ground

As the tractor and MCR passed over the mines, one mine was covered with dirt by the MCR and the other remained in place as the MCR drag mat moved across the top of the mine. The mine that remained in place was captured by photograph as the drag mat crossed over the top, as shown in Figure 22.

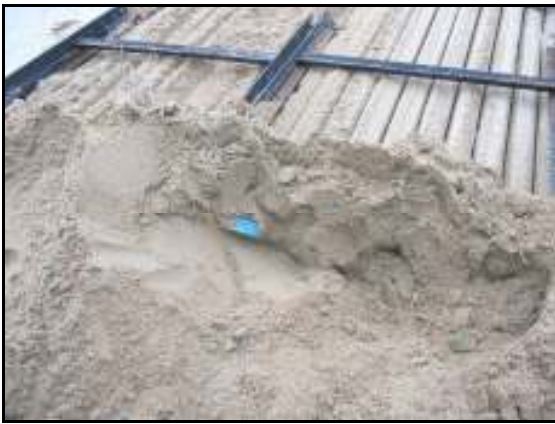
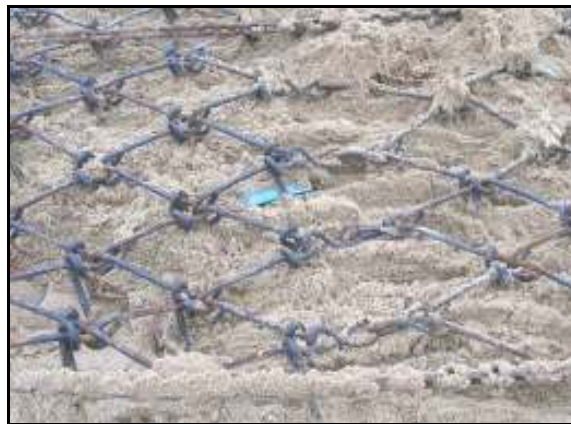
After one pass of the MCR, the field and the MCR accumulation mounds were closely examined for mines. This investigation found seven mines within the accumulation in front of the digging knives, one under the drag mat, one mine slightly exposed in its original location, and the last mine buried in its original location. Of the seven mines found within the sand accumulation in front of the digging knives, none were visible by the tractor operator during or after the test. The locations of these mines were not discovered until the buildups in front of the digging knives and within the drag mat were shoveled away. The final orientation of the mines within the front buildup varied from their original (burial) orientations indicating that they had been tumbled and rolled within the sand. Pictures of the mines discovered within the MCR sand accumulation are shown in Figures 25, 26, and 27.

Figure 25. Mine Found in Accumulation Heap

Figure 26. Two Mines Found Stacked within Accumulation Heap

Figure 27. Mine Found within Drag Mat Accumulation

Only one mine was exposed, but not moved or brought to the surface by the MCR during the sand soil test. When the sand buildup in front of the digging knives array was shoveled away, seven of the mines were found buried in the sand against the front edges of the digging knives and one was found buried in the sand accumulation under the drag mat. An analysis of the location of where the mines were found showed that once the mines were engaged by the rake-portion of the MCR, the mines were pushed along in front of the rake rather than flowing up the front of the knives and being deposited on the surface. The distance from the point of burial to where the sand buildup was removed by shovel was 145 feet (44 m). After the test, the last mine was uncovered with a shovel at its original burial position.

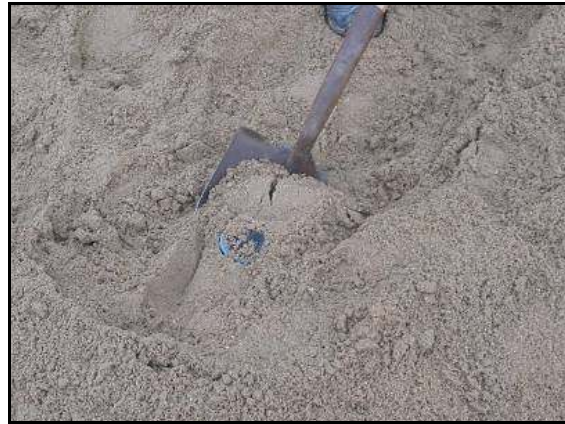
The remaining two mines were left in their original burial location. The uncovered mine was not shifted from its original burial location and was only visible due to its bright blue paint color and after close inspection of the area. The second mine

appeared untouched by the MCR and was uncovered by shovel after the test was complete. Pictures of these two mines are found in Figures 28 and 29.

Figure 28. Exposed Mine in Original Location

Figure 29. Tenth Mine Found after Shoveling
