U.S. Humanitarian Demining Research and Development Program Provides "Reach-In" Technology

Wanner, Chris (2004) "U.S. Humanitarian Demining Research and Development Program Provides "Reach-In" Technology," *Journal of Mine Action* : Vol. 8 : Iss. 2 , Article 1.

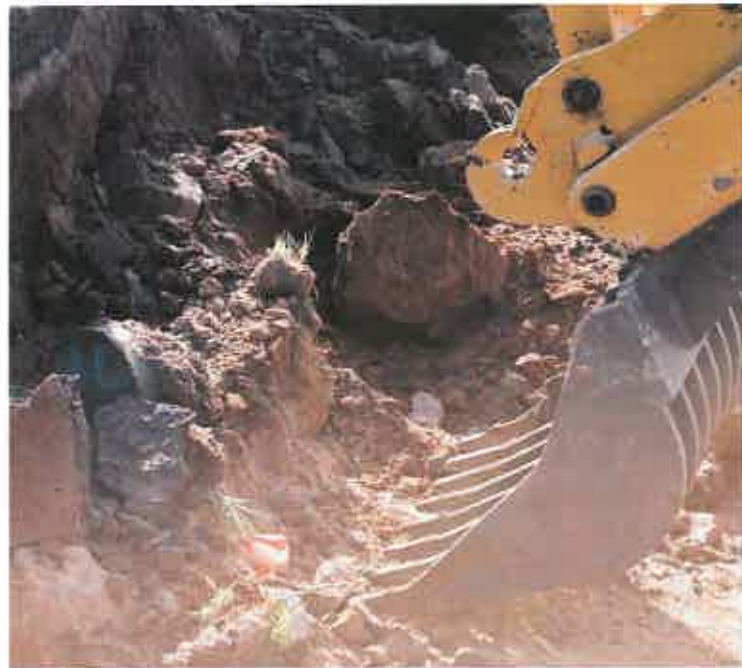
Wall collapses revealing AT mine.

The approach developed to meet the challenge at Las Canoas is a two-step mechanical process that is designed to advance an excavated trench face across a mined area and leave cleared ground in its wake. The process is based from a mine-protected excavator equipped with a standard bucket and four special-purpose tools. Clearance begins from a trench dug outside of the boundary of the minefield. The excavator "reaches in" to the hazardous areas from the safe side of the trench. One of the two special-purpose excavating tools is used to "rake" the vertical wall on the contaminated side of the trench. The objective of this step is to expose AT mines in the face of the wall and gently collapse the wall.

Large mines exposed from this initial raking are destroyed in situ. The excavator works from one end of the trench to the other, excavating into the contaminated wall face between 40 and 60 centimeters with each pass. When sufficient spoils have accumulated at the base of the contaminated wall, the raking tool is exchanged for one of two special-purpose sifting tools. The loosened spoils on the mined side of the trench, which have already been scoured visually for large mines, are lifted in the sifter. The sifting occurs over

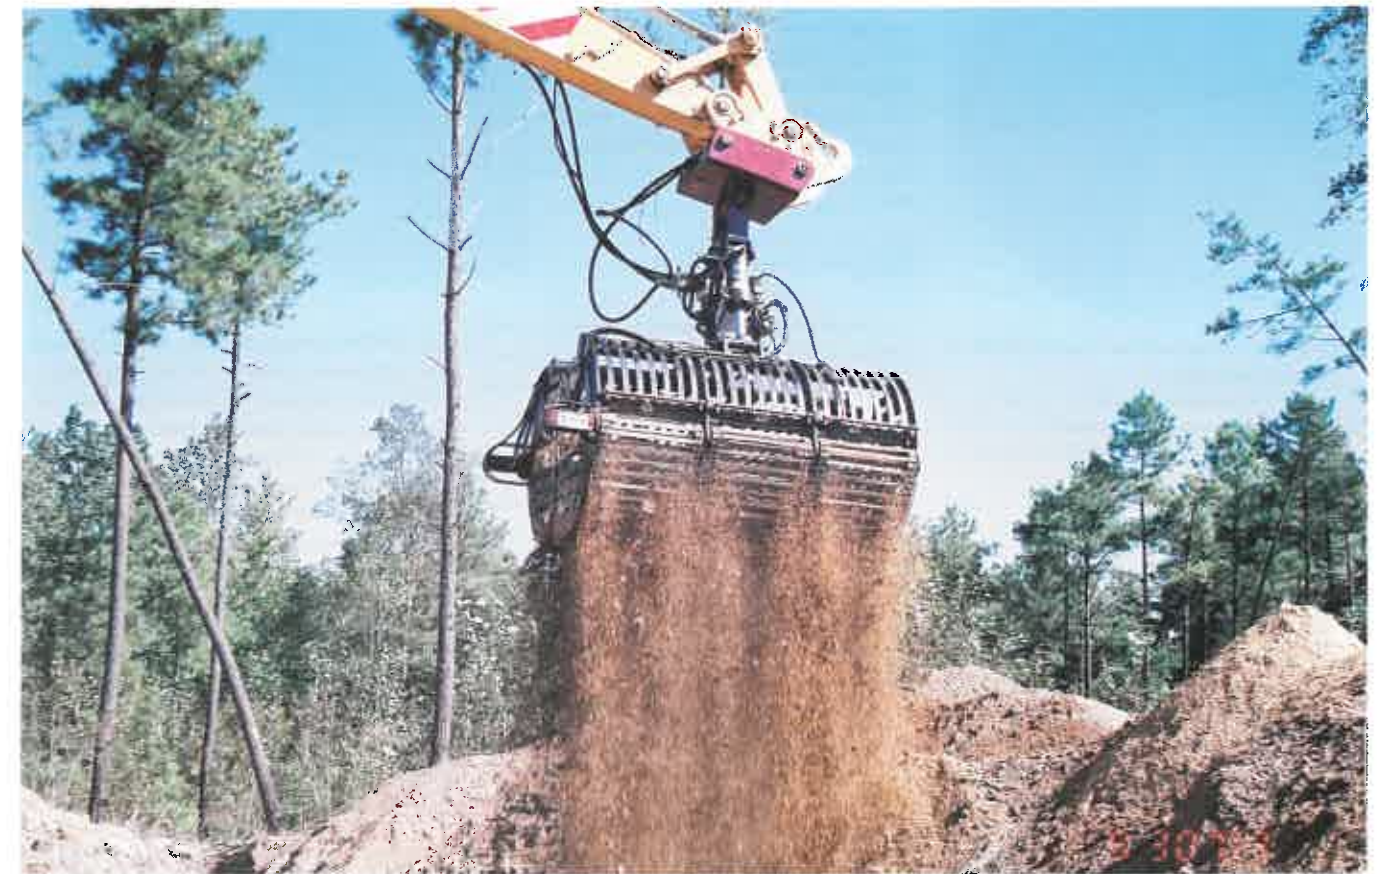
Sifting/Backfilling trench.

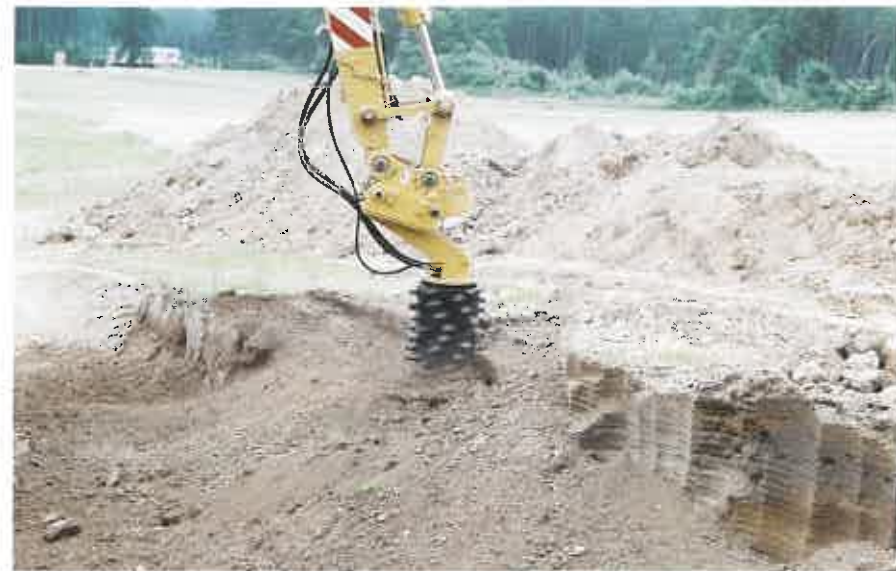
Shaving contaminated wall with vertical mill.

In addition to the standard quick-release digging bucket, four special purpose tools are fitted for use with the Sifting Excavator. The vaned bucket is used for picking and raking at the base of the contaminated wall in order to collapse the bank and expose AT mines. In addition there is a "vertical mill" for shaving the bank with a horizontal milling action. The vertical mill is intended as an alternative to the vaned bucket for use in heavily rooted soils, hard soils (which are resistant to collapse) or locations where precise control of the digging action is required. The first of the sifting tools is the Rotar sifting bucket for scooping up loosened soils and separating soil from mines and other unsiftable debris. The second sifting implement is the Bertani Bucket, originally designed and sold commercially for harvesting beets. Because of a larger volume and more aggressive sifting action, the Bertani is capable of reducing piles faster than the Rotar; however it does not pick up material as cleanly, nor does it have provision for retaining granular materials inside the bucket until the sifting action has begun.

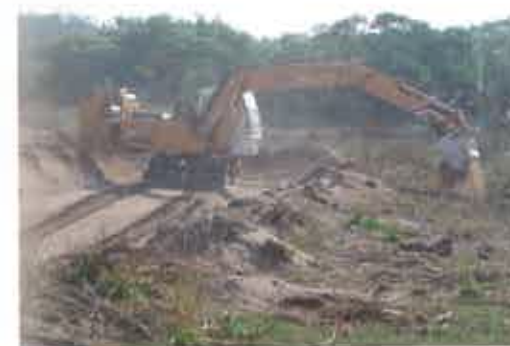
Minefield operations at Las Canoas.
