DDASaccident161

Humanitarian Demining Accident and Incident Database
AID

DDAS Accident Report

Report date: 17/05/2006	Accident number: 161
Accident time: 08:30	Accident Date: 05/10/1998
Where it occurred: Trapeing Phlong Commune, Ponhea Krek, Kampong Chan Province	Country: Cambodia
Primary cause: Unavoidable (?)	Secondary cause: Inadequate equipment (?)
Class: Excavation accident	Date of main report: 12/10/1998
ID original source: none	Name of source: CMAC
Organisation: Name removed	
Mine/device: M14 AP blast	Ground condition: bushes/scrub dry/dusty electromagnetic hidden root mat
Date record created: 14/02/2004	Date last modified: 29/02/2004
No of victims: 1	No of documents: 2

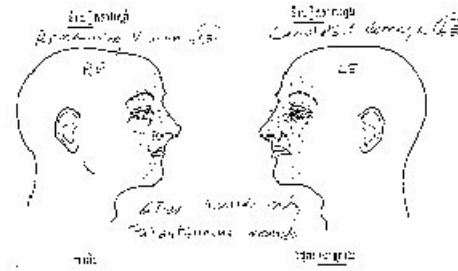
On 6th October a surgeon from a "Ophthalmologic Section" (hospital not stated) said that he had found "numerous very small holes on the eyeball".

On 7th October the Medical Officer was told by International Resources for the Improvement of Sight (IRIS) that the victim had microscopic holes on both eyeballs which could not be repaired.

On 8th October the DU4 Medical Officer himself tested the sight of the victim and found that he still had some vision and was able to identify colours, numbers and objects.
