DDASaccident327

Humanitarian Demining Accident and Incident Database
AID

DDAS Accident Report

Report date: 15/03/2004	Accident number: 327
Accident time: 10:43	Accident Date: 18/09/2000
Where it occurred: Morina village, MNB West, VJ MF 3501	Country: Kosovo
Primary cause: Field control inadequacy (?)	Secondary cause: Inadequate training (?)
Class: Excavation accident	Date of main report: 18/04/2001
ID original source: MD/EW/LH/JF	Name of source: KMACC
Organisation: Name removed	
Mine/device: PMA-2 AP blast	Ground condition: bushes/scrub grass/grazing area
Date record created: 20/02/2004	Date last modified: 20/02/2004
No of victims: 1	No of documents: 3

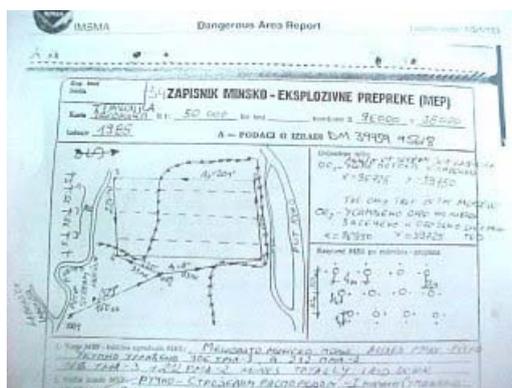
His section commander had inspected the lane seconds before the accident. The section commander has been with [Demining group] for a year, and has taken the section commanders' course.

The section commander indicates the deminer was working in the correct position and correctly wearing his PPE.
