# DDASaccident353

# DDAS Accident Report

A Board of Inquiry (1301) 03/01 2001 was convened as a result of a mine strike on a Hydrema flail being operated by [two NGO's together] on 29 Sep 01 in Shilalo minefield ER246.

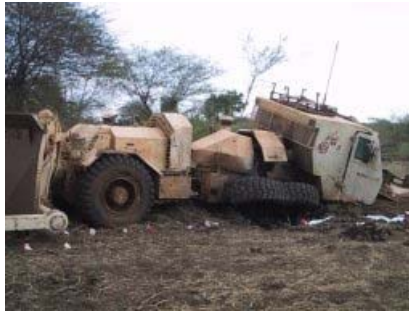
- h. It is thought both machine and operator failure may have contributed to the accident as the wheels may not have tracked each other and the flail did not penetrate the ground sufficiently either due to mechanical or operator failings.

- j. The vehicle cab is not sufficiently protected against AT mines as shown by all the internal damage, the broken door and the injuries to the operator.

- 1. They did not track the same as the rear wheels and did not drive over the mine.
  - 2. The stump, soil conditions or surface variations prevented sufficient pressure being exerted on the pressure plate by the front wheel, and only the second wheel for whatever reason exerted sufficient pressure to initiate the mine.

- a. The Hydraflail should be suspended from operations in AT minefields in UNMEE AOR until safety modifications are done and the machine is retested and certified to be suitable for use.

- b. The Hydraflail when returned for service should be repeatedly tested for ground penetration; failure to achieve 200mm consistently should result in the machine being classified as a ground preparation and not clearance tool.
