DDASaccident395

DDAS Accident Report

REPORT FOR ACCIDENT INVESTIGATION BOARD OF INQUIRY – No010/2002
MINE Accident that occurred in OES 3 on 26th September 2002.
Map Reference: UNIFIL Genimap 1:50,000 Sheet A (Tibnin).

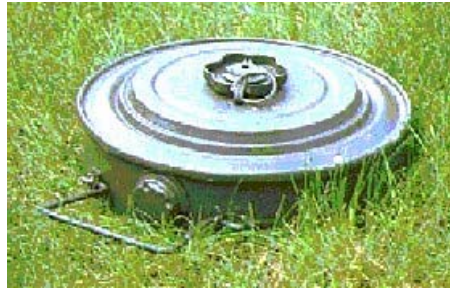
17. In addition to the standard pressure fuzes (MV-5 and MVM), the mine can also accept a tilt-rod fuze (MVSh-46), that gives it a full width attack capability against vehicles.

PICTURE SHOWING TM-46 AT MINE WITH MVM FUZE FITTED
