# DDASaccident454

# DDAS Accident Report

Sub: [Demining Group] Demining accident report

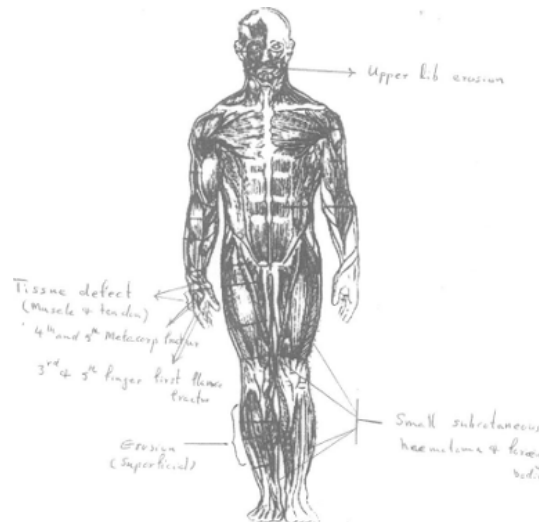
One deep wide and serious injury on his right hand with tissue defect and multiple fractures

Both side of right hand has wide tissue, muscle and tendon defect.

His general condition is good but according to the German surgeon specialist the prognosis of right hand injury is very bad, because of very bad multiple fractures and tissue defect. If he get a good chance with current treatment, he wouldn't able to use his right hand as a normal hand. The chance of complication like necrosis, gangrene, osteomyelitis and amputation is present.
