## DDASaccident482

# DDAS Accident Report

## **REPORT OF BOARD OF INQUIRY**

INTO DEMINING ACCIDENT AT SHULL MOUNTAIN ON 21 AUGUST 2006

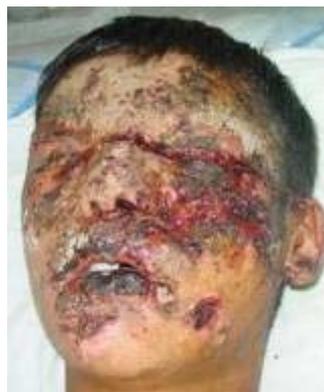
31st August 2006 below

Photographs showed one leg bandaged top to bottom, the other peppered with small fragmentation wounds at the thigh. Both hands were bandaged and bloody with lacerations of the fingers.

“Today the operator had another surgery in Russian military hospital for 1hr 30min on his eyes. No frags in his skull. I've talked with the doctor who made surgery, she said that [the Victim] lost sight in both eyes.”
