DDAS Accident Report

Report date: 25/01/2008	Accident number: 509
Accident time: 09:10	Accident Date: 18/01/2007
Where it occurred: MF # AF/3208108364/MF01 1, Dwa-Mandy Village, Nadersh-Kot District, Khost Province	Country: Afghanistan
Primary cause: Field control inadequacy (?)	Secondary cause: Victim inattention (?)
Class: Detection accident	Date of main report: 24/01/2007
ID original source: OPS/2/2/21-014-07	Name of source: UNMACA
Organisation: [Name removed]	
Mine/device: PMN AP blast	Ground condition: dry/dusty rocks/stones
Date record created:	Date last modified: 25/01/2008
No of victims: 1	No of documents: 2

Subject: Demining Accident Investigation Report of [National demining agency] MCT#1

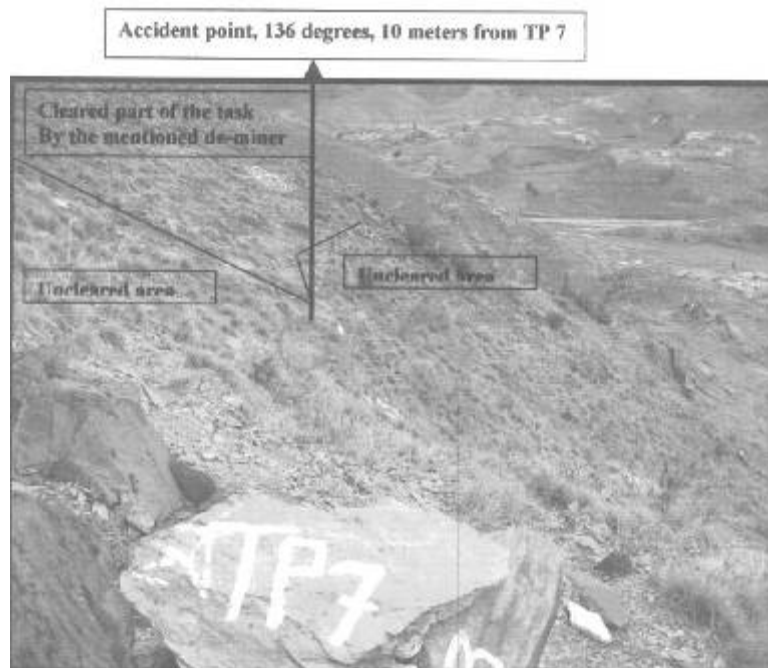
The device detonated when the deminer moved into an un-cleared area before using the metal detector. [The detector was damaged, so with the deminer, who said he was preparing to use it.]

Device was detonated in area where it was difficult to be clear from the right to left, due to sloppy [sloping] condition.

The area of ground being cleared was sloping and the deminer was clearing 1 meter across the slope before proceeding up the slope a further 5 meters.

The accident site

3. That Section Commanders ensure that their deminers fully understand how to perform clearance before moving into the hazard area and if they are unsure then they should ask for clarification immediately.
