DDAS Accident Report

SUBJECT: BOARD OF INQUIRY REPORT

FOR [Demining group] UXO ACCIDENT IN AR RAFIYAH DISTRICT, SOUTHERN IRAQ, 09 January 2007

FILE REFERENCE: BOI 001 091007

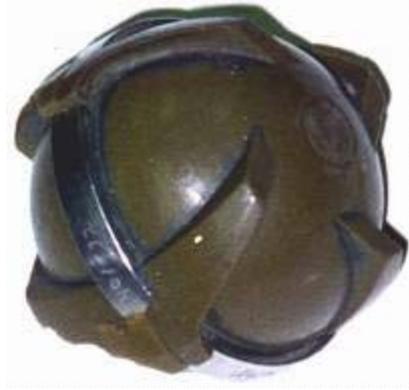
BLU-61A/B HE fragmentation/Incendiary

This is an aerial dispensed, spin-armed, impact-initiated, high explosive incendiary, anti-material, fragmentation bomb. It is detonated by an M219E1, all-ways acting (omni-directional) fuze. The bomb is painted olive drab without markings. Each hemisphere is made from a coined steel fragmentation liner, and an incendiary liner of zirconium-tin. The hemispheres are encased in a urethane plastic shell. The clamp ring is stainless steel.

Diameter 99mm 277g TNT/HMX Total weight 1 kg

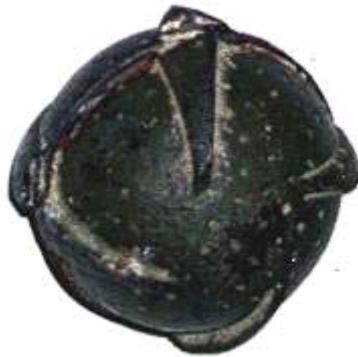
BLU-63 HE fragmentation

These are aurally dispensed, centrifugally armed, high-explosive fragmentation (HE-frag) bombs. The bombs comprise two hemispheres held together by a crimp ring. The BLU-63A and A/B are impact-fired.

These bombs are olive drab with a small yellow dot on one hemisphere. Designation and loading data may be stencilled in yellow. The BLU-63(T-1)/B are painted blue with white markings.

Diameter 76mm HE content: 113g Cyclotol Total weight: 430g
