# DDASaccident548

# DDAS Accident Report

## Demining Investigation Report

Location: Former Border Regiment-5, Dopushta, Injil District, Herat Province

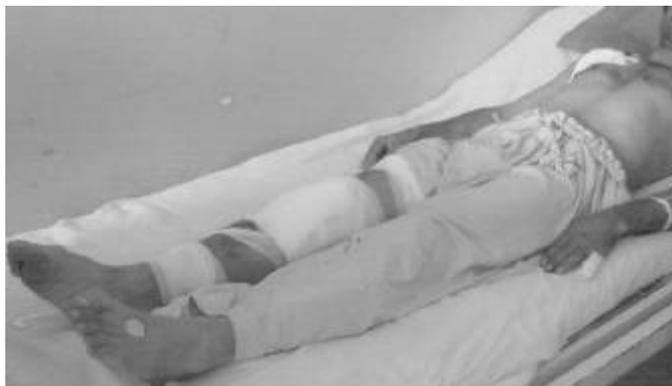
Medical sketch shows left of body arm and leg with "severe" fracture", "haemorrhage", "laceration" and "loss of function" circled.

B – multiple small injuries over right leg and knee joint (penetrating injury and patella fracture on the right knee joint)

Treatment:- debridement injuries, remove foreign body, put drainage in the joint and immobilise knee joint.
