DDAS Accident Report

| Where it occurred: CBU Site No: 483, Nr Al Smaaiyeh Village, Tyre District | Country: Lebanon |

BOARD OF INQUIRY – No 001/2007

BAC Accident that occurred in Area 7-004 (CBU 834), UTM 707747/3677539 on 19th January 2007 in which [Demining group] BAC Team Leader [Name removed] was injured.

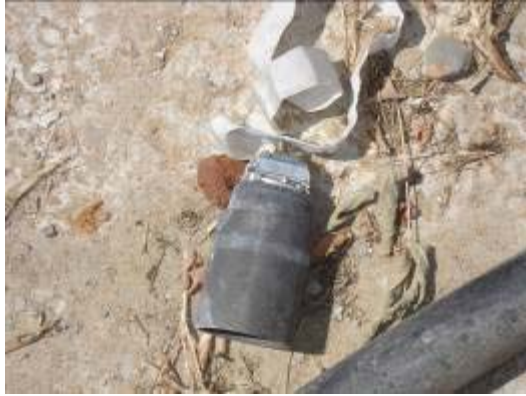
US M-77

26. The M77 HE cluster bomb is commonly referred to among the Lebanese and Palestinian population as the "battery bomb" or "lighter" bomb because of its shape. There M77 HE grenades are dispensed from various sizes of projectiles, which are initiated by mechanical time fuses above the target areas to allow dispersion of the grenade. The M77 has a white nylon ribbon which when pulled or touched can detonate. Shortly after ejection from the projectile, artillery shell or various size of container or dispenser, the M77 HE grenade arms due to the rotation of the white nylon ribbon. This ribbon also acts as stabilizing tail to orient the cone of the grenade towards the target. Upon impact a charge in the grenade launched downward to penetrate armour while the metal grenade body bursts into shrapnel-like fragments to wound and kill personnel. The M77 has a white band around its body.
