# DDASaccident563

Humanitarian Demining Accident and Incident Database  
*AID*

# DDAS Accident Report

## **BOI Investigation report**

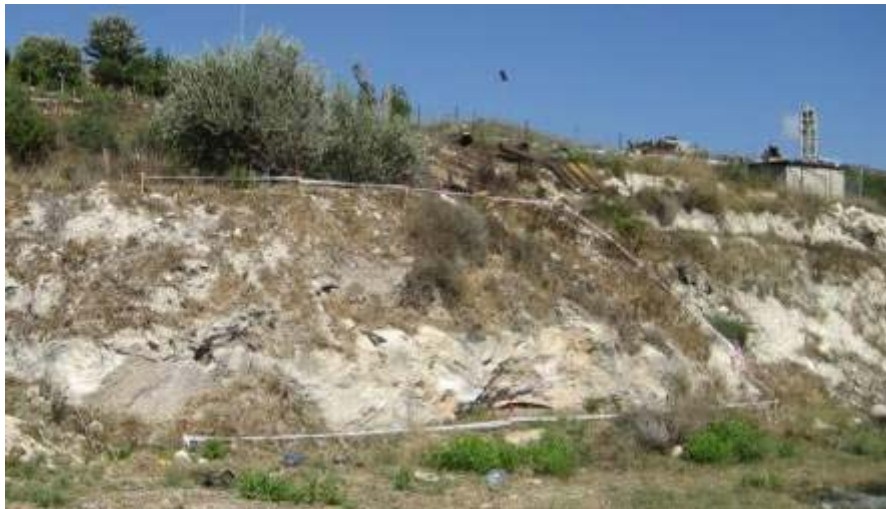
The task site, CBU 434, is a combination of both flat and steep terrain, with the steep areas requiring greater planning to allow searchers to conduct clearance in a safe manner.

[The site on the steep side of a ridge. The point of detonation is roughly central in the photograph below.]

No crater was evident at the site of detonation, however there was approximately 50cm of ground disturbance. Blood stains were seen on a stone 20cm from the area of the disturbed ground. The BOI where able to view the detonation site/area from a point of 1.5m.
