# DDASaccident566

# DDAS Accident Report

## **BOARD OF INQUIRY (BOI) REPORT 003/2007**

on [International demining company] INTERNATIONAL LIMITED DEMINING ACCIDENT that occurred on the 05th March 2007 in which a [International demining company] Deminer was injured

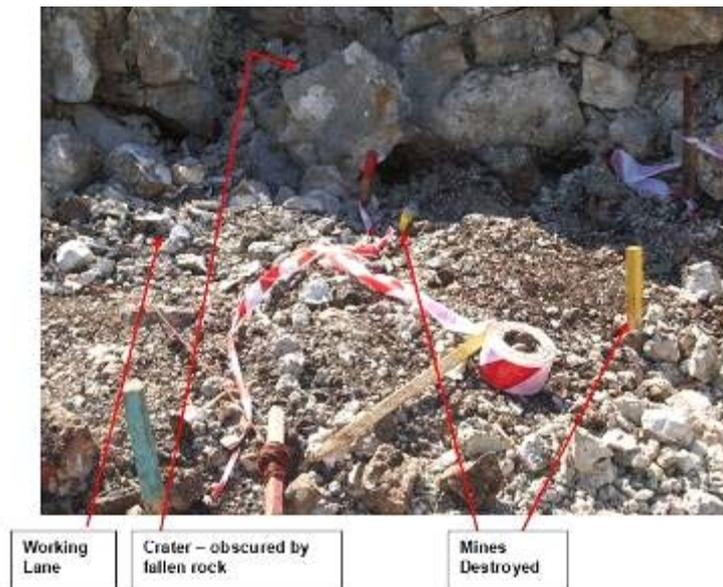
Based on the evidence gathered at the accident site, medical reports and interviews conducted by the MACC SL BOI team during the course of the investigation; it is of the opinion of the BOI team that the mine was positioned in the uncleared area to the front of the demining lane. It had been buried in the ground or covered by rocks and had been initiated as a result of direct pressure from one or more rocks falling from the rocky slope above.

The ground is hard and rocky and the seat of the explosion is at the base of a rocky outcrop comprising a large boulder partially concealing / obstructing the view of the crater. The large boulder appears to have been severed from the outcrop immediately above. It was not possible to confirm the dimensions of the crater however, some charring and splintering is evident around the walls. There are loose rocks / fragments to the left side of the crater.

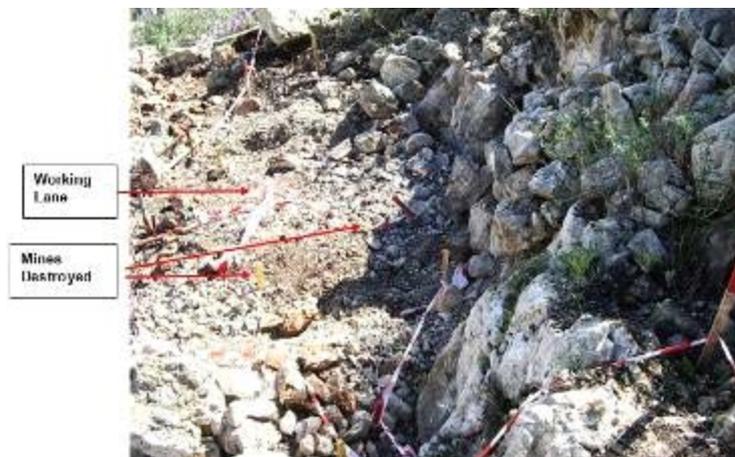
On 05 March 2007 at 0953 hrs, [the Victim], a [International demining company] Deminer was involved in a Demining Accident at [International demining company] Task MF 356 (Sowaida position). [The Victim] was removing a rock from the front of his lane during the course of the manual mine clearance operations when an explosion occurred, resulting in injuries to his left arm, hand and head.
