DDASaccident567

DDAS Accident Report

REPORT FOR ACCIDENT INVESTIGATION BOARD OF INQUIRY – No 004/2007

INVESTIGATION REPORT ON A M77 SUB-MUNITION ACCIDENT AT CBU 040, AREA 7-001. Al Bazuriyah

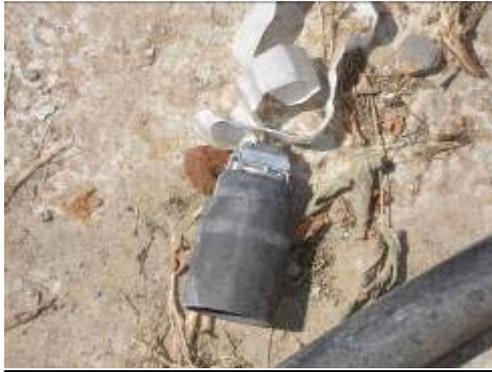
US M-77

19. The M77 HE cluster bomb is commonly referred to among the Lebanese and Palestinian population as the “battery bomb” or “lighter” bomb because of its shape. There M77 HE grenades are dispensed from various sizes of projectiles, which are initiated by mechanical time fuses above the target areas to allow dispersion of the grenade. The M77 has a white nylon ribbon which when pulled or touched can detonate. Shortly after ejection from the projectile, artillery shell or various size of container or dispenser, the M77 HE grenade arms due to the rotation of the white nylon ribbon. This ribbon also acts as stabilizing tail to orient the cone of the grenade towards the target. Upon impact a charge in the grenade launched downward to penetrate armour while the metal grenade body bursts into shrapnel-like fragments to wound and kill personnel. The M77 has a white [grey] band around its body.
