DDASaccident804

Humanitarian Demining Accident and Incident Database

DDAS Accident Report

Report date: 12/08/2016	Accident number: 804
Accident time: 07:17	Accident Date: 01/10/2014
Where it occurred: Mf: #96, Qomsangir District, Khatlon region	Country: Tajikistan
Primary cause: Unavoidable (?)	Secondary cause: Inadequate training (?)
Class: Excavation accident	Date of main report: 09/10/2014
ID original source:	Name of source: Demining group
Organisation: [Name removed]	Ground condition: dry/dusty; steep slope
Mine/device: PMN-2 AP blast	Date last modified: 12/08/2016
Date record created:	No of documents: 3
No of victims: 1

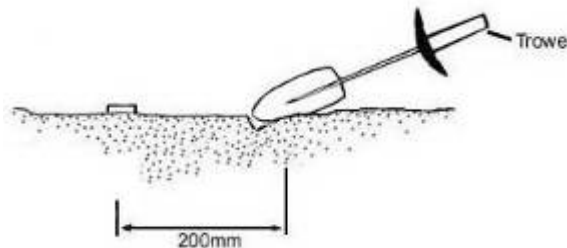
- 1) The deminer must begin by looking closely at the ground surface for sources of the metal-indication. If any metal is found, the deminer should remove the metal and check the position with the metal-detector. Throughout the investigation, the deminer should be constantly searching the ground by eye, looking for the source of the metal-detector signal

- 2) An investigation should be started by prodding the ground at least 20cm back from the metal detector signal. In most ground, the prod will not penetrate more than a few centimetres. The deminer must not apply excessive pressure to make the prodder go more deeply into the ground. If the prodder will not penetrate 3cm, the deminer should use another approved tool to break the ground surface. Sometimes the ground has a crust with softer spoil underneath. Frequently the ground becomes harder as the investigation gets deeper, and the use of other tools may be required. The ground should be prodded or broken-up over a width of excavation equal to the width of the anticipated threats at the site. If AP mines are expected, a width of 15cm is required. If AT mines are expected, a width of at least 30cm is required.

- 3) The ground that has been loosened with the prodder should then be removed with a trowel. The soil of the investigation area should be cut and removed by trowel for 5cm deep from the top. Layer by layer every 5 cm in depth of excavation, followed every time by metal detector. If metal detector continues reading the signal, deminer should repeat step 2 and 3 accordingly.

Whenever metal is found during the excavation the deminer should check the position of the original indication with the metal-detector.
