### DDASaccident807

# DDAS Accident Report

<b>Report date:</b> 13/08/2016	<b>Accident number:</b> 807
<b>Accident time:</b> 10:52	<b>Accident Date:</b> 10/07/2015
<b>Where it occurred:</b> MF: HZTJ99 MF6, Sagirdasht Sub- district, Darvaz, Gorno- Badakhshan Autonomous (GBAO) Region	<b>Country:</b> Tajikistan
<b>Primary cause:</b> Field control inadequacy (?)	<b>Secondary cause:</b> Management/control inadequacy (?)
<b>Class:</b> Excavation accident	<b>Date of main report:</b> 11/08/2015
<b>ID original source:</b>	<b>Name of source:</b> Demining group
<b>Organisation:</b> [Name removed]	<b>Ground condition:</b> dry/dusty; grass/grazing area; soft
<b>Mine/device:</b> PMN AP blast	<b>Date last modified:</b> 13/08/2016
<b>Date record created:</b>	<b>No of documents:</b> 2
<b>No of victims:</b> 2

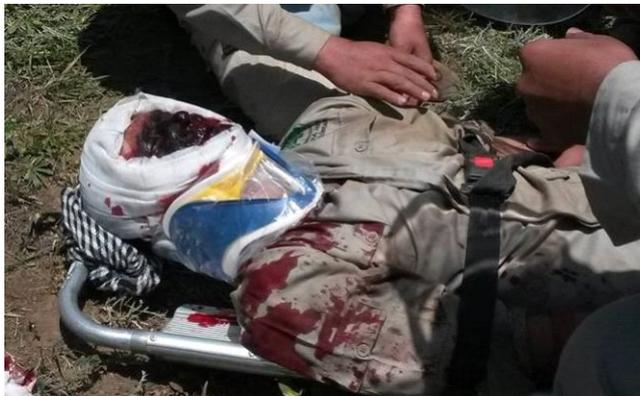
Casualty was delivered from uncleared to safe area less than 01 minute after explosion occurred.

Medic assessed the casualty, assured that the injured was conscious, and provided immediate first aid as follows:

1. Fixed neck brace/ protector;
2. Stopped bleeding of the right hand and face;
3. Did initial debridement of the wounds and bandaged;
4. Did splinting on the right hand;
5. Administered local anaesthetic pain reliever and antibiotic injections to casualty (Trimeperidine hydrochloride)
