DDASaccident814

DDAS Accident Report

Report date: 08/04/2019	Accident number: 814
Accident time: 11:40	Accident Date: 25/09/2017
Where it occurred: Sarichashma MF-10, Shamsiddin Shohin district, TAB, Khatlon Province	Country: Tajikistan
Primary cause: Victim inattention (?)	Secondary cause: Field control inadequacy (?)
Class: Excavation accident	Date of main report: 29/09/2017
ID original source: MAR #1/17	Name of source: [Name removed]
Organisation: [Name removed]	Ground condition: hard; metal fragments; rocks/stones; steep slope
Mine/device: PFM-1 AP blast	Date last modified: 08/04/2019
Date record created:	No of documents: 2
No of victims: 1

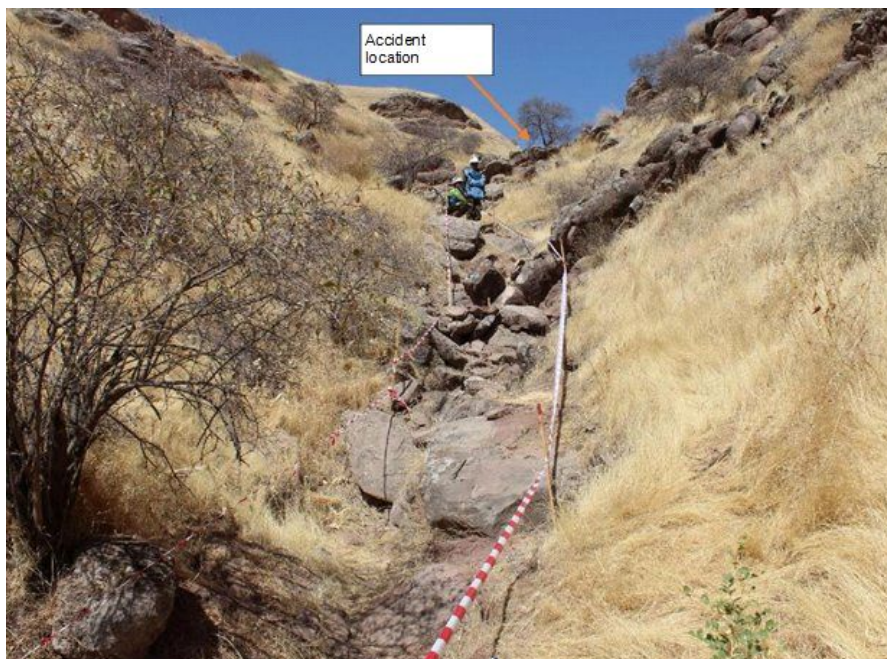
The accident occurred in one of the remote Mine Field (MF) tasks (HZTJ-335-MM10) located in TAB region of Tajikistan, Shamsiddin Shohin district: 30 km from nearest hospital, 60 min of driving by narrow and bad condition restricted border zone road, and was caused due to hand excavation tool (demining trowel) penetration into the liquid explosive container of an AP blast mine type PFM-1. Penetration, fortunately, did not provoke any detonation, but resulted in rupturing the plastic mine casing and spraying of the liquid explosive charge contents into the eyes, mouth and facial area of the deminer operating the demining tool.
