Falkland Islands Malvinas Exploitation Report 2010

Demining Programme Office in the Falkland Islands – Technical Support 2010

TECHNICAL SUPPORT TO THE FALKLANDS DEMINING PROGRAMME

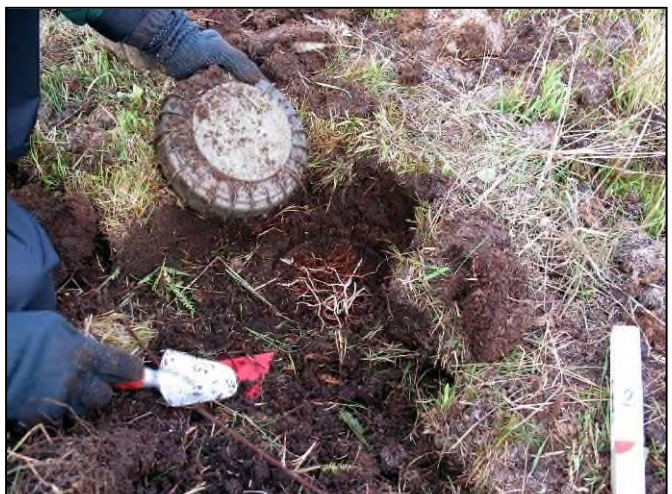
With the mine extracted, the underlying ground was photographed and examined

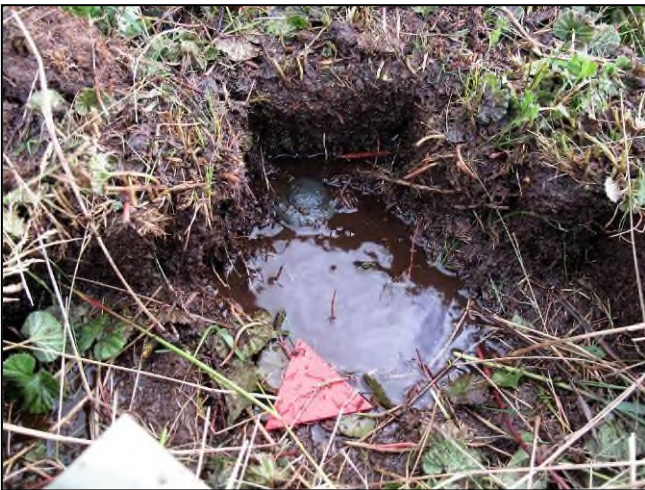
An SB-33 AP mine under water

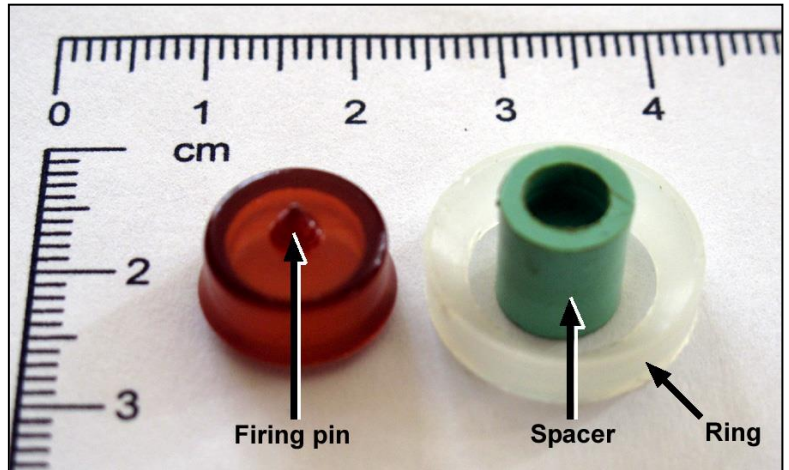
Figure 7

It is important to note that the P4B can function regardless of the spring's condition. The firing pin is made from polymethylacrylate plastic, which is unlikely to deteriorate significantly within the foreseeable future. It is forced through a polythene ring by a spacer and this action alone may be sufficient to cause initiation without the additional impetus of the spring. These plastic components are shown in Figure 7.

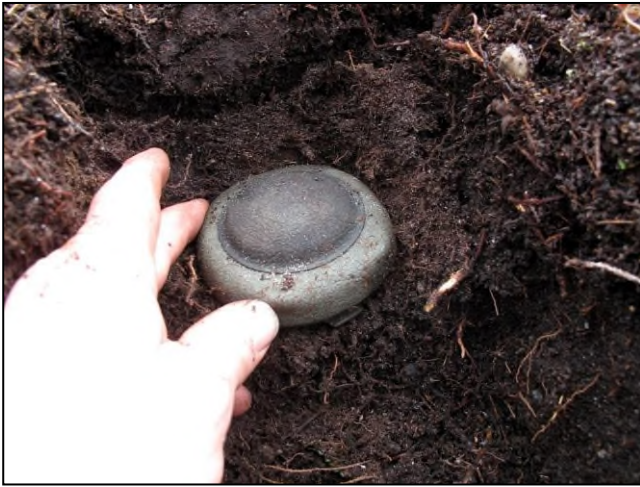
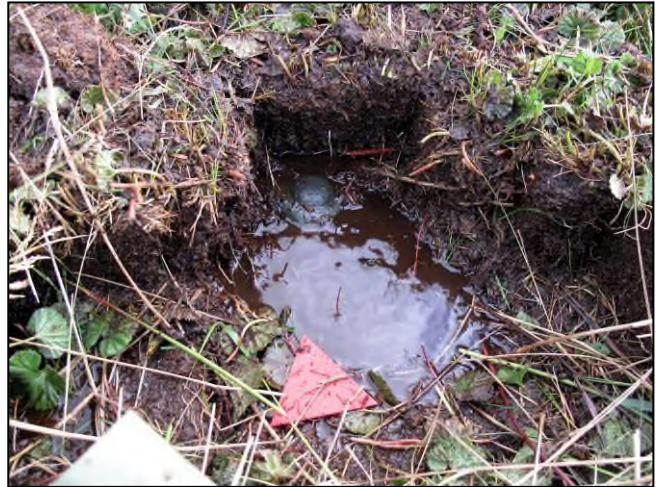
Seventeen SB-33 mines were recovered from a mixture of dry and wet sites (Figures 1 and 2). None of the SB-33 mines examined showed signs of significant external degradation, other than a notable increase in the profile of the rubber pressure plate; this is clear from Figures 3 and 4.

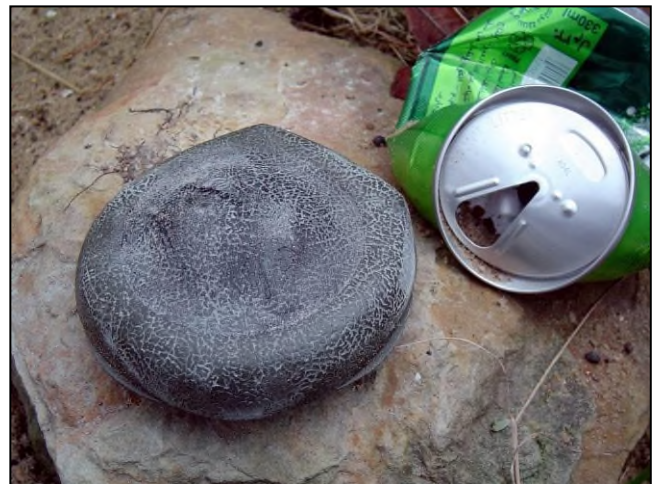
Figure 4: The normal appearance of the SB-33, with a relatively flat pressure plate

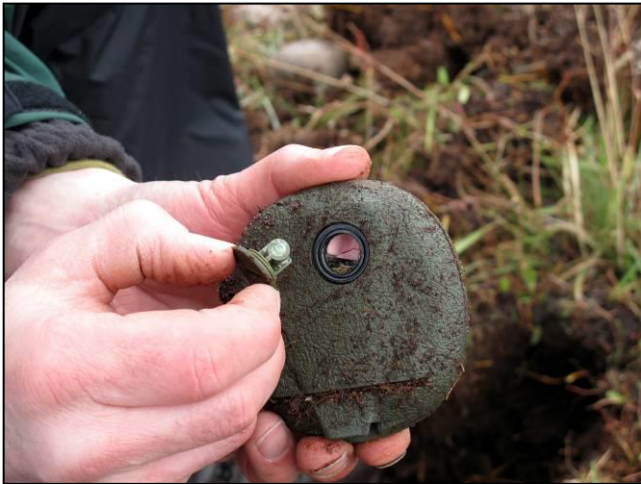
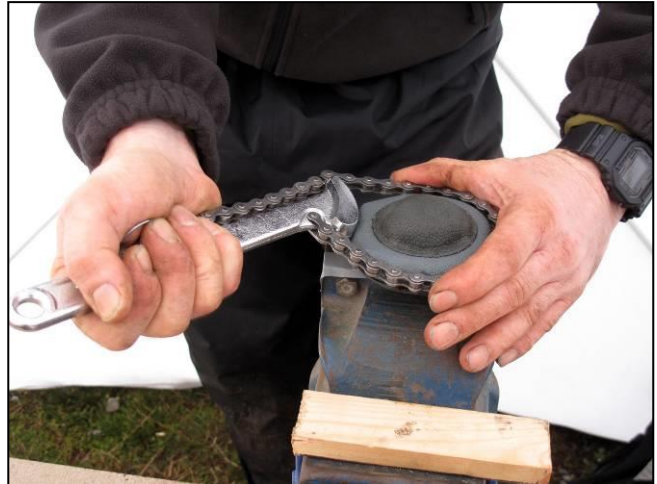
Mines were disarmed by unscrewing the detonator assembly from the base well (Figure 5); in most cases, this plug had been fitted tightly. Once disarmed, the two halves of the mine were unscrewed using a chain wrench (Figure 6) to access the internal components and main charge.

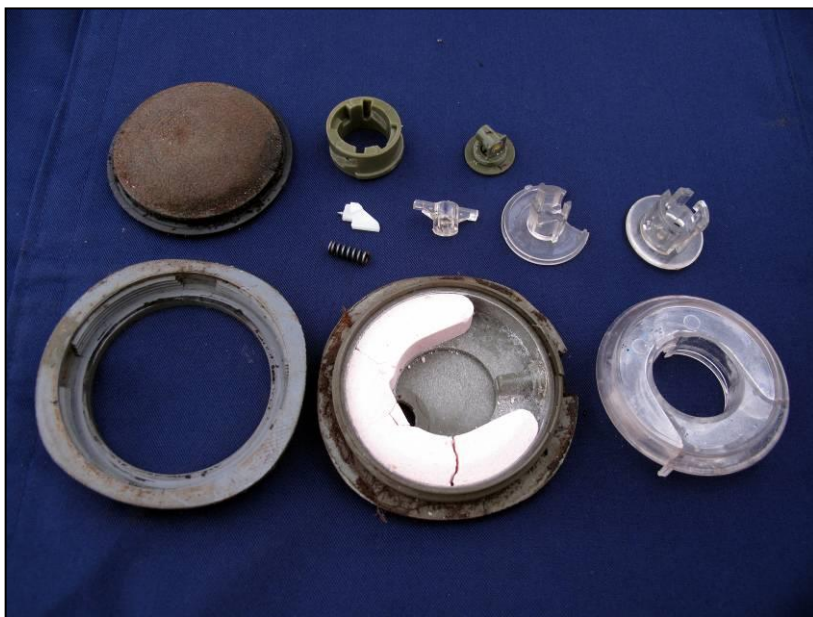
Figure 7 shows a recovered SB-33 disassembled. Most of the clear plastic internal fuze components are made from polycarbonate, and are therefore extremely strong.

None of the internal components showed any mechanical damage. The main charge (RDX/HMX) was often cracked, but this would not affect performance.

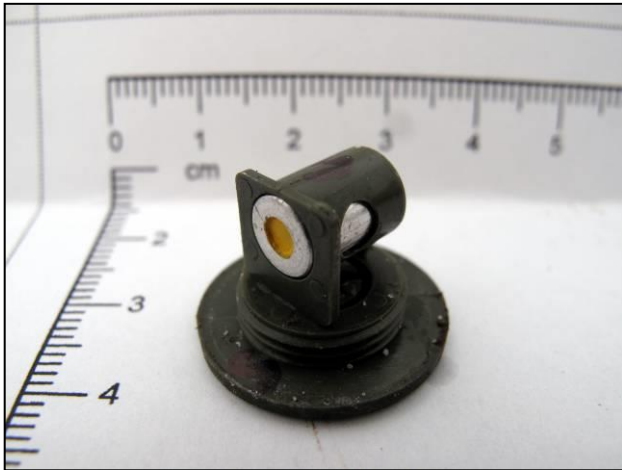
Most of the aluminium detonator capsules were in good, functional condition (Figures 8 and 9), but some did show significant signs of corrosion; see Figures 10 and 11.

Figure 8: Most detonator assemblies were in very good condition

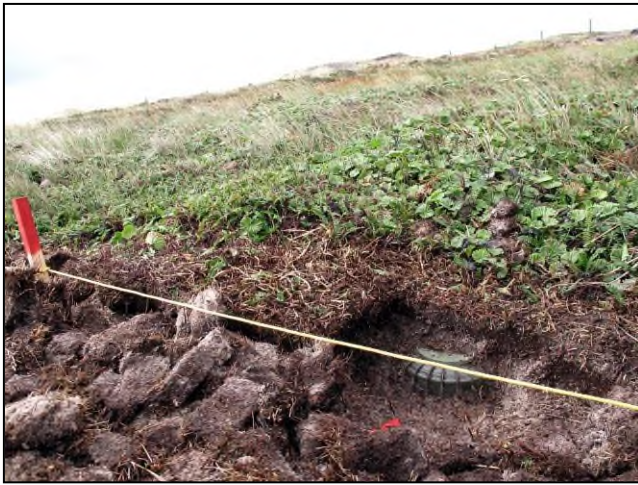
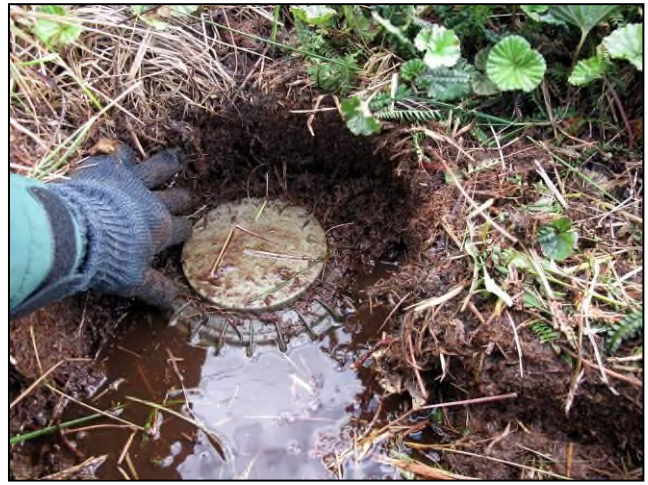
Fifteen SB-81 Anti-Tank (AT) mines were recovered from a mixture of dry and wet sites (Figures 1 and 2). None of these mines showed signs of significant external degradation; in fact, their appearance was virtually 'as new', as shown in Figures 3 and 4.

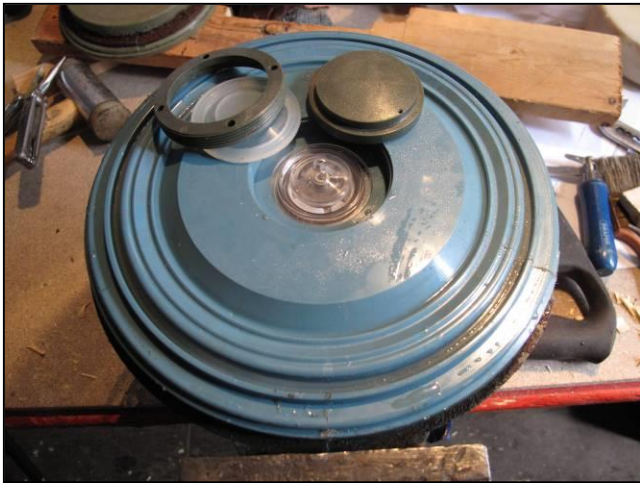
With the halves of the casing separated, the internal components could be examined. Figure 5 shows upper section of the mine with the pressure plate removed to reveal the top of the fuze assembly. The seal around the edge of the pressure plate is critical to the pneumatic function of the fuze; this is a common point of failure among Italian AT mines. Although small roots were present on the outside (Figure 6) all seals were intact.

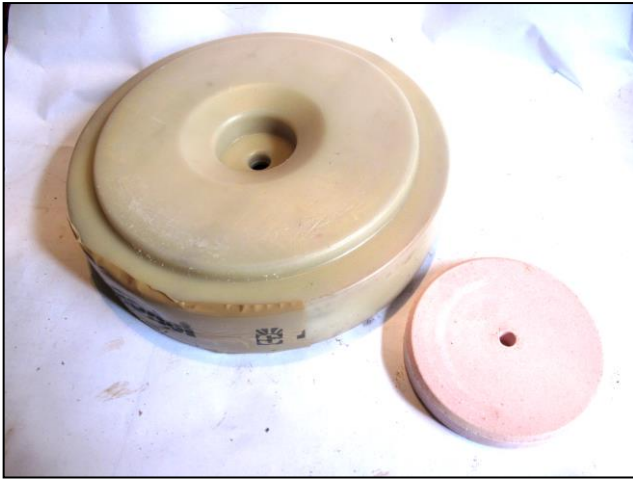
The main charge (approximately 2 kg of TNT/RDX/HMX) is encapsulated in plastic, while the booster (approximately 140 g of RDX/HMX/wax) is in the form of a pressed disc. These are shown in Figure 8. Removal of the plastic showed the main charge to be in perfect condition (Figure 9).

Figure 8: The main charge and booster
