Evaluating the Mini MineWolf

The U.S. Department of Defense Humanitarian Research and Development Program conducted operational field evaluation to assess the capabilities of Mini MineWolf technology.

by Phil Straw [U.S. Department of Defense Humanitarian Demining Research and Development]

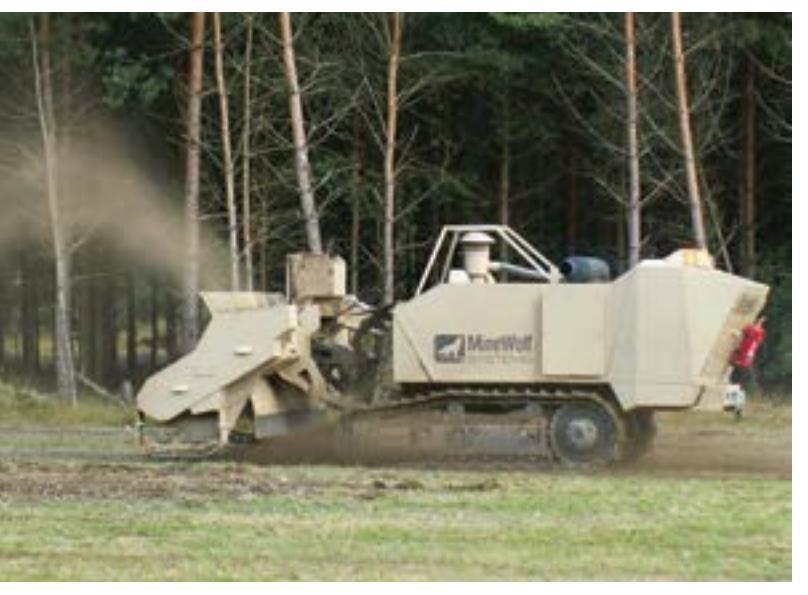
The Mini MineWolf System. Photo courtesy of MineWolf Systems.

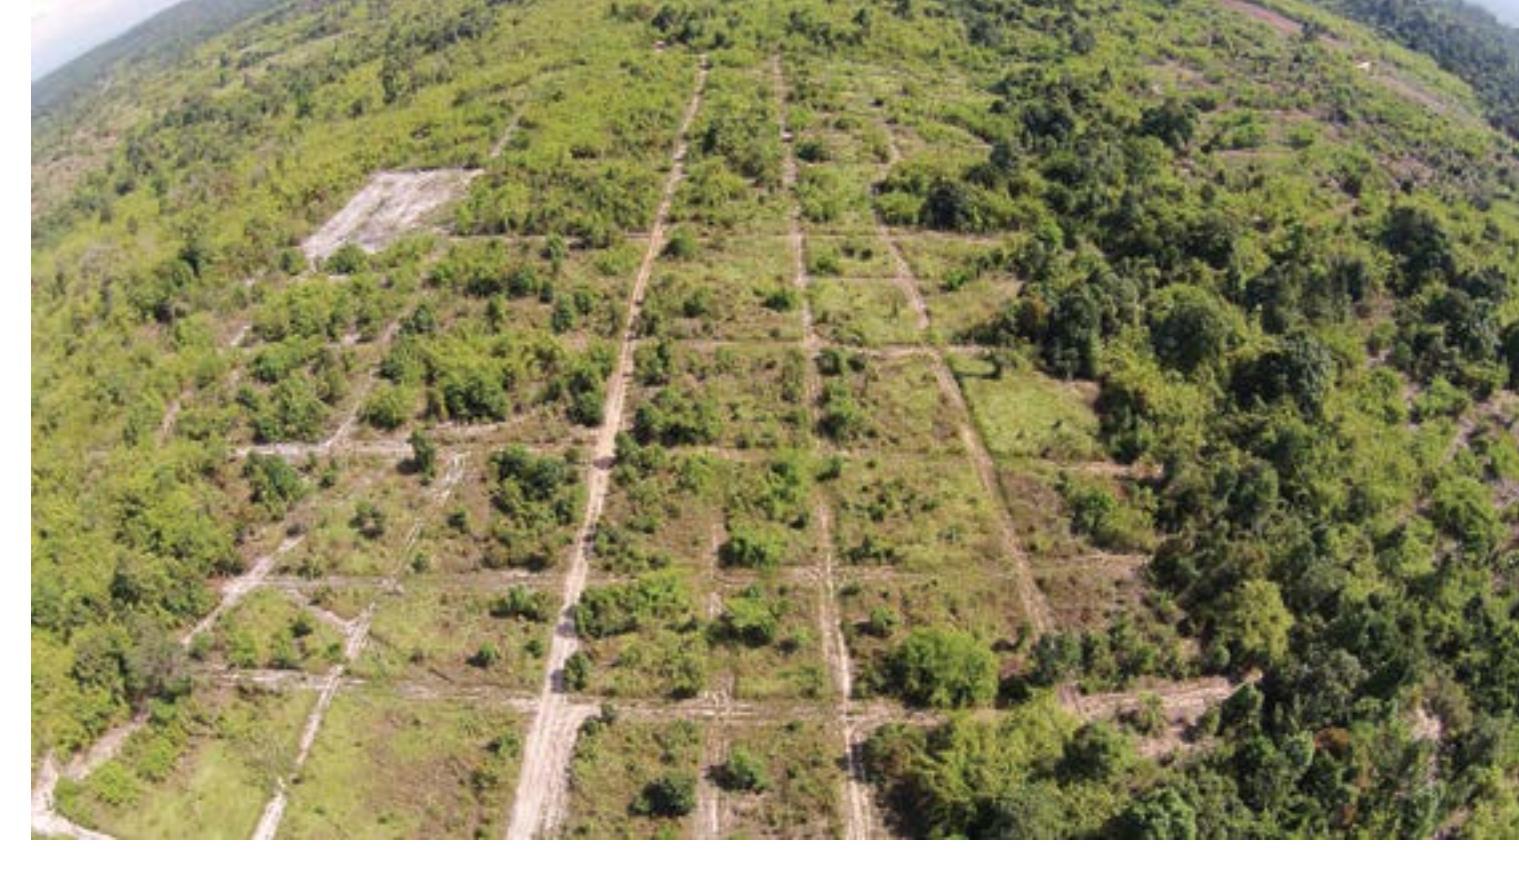
In Phase 2, lanes are cut every 25 meters, perpendicular to each other to form a grid. *Photo courtesy of HD R&D*.

Phase 2. Directed remotely by an operator, the Mini MineWolf conducted a mechanical technical survey. Lanes were cut every 25 m (82 ft), perpendicular to each other. This formed a grid pattern across the lower threat areas and led into the higher threat zones. The technical survey lanes were closely monitored for any mine indicators.

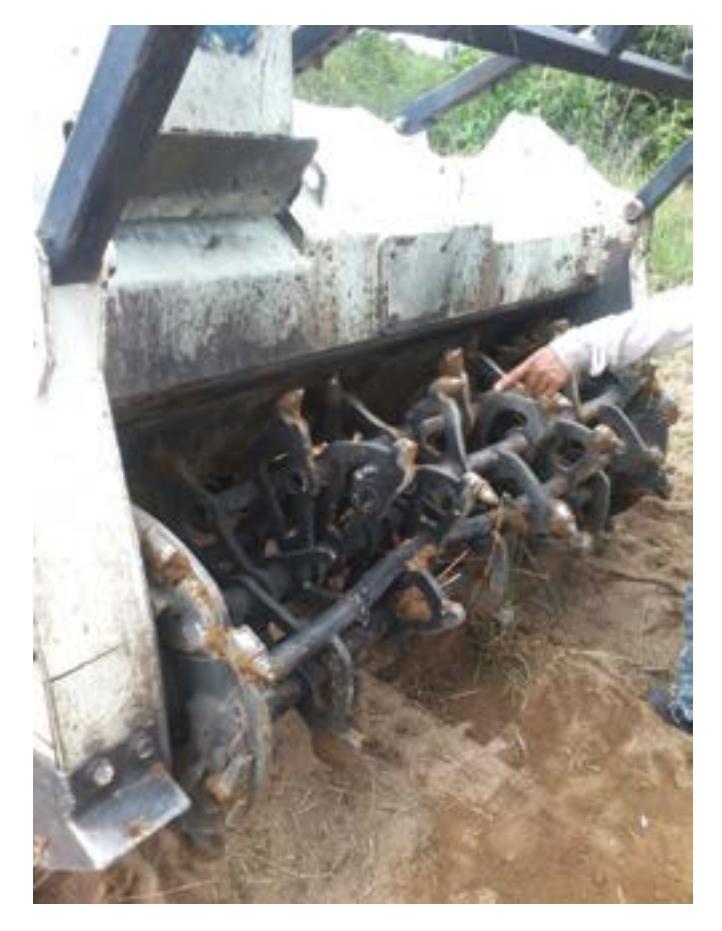
The tiller of the Mini MineWolf is capable of detonating AP mines without sustaining any damage. *Photo courtesy of HD R&D.*

During the OFE from 2013 to 2014, the Mini MineWolf tiller detonated three TM46 anti-tank (AT) mines. These were rogue mines laid in conjunction with anti-personnel (AP) mines. On each occasion the tiller suffered considerable damage, which required comprehensive repair to return it to operation. Local staff conducted these repairs on site under the supervision of the HD R&D field officer. The Mini MineWolf was not designed for use against AT mines, which were not anticipated to be within the area of operation. The machine, however, detonated many AP mines without sustaining any damage.

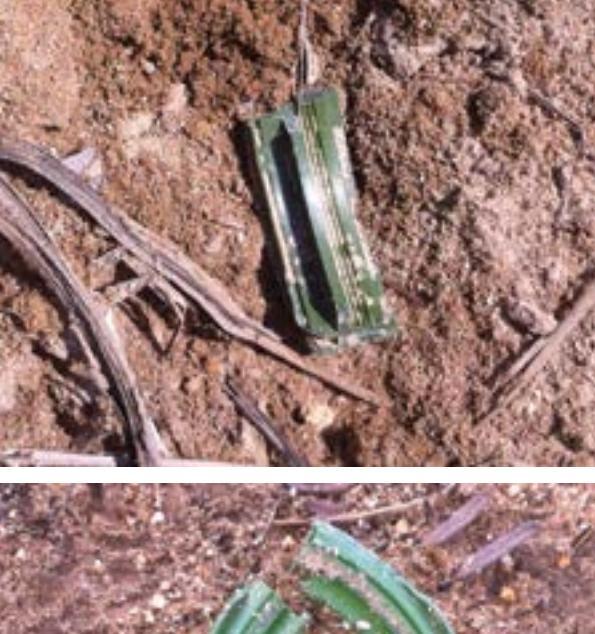
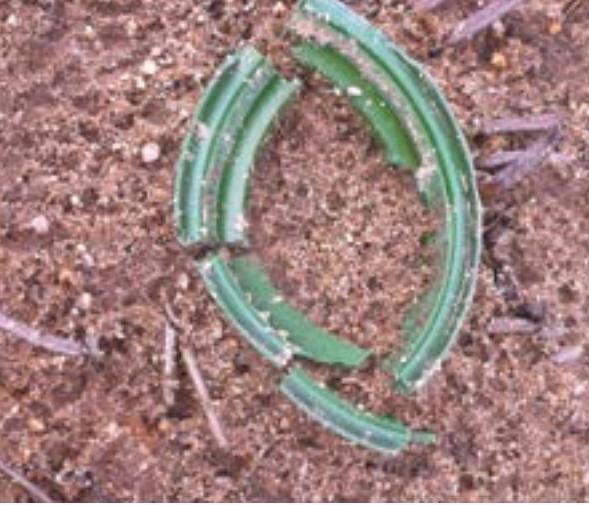
Recovered items are photographed, recorded and inspected for their state of function. *Photos courtesy of HD R&D.*

Phase 4. Collecting the clearance performance data was critical to the OFE's success. One of the major questions within the OFE was whether the Mini MineWolf could consistently destroy or otherwise render mines inoperative. To this end, the painstaking process of recovering every piece of the remaining mines left behind by the Mini MineWolf has been paramount. All items were photographed, recorded and inspected for functionality.

The search process involved three steps. Firstly, a deminer equipped with a Minelab F3 searched the area for all metallic components. Next, the soil was raked to locate any metallic components. Lastly, a deminer conducted a deep search with a Large Loop Detector (LLD) to locate any deeply buried UXO.
