HD R&D Field Evaluation: Rotary Mine Comb

U.S. Humanitarian Demining Research and Development U.S. HD R&D

TEST REPORT ROTARY MINE COMB

Christopher Wanner March 2005

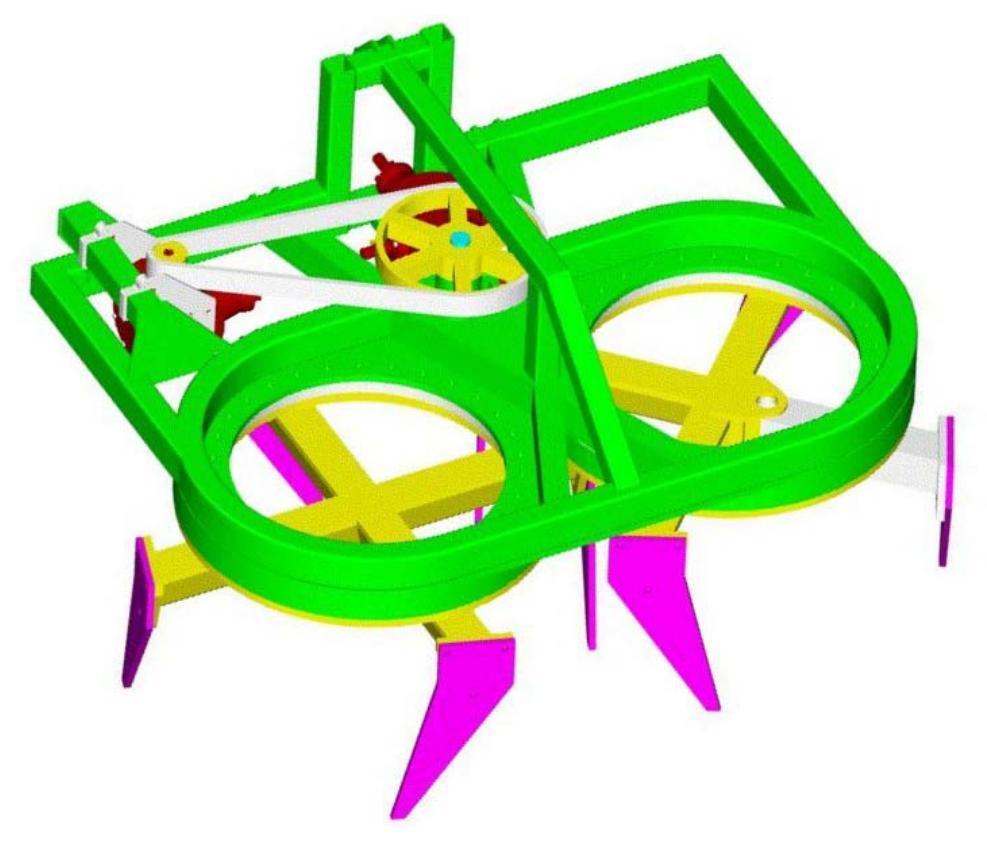
Figure 1. Rotary Mine Combing Tool

The Rotary Mine Comb is an innovative tool capable of gently extricating buried objects from the soil and pushing them to the side of the path of the host vehicle. The RMCT's two rotors, each containing four soil-engaging tines, intermesh and counter-rotate about the vertical axes as the vehicle travels forward. The tines lift and continuously nudge objects (including mines) above a minimum size from the center line of the host vehicle path to the outside edge. A given object will be nudged dozens of times in small increments as it is worked to the surface and off to the edge of the path. This action clears a mine free path in front of the vehicle without creating a large berm or soil heap. Previous testing has shown that the comb has a remarkable ability to cut through hard packed soils, clay, rocky and vegetated soils.

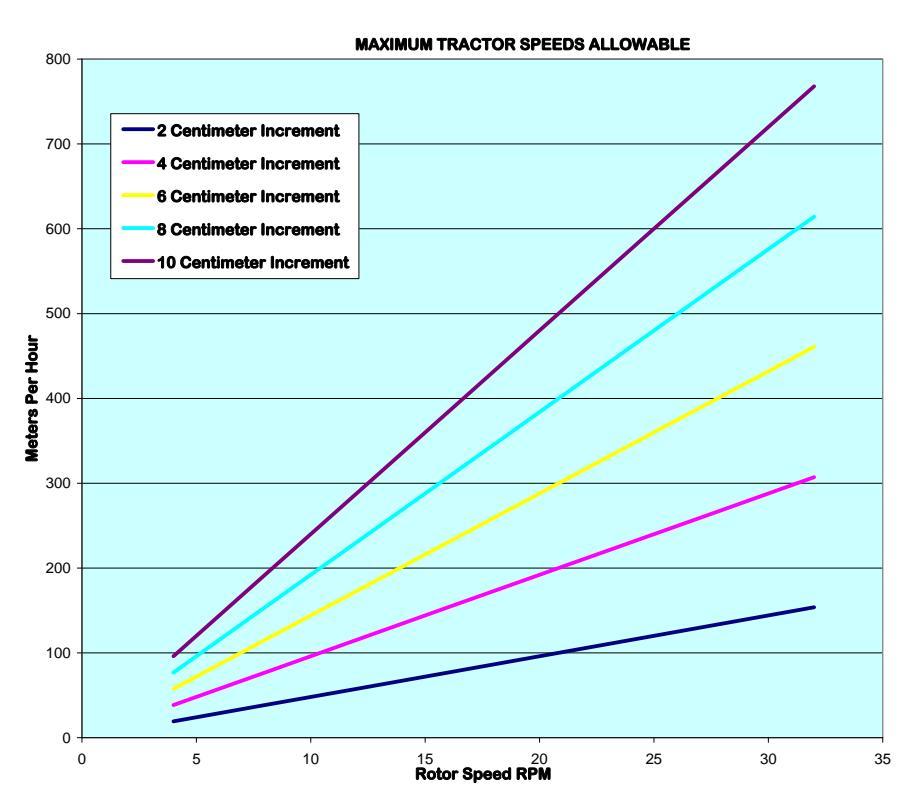
Figure 2. Tractor Speed vs. Rotor Speed at Selected Tine Increments

A key parameter in the performance of the tool is the "tine increment", which is the distance the vehicle travels forward between any two successive passes of the tines. Generally this must be kept small enough to avoid allowing the smallest objects desired to be excavated from slipping through the space between the pass of one tooth and the pass of the next one. As a practical matter it is speculated that keeping the tine increment smaller than 1/3 the diameter of the mines being cleared will permit the tines to always engage the mines from the rear. Figure 2 shows the vehicle speed as a function of the chosen rotor speed and chosen tine increment. Because the RMCT requires a reasonably large target to engage as the combing action occurs, it is intended for use in clearing antitank mines and not antipersonnel mines. The weight of the RMCT is 3160 KG, and the combing width is 3.5 meters.

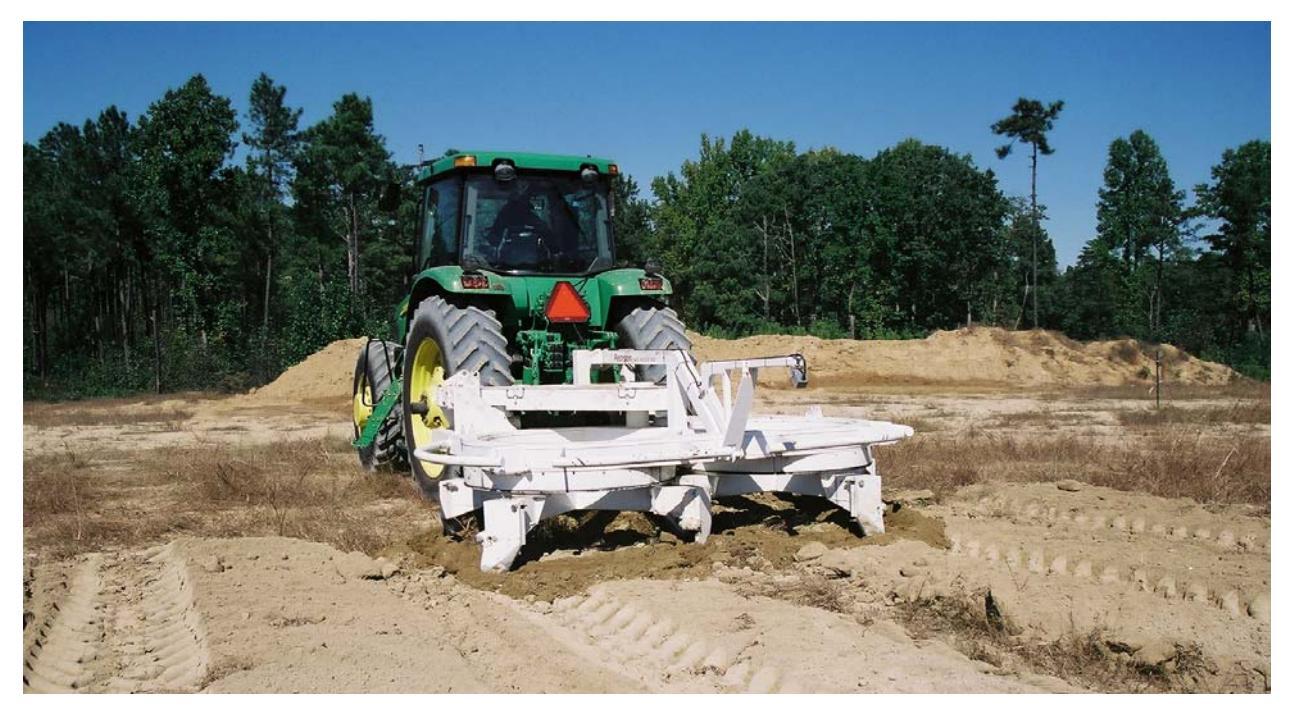
Figure 3. RMCT On Farm Tractor

The first vehicle configured is the 115 kW, John Deere 7820 farm tractor. The comb attaches to the standard three point hitch on the rear of the tractor, and no special interface is required. The comb is driven from the standard PTO shaft available on the tractor. The mechanical drive internal to the comb includes both gears and chain drives in series. Two different sized chain drive sprockets and two gear box ratios are provided, which along with the tractor selectable 540 RPM and 1000 RPM PTO drive speeds gives 8 different, full power rotor speeds ranging from 9 to 34 RPM.

The tractor is driven backwards when combing in order to clear the vehicle path. The tractor is equipped with a regulated and infinitely variable mechanical transmission which allows precise setting and control of the vehicle speed independent from the setting and control of the engine speed. This allows the engine to supply high power to the comb drive through the PTO while traveling slowly as required by the "tine increment" considerations. The range of tractor speeds required can be bounded by considering a conservative minimum of one quarter of the diameter of the smallest toe popper mine being combed at the lowest rotor speed available (1.5 cm and 9 RPM respectively). These requirements result in a vehicle speed of 32 meters/hour. The upper bound can be established by considering a risky maximum of one half of the diameter of the largest AT blast mine being combed at the highest rotor speed (16 cm and 34 RPM respectively). These requirements result in a vehicle speed of 1305 meters/hour. Practical considerations and experience with the RMC tool has more narrowly focused vehicle operations in the range from 100 meters/hour to a high of 380 meters/hour for most mines and clearing situations of interest.

Although the comb weight is well within the 6500 KG limit for the three point hitch, its front-toback length of 2.5 meters places a heavy cantilevered load on the tractor. The manufacturer of the RMCT has equipped the system with skid shoes to provide depth control and lateral stability, and to support the implement weight when combing. The skids however are vulnerable to mine blast and part of the objective of the test was to document how well the operator and system can control the comb without using the skid shoes. As is common in three point hitch configurations, the raising of the hitch is hydraulically driven; however the lowering is driven solely by gravity. Further, the angle the hitch and comb make with respect to the plane of vehicle travel is mechanically fixed. It can be adjusted between passes, but during a combing run, the RMCT will only be exactly on parallel plane with the vehicle at one depth. If ground undulations and terrain discontinuities are considered, the ability of the operator to make adjustments would be a desirable, yet unavailable and untested feature of the Deere vehicle.

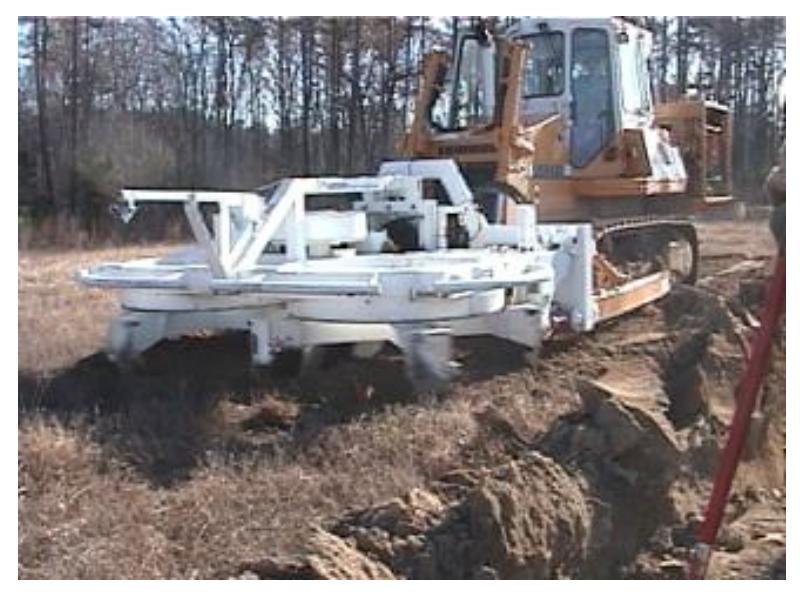
Figure 4. RMCT on Construction Dozer

The second vehicle configured is the 77 kW, Liebherr 712 tracked, crawler tractor. The comb attaches to a special mounting built to interface with the standard front dozer blade lifting arrangement. The comb is driven from a hydraulic motor built into the interface. Power for the hydraulic motor is supplied from an 80 kW hydraulic system with a separate diesel engine mounted on the rear of the tractor. Both the hydraulic motor and the supply pump have electrically controlled, continuously variable displacements, giving rotor speed control beyond the ranges of interest discussed above in the farm tractor description. The tractor is equipped with a hydrostatic drive system. This gives the vehicle unregulated but continuously variable speed control, set independently from the vehicle engine throttle. Because the speed is not regulated or monitored, operation at the very low speeds required by the comb does require the constant attention of the operator to keep motion going and controlled. Having the capability to "set and forget" the vehicle speed is a desirable yet unavailable feature of the Liebherr vehicle.

In contrast to the Deere implementation in which the comb floats on the three point hitch, the mechanical interface rigidly fixes the comb to the tractor. The comb is both lifted and driven into the ground hydraulically. In addition, the pitch of the comb relative to the plane of travel is controllable and adjustable by the operator "on the fly".

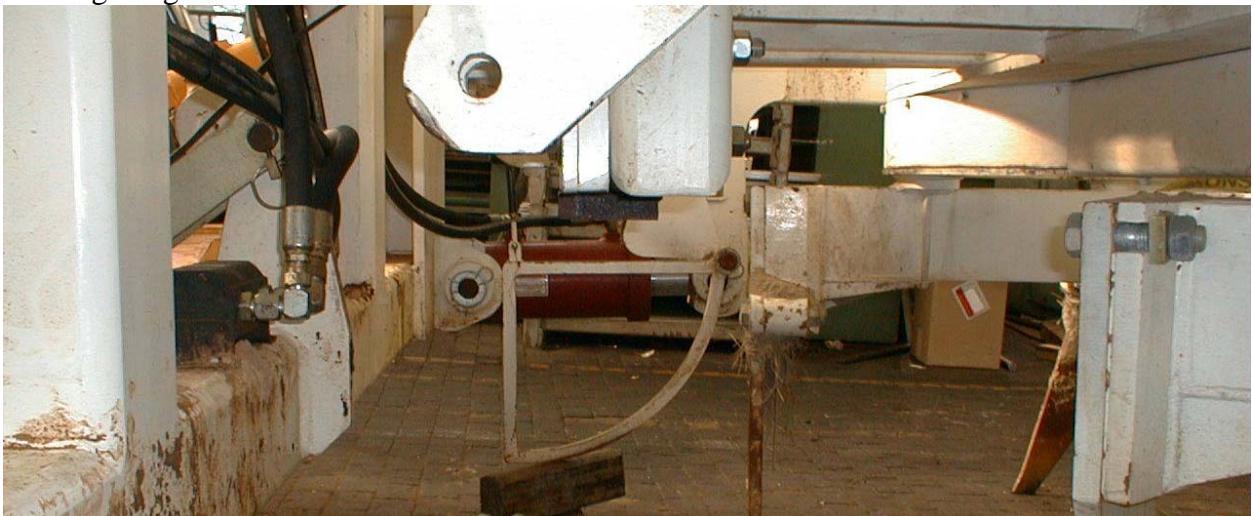
Figure 5. Hinged Depth Shoe.

The skid shoes which the RMCT manufacturer supplies for depth control are weight bearing devices located in front of the comb. The shoes' ground pressure over uncombed soil makes them vulnerable to mine detonation. Both of the vehicles on which these tests were conducted are larger, more stable platforms than the New Holland 160/90 tractor on which the original RMCT development and testing was conducted. These tests were conducted with the operator exercising control over the combing depth on the basis of feedback from a depth-indicating shoe tracking the ground surface behind the combs.

This change in depth control was designed to allow the forward mounted, weight bearing skid shoes to be eliminated from the system. Placing the indicator behind the comb removes the threat of mine damage and vegetation interference with the operation of the shoe. However, the comb's shearing of the soil into a more fluid medium, and its creation of large clods or sod chunks provides a less readable surface to sense. The shoe implemented for these tests is intended to provide moderate ground pressure which sinks the shoe 0-5 centimeters into the sheared soil under most conditions, but allows it to cut through soft discontinuities. The shoe is attached to a depth indicating rod which has alternately white and black bands which can be calibrated to give a rough indication of current combing depth. The task of the operator with respect to controlling the depth amounted to keeping the indicating rod within one of these 5 centimeter black or white bands.

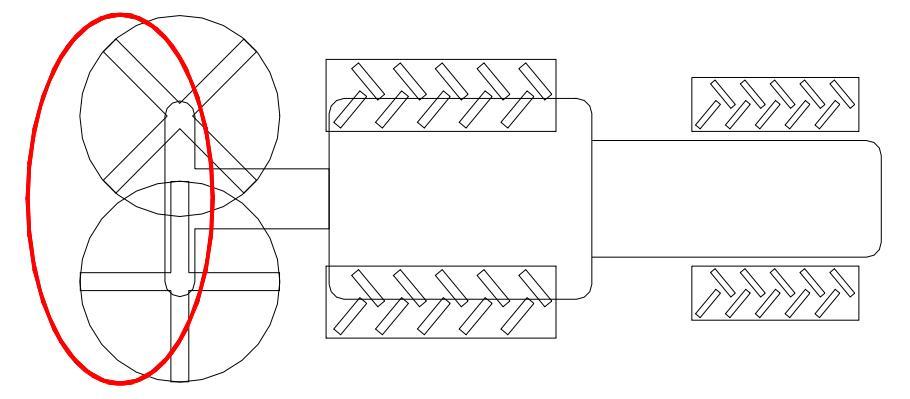
Figure 6. Approximate Camera Field of View

The workspace in front of the comb is monitored with an inexpensive video camera mounted in the center of the comb. A wide angle lens captures the full width of the comb from the centerline to point of tangency with the left and right edges of the cleared path. The view provided looks nearly straight down, centered 30 centimeters to the front of the comb. About 1/3 of the rotor interior diameter is visible; however none of the area beyond the right or left edges of the rotors

is visible, nor is any of the rear portion of the rotor arcs (closest to the tractor). A second camera also mounted on the comb is fixed on the depth indicating rod. Although the operators of both systems are able to see the rods from the vehicle cab, the rod camera was evaluated for possible inclusion in a future remote control implementation of the system. A third, external camera was available at the remote station where the video signals were received and monitored. The external camera, like the rod camera, was evaluated for general site monitoring in support of future remote control developments.

The 7 mines which the camera observers failed to detect are each believed to have been engaged near the outside edges of the comb. As discussed the camera field of view barely covers the full comb width, and objects moving along the forward face of the tine arc were difficult to perceive when they were within half a meter of the outside edge of the comb. The mines buried at 10 centimeters nearly instantly broke the surface when engaged and became visible. As discussed in the test of the effective lane width, mines buried 20 and 30 centimeters are pushed a short distance before becoming visible. Mines breaking the surface in the regions near the edges of the camera view simply were not perceptible to the observers. Compounding this shortcoming of the camera system was the overly wide (235 centimeters) lane to lane spacing realized on the test. These effects are believed to be responsible for the difference in the fraction of mines detected by the observers for the mines buried at 10 centimeters and those buried at 20 and 30 centimeters.

The picture quality and ability of the observers to perceive AT mines appearing in the middle of the field of view of the on board camera were excellent. The coverage and field of view provided by the onboard cameras of the workspace immediately in front of the comb was inadequate to realize the full potential of using observers to detect mines as they are excavated. As discussed, mines engaged near the outer 15%-20% of the path were generally not perceptible to the observers. Overall 86% of the AT mines buried at 10 centimeters were visually detected, 78% buried at 20 centimeters, and 69% buried at 30 centimeters. The chance of significantly raising these efficiencies to the high 90's is believed excellent with the use of two cameras more fully covering the path and adjacent strips.

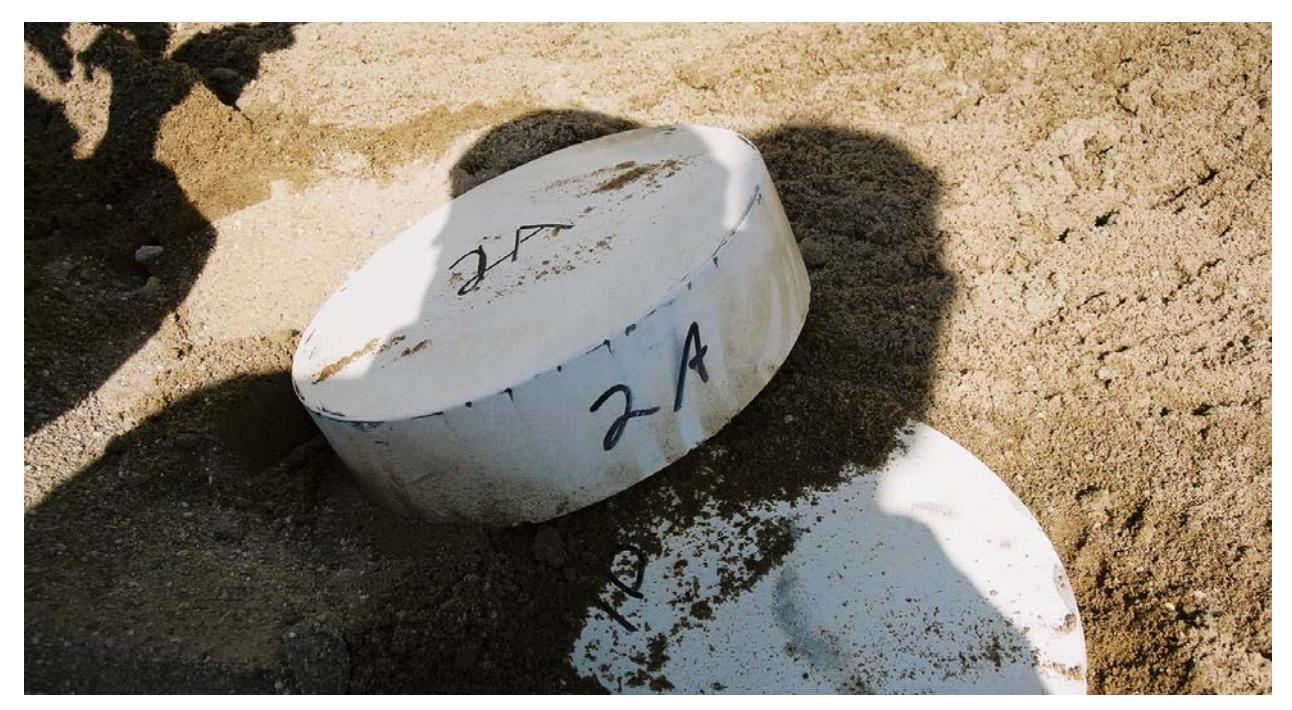
Figure 7. Mine Surrogate

The surrogate mine bodies are constructed from sand filled, 20 gauge, low carbon steel shells, generically representing large antitank landmines. The test lanes were prepared as diagrammed in figure 8.

A key defining parameter in the operation of the Rotary Mine Comb is the maximum rotational speed allowable. As tine speed is increased, so is the potential for structural damage to mines encountered, and quite probably the risk of mine detonation. Properly assessing the maximum allowable rotor speed is important for both managing the risk of detonating AT mines and for defining the overall clearance rate with the comb. AT mine detonation risk as a function of rotor speed was not directly measured; however, observations were made of structural damage to mine AT bodies at varying rotor speeds. These tests were conducted using surrogate AT mine bodies (see Fig. 7) buried in both sand and unvegetated clay.

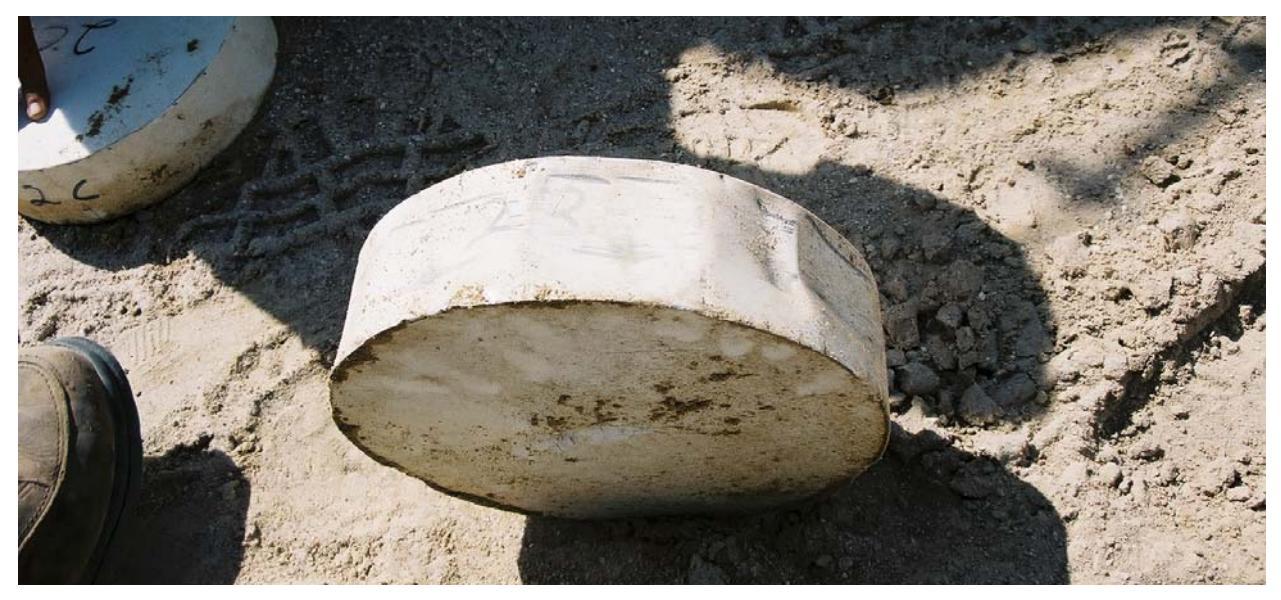
Figure 9. Example of Surrogate with Moderate Dent and Slight Case Buckling

In contrast, the clay soil results reflect a much tougher challenge. The surrogates were buried as prescribed and the test lane was compacted with a vibratory roller to produce a very hard, unyielding medium. The farm tractor used for these tests did have some difficulty in achieving and maintaining the desired combing depth. This is reflected in the results at 30 centimeters burial depth where many of the test objects were speared by the tines rather than being lifted to the surface. With no apriori knowledge of detonation risk, subsequent test expectations place a conservative lower limit of risk at the level of stress producing minor dents and slight case buckling. An upper limite of risk was established at conditions producing moderate dents and moderate case buckling.

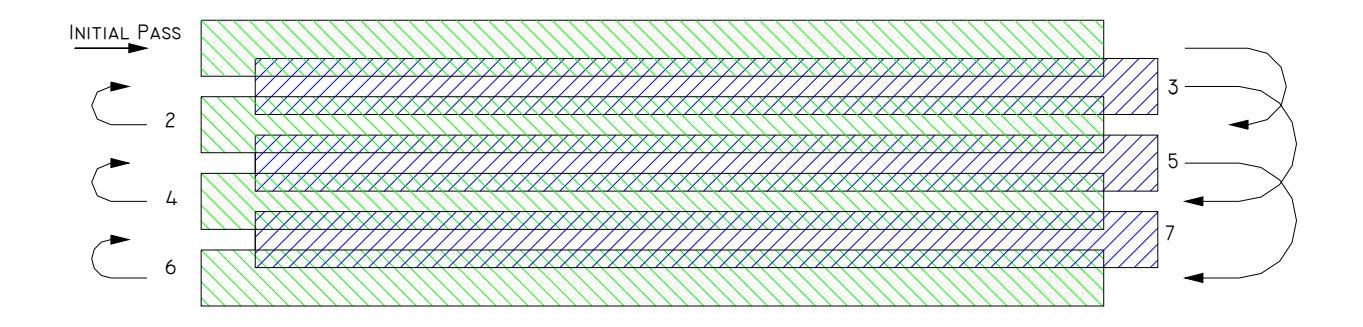
Figure 10. Alternating Combing Pattern

The development of an effective pattern for combing an area is a necessary requirement. Prior testing had led to the conclusion that a path as diagrammed in figure 10 is required to keep balanced draft and side shifting forces on the comb. As diagrammed the comb is always either engaging a full width cut of bank condition soil or a center "slice" of bank soil with equal strips of previously tilled soil at the edges of the cut.

Without this method, experience has shown the comb will wander inexorably to the softer soils in the previously tilled area despite the operator's best efforts to the contrary. Planning for proper overlap from pass to pass required consideration of the effective lane width as measured in the previous test. In addition consideration must be made of the placement of the wheels or tracks of the host vehicles with respect to previous passes with the comb. Figure 11 diagrams the various widths associated with the tractor as it makes a combing pass. The center line spacing from adjacent passes must be less than the effective lane width if all mines are to be made visible. The uncombed gap left between alternating lanes which is combed last must either be wider than the outer track width, or must be narrower than the inner track width in order to keep both tracks either both on combed soil or both on uncombed soil. Leaving a pass-to-pass gap wide enough for the outer track width will result in lane spacings of 293 centimeters which is too wide for the effective lane width consideration. Leaving a pass-to-pass gap narrow enough for the inner track width to straddle will result in permitted lane spacings of less than 232 centimeters. 210 centimeter lane spacings were chosen for the simulated minefield clearance tests. This spacing left gaps of 70 centimeters which were taken out on the odd numbered passes as diagrammed in figure 10.

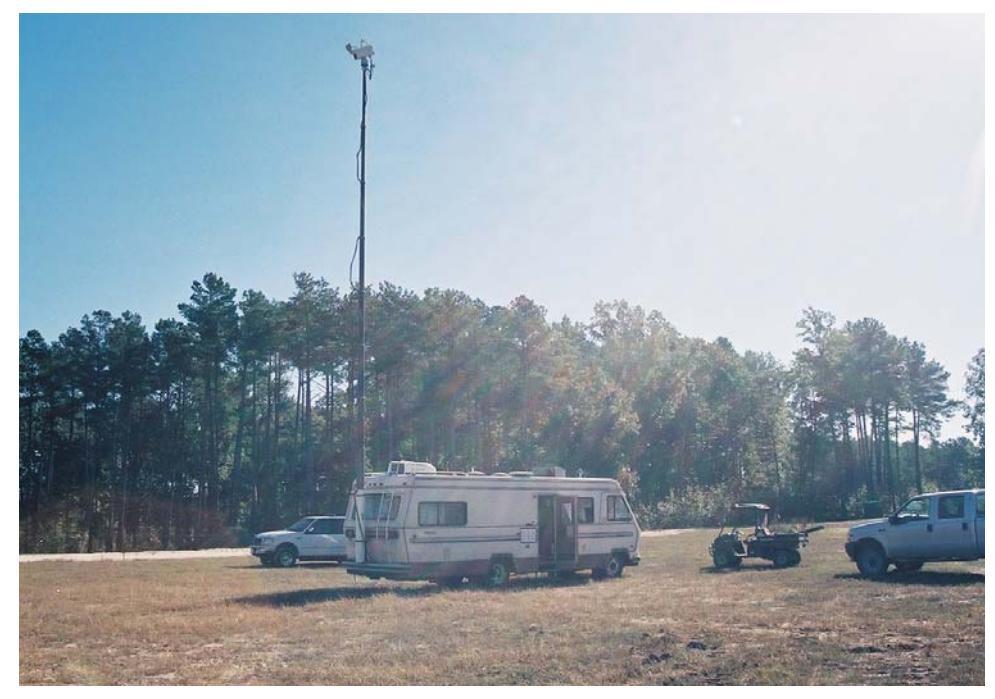
Figure 12. External Monitoring Station

An external monitoring station was placed 15 meters beyond the end of the minefield border. The monitoring station was equipped with a mast mounted pan and tilt camera and receivers/monitors to allow observers to watch the comb-mounted cameras.

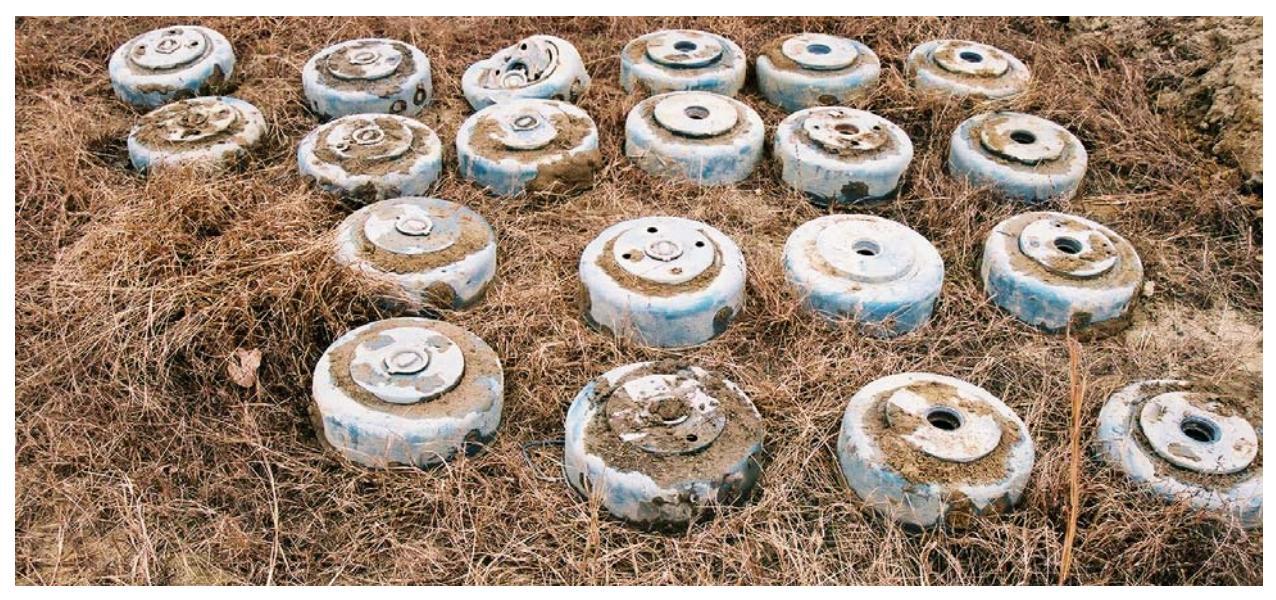
Figure 13. AT Test Mines Recovered from 10 cm Burial

The dependence of the fuze triggering on the depth of burial in table 6 is not surprising. The increasing damage observed in the surrogates reported in the investigation of rotor speed with increased depth is consistent with these results; see figures 13-15.

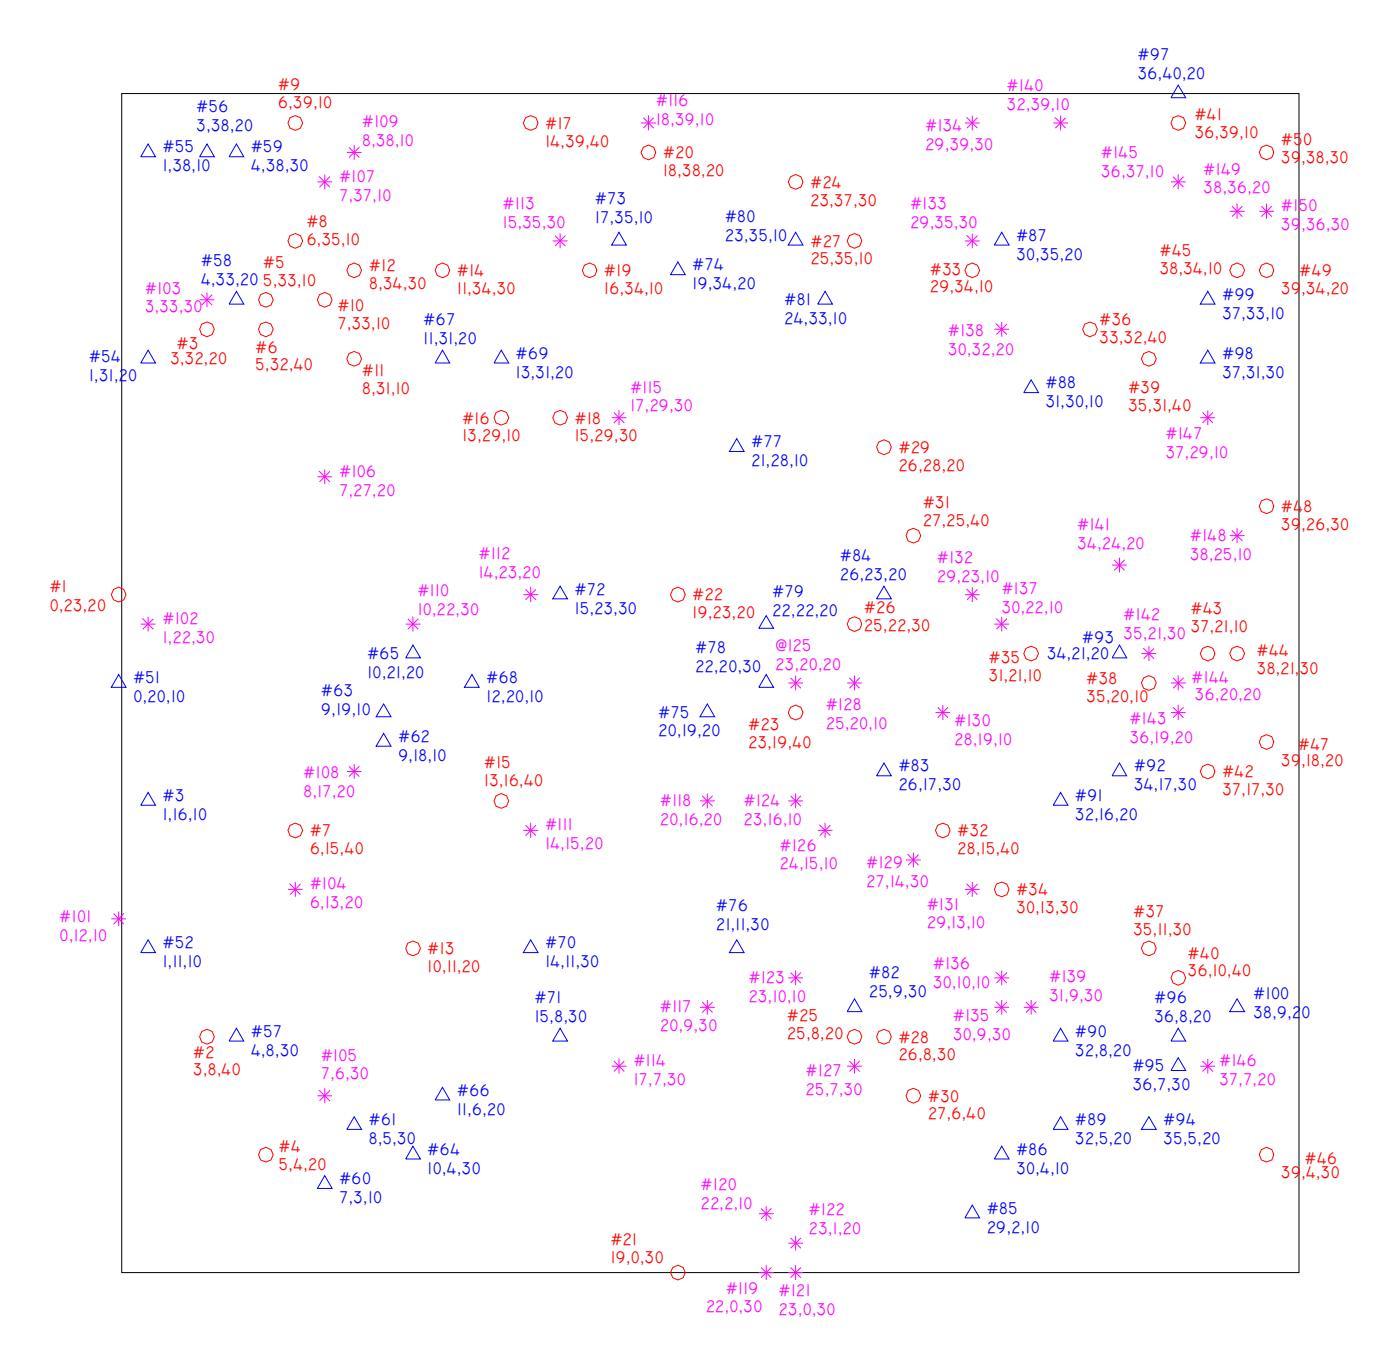
Figure 16. MINE COORDINATES AND BURIAL DEPTH

APPENDIX 3 RANDOM MINEFIELD LAYOUT

Field trials with the Rotary Mine Combs culminated in tests in which the combs covered areas seeded with mines randomly placed. The purpose of this phase of testing was to prove that all of the elements of control, efficiency, perception, and procedure can be put together into a single, workable concept for minefield clearance. Each vehicle was used to comb a 40 meter square containing 50 fuzed, AT mine simulants, 50 fuzed Type 72 AP mine simulants, and 50 fuzed PMN mine simulants as shown in Appendix 3. The mines were randomly assigned to one of three burial depths: 10 centimeters, 20 centimeters, or 30 centimeters measured to the bottom of the mines. The mock minefields were constructed six months prior to the test and seeded with grass in order to let the earth settle and vegetation grow.
