Evaluating the Mini MineWolf

The U.S. Department of Defense Humanitarian Research and Development Program conducted operational field evaluation to assess the capabilities of Mini MineWolf technology.

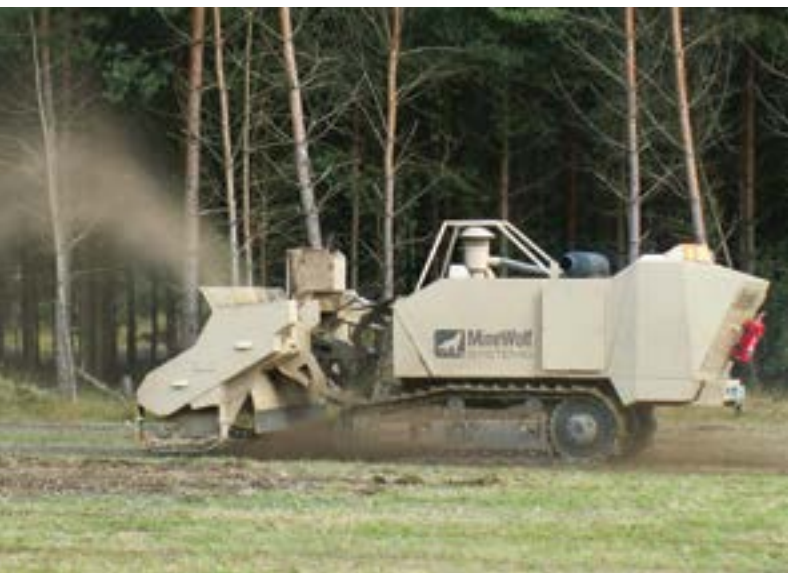
The Mini MineWolf System.
Photo courtesy of MineWolf Systems.

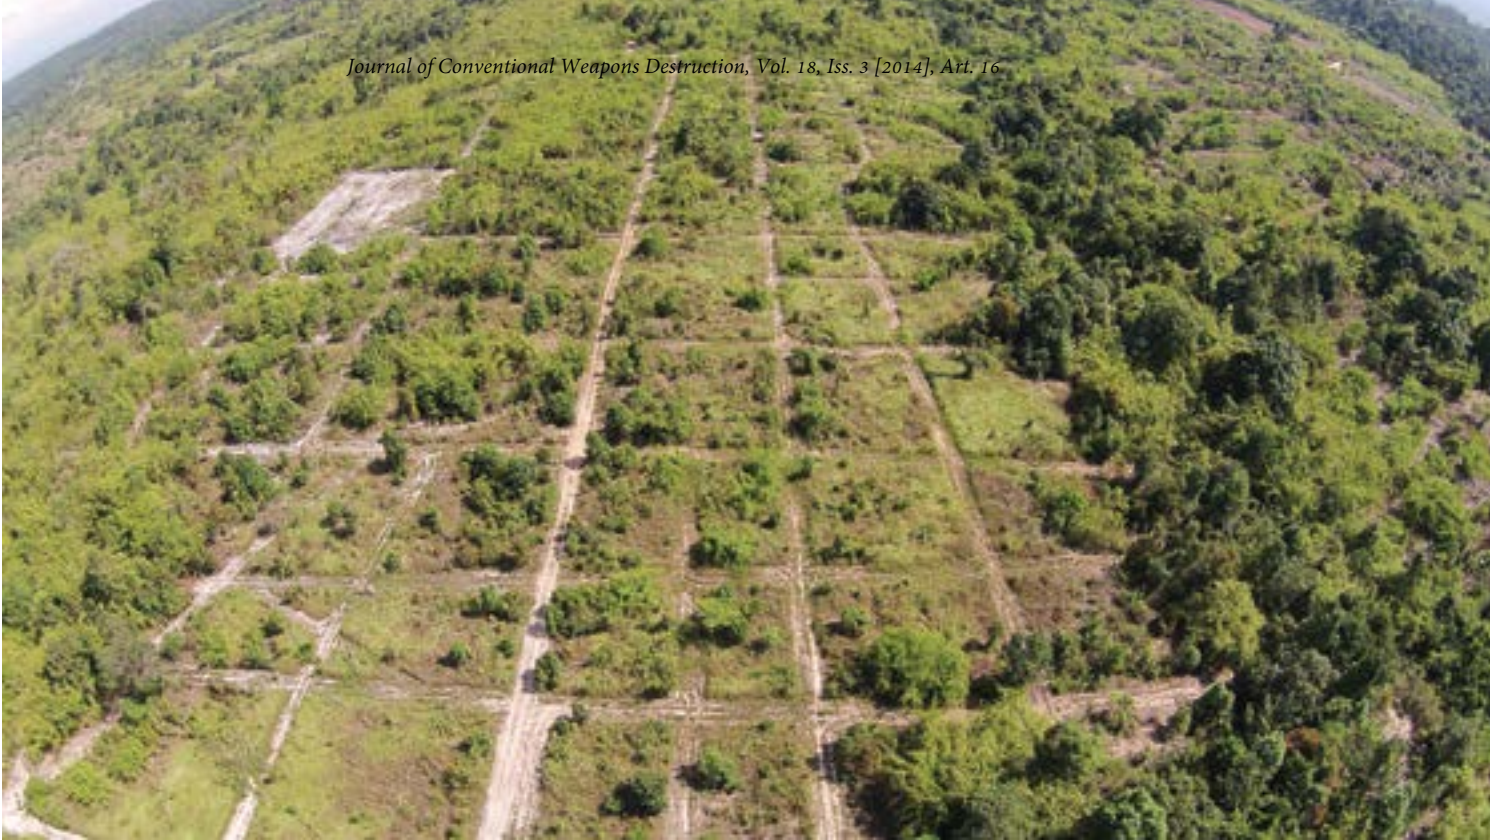
In Phase 2, lanes are cut every 25 meters, perpendicular to each other to form a grid.
Photo courtesy of HD R&D.

Phase 2. Directed remotely by an operator, the Mini MineWolf conducted a mechanical technical survey. Lanes were cut every 25 m (82 ft), perpendicular to each other. This formed a grid pattern across the lower threat areas and led into the higher threat zones. The technical survey lanes were closely monitored for any mine indicators.

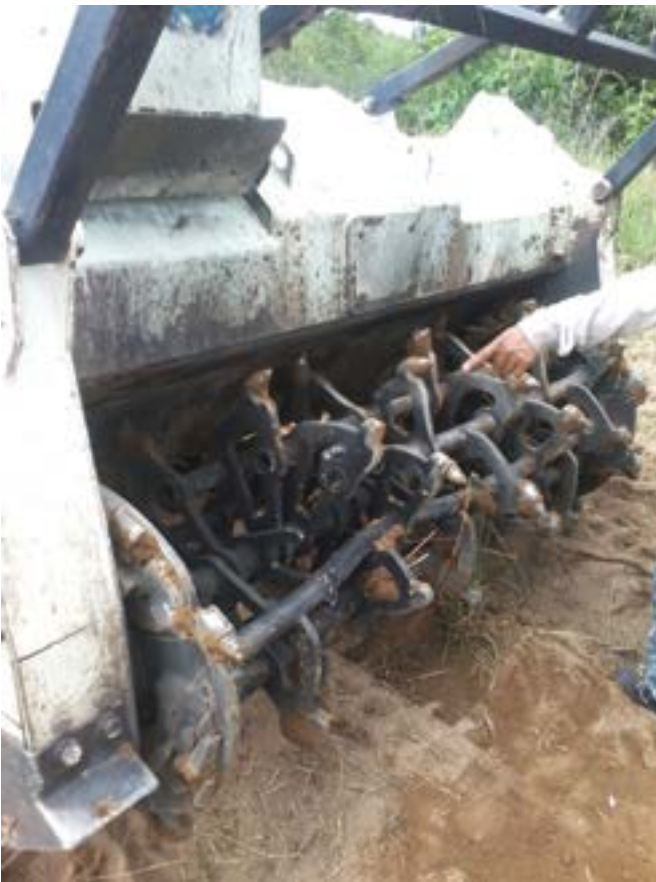
The tiller of the Mini MineWolf is capable of detonating AP mines without sustaining any damage.
Photo courtesy of HD R&D.

During the OFE from 2013 to 2014, the Mini MineWolf tiller detonated three TM46 anti-tank (AT) mines. These were rogue mines laid in conjunction with anti-personnel (AP) mines. On each occasion the tiller suffered considerable damage, which required comprehensive repair to return it to operation. Local staff conducted these repairs on site under the supervision of the HD R&D field officer. The Mini MineWolf was not designed for use against AT mines, which were not anticipated to be within the area of operation. The machine, however, detonated many AP mines without sustaining any damage.

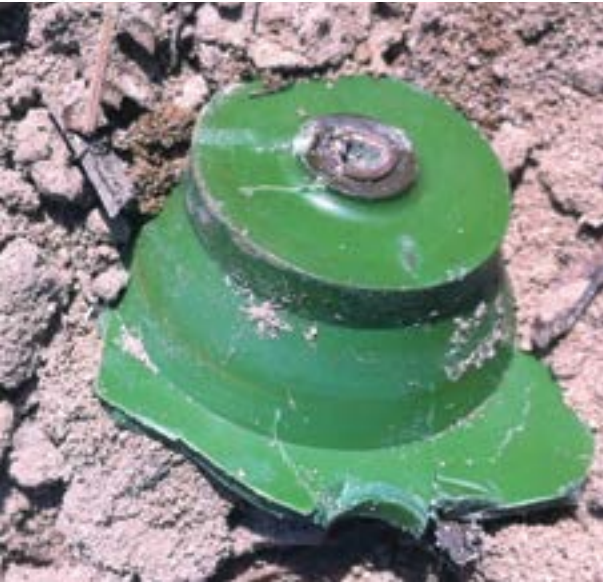
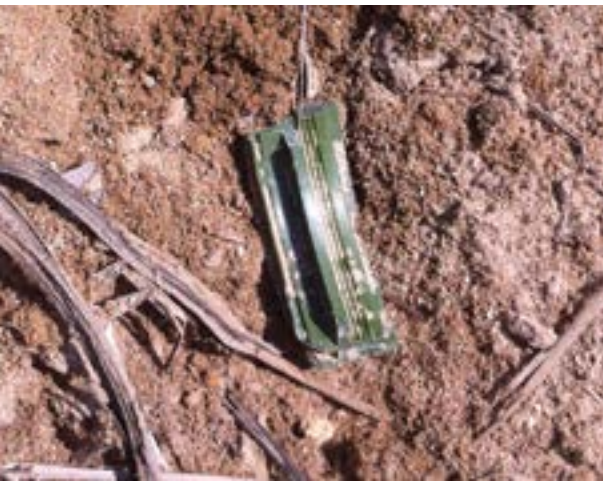
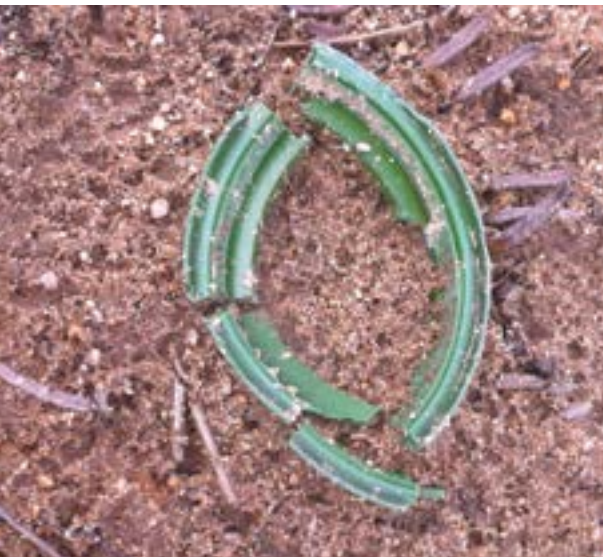
Recovered items are photographed, recorded and inspected for their state of function.
Photos courtesy of HD R&D.

Phase 4. Collecting the clearance performance data was critical to the OFE's success. One of the major questions within the OFE was whether the Mini MineWolf could consistently destroy or otherwise render mines inoperative. To this end, the painstaking process of recovering every piece of the remaining mines left behind by the Mini MineWolf has been paramount. All items were photographed, recorded and inspected for functionality.

The search process involved three steps. Firstly, a deminer equipped with a Minelab F3 searched the area for all metallic components. Next, the soil was raked to locate any metallic components. Lastly, a deminer conducted a deep search with a Large Loop Detector (LLD) to locate any deeply buried UXO.
