## Evaluating the Mini MineWolf

# Evaluating the Mini MineWolf

The U.S. Department of Defense Humanitarian Research and Development Program conducted operational field evaluation to assess the capabilities of Mini MineWolf technology.

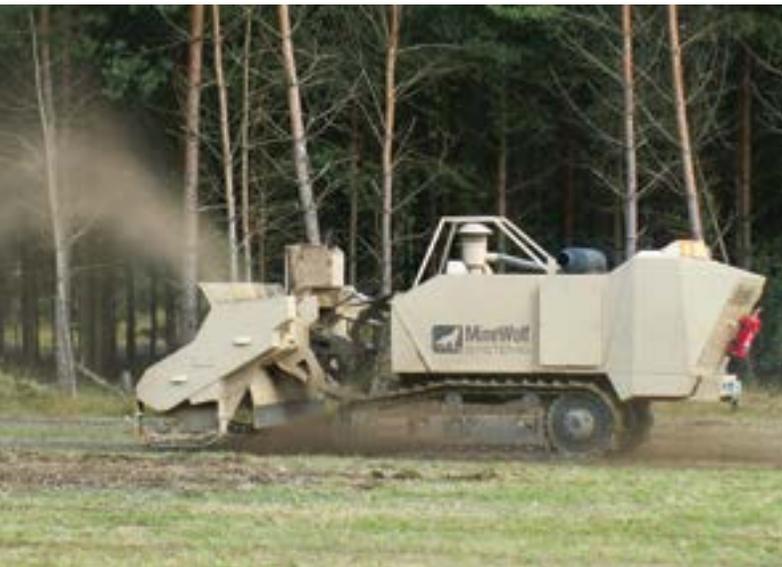
The Mini MineWolf System.  
Photo courtesy of MineWolf Systems.

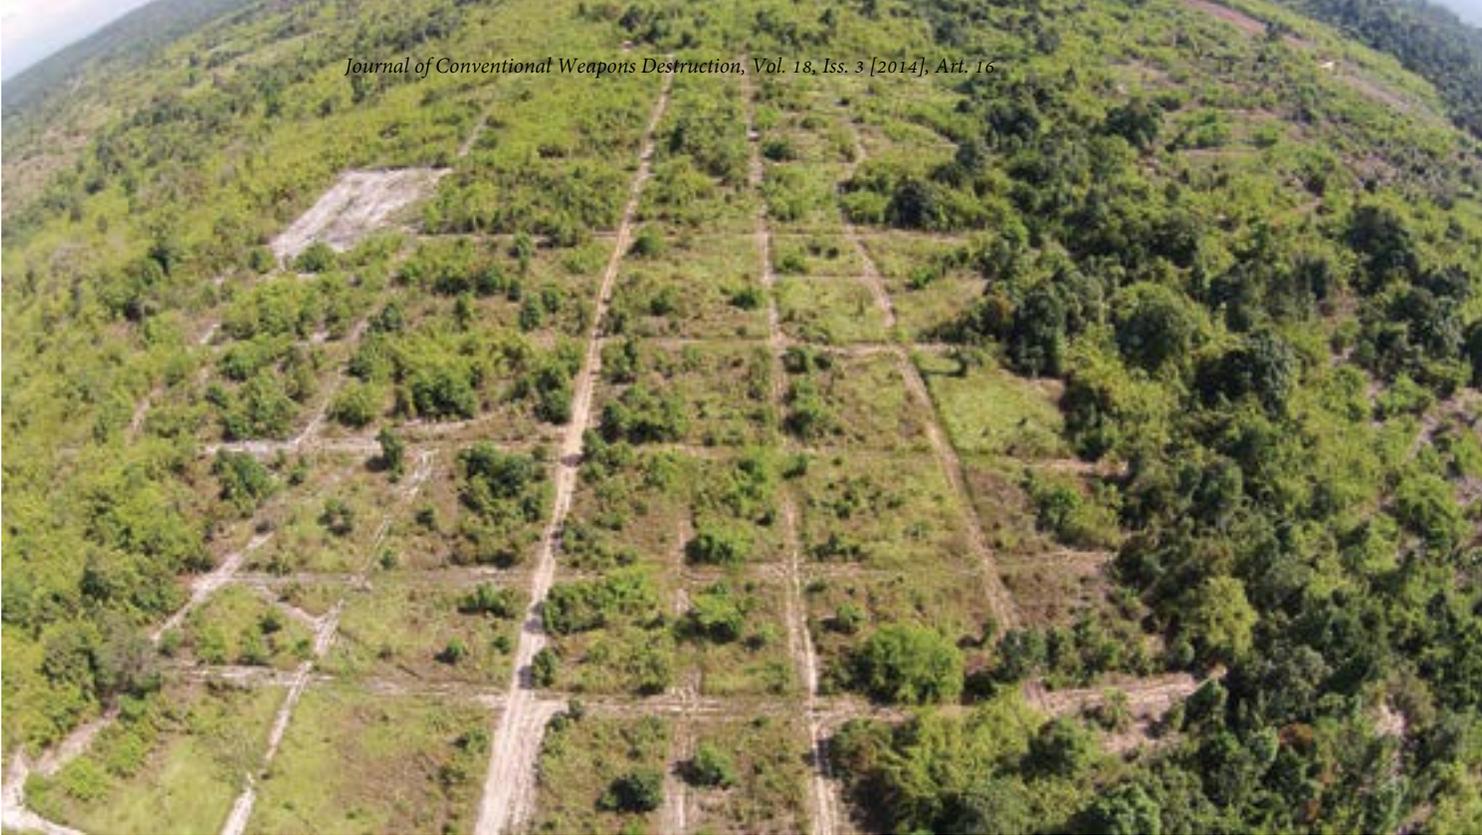
In Phase 2, lanes are cut every 25 meters, perpendicular to each other to form a grid.  
Photo courtesy of HD R&D.

**Phase 2.** Directed remotely by an operator, the Mini MineWolf conducted a mechanical technical survey. Lanes were cut every 25 m (82 ft), perpendicular to each other. This formed a grid pattern across the lower threat areas and led into the higher threat zones. The technical survey lanes were closely monitored for any mine indicators.

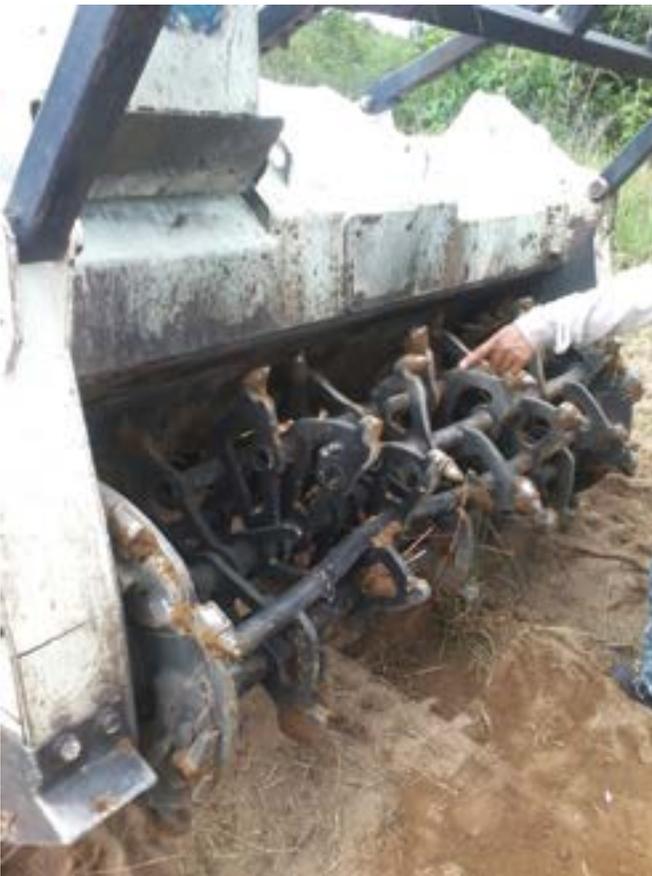
The tiller of the Mini MineWolf is capable of detonating AP mines without sustaining any damage.  
Photo courtesy of HD R&D.

During the OFE from 2013 to 2014, the Mini MineWolf tiller detonated three TM46 anti-tank (AT) mines. These were rogue mines laid in conjunction with anti-personnel (AP) mines. On each occasion the tiller suffered considerable damage, which required comprehensive repair to return it to operation. Local staff conducted these repairs on site under the supervision of the HD R&D field officer. The Mini MineWolf was not designed for use against AT mines, which were not anticipated to be within the area of operation. The machine, however, detonated many AP mines without sustaining any damage.

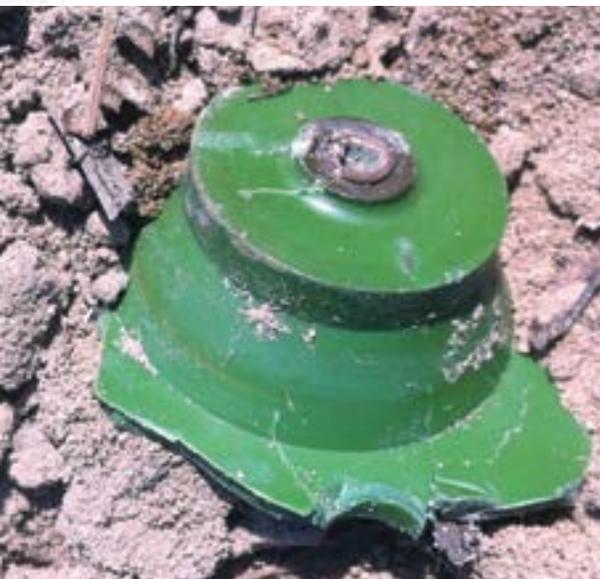
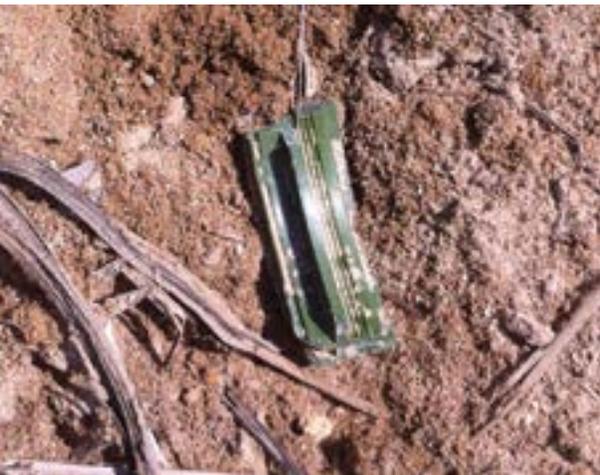
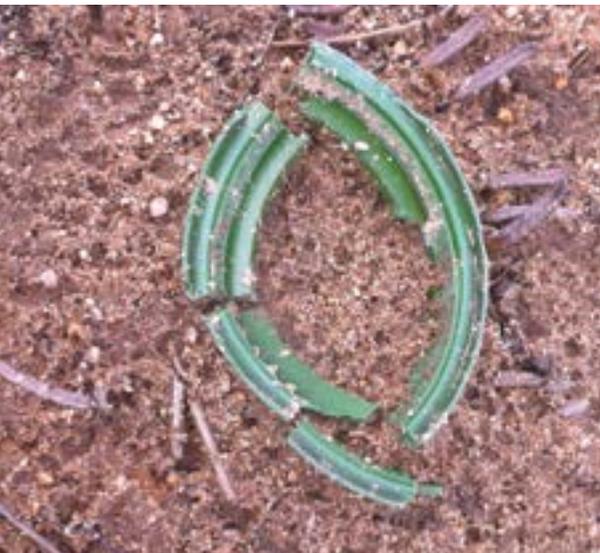
Recovered items are photographed, recorded and inspected for their state of function. Photos courtesy of HD R&D.

**Phase 4.** Collecting the clearance performance data was critical to the OFE's success. One of the major questions within the OFE was whether the Mini MineWolf could consistently destroy or otherwise render mines inoperative. To this end, the painstaking process of recovering every piece of the remaining mines left behind by the Mini MineWolf has been paramount. All items were photographed, recorded and inspected for functionality.

The search process involved three steps. Firstly, a deminer equipped with a Minelab F3 searched the area for all metallic components. Next, the soil was raked to locate any metallic components. Lastly, a deminer conducted a deep search with a Large Loop Detector (LLD) to locate any deeply buried UXO.

tilling an area. All of the mines encountered during inspection were detonated, initiated (but failed to function) or otherwise rendered inoperative.
