**Test Report  
of  
Improved Backhoe**

**July 2003**

# **Test Report of Improved Backhoe**

The objective of this test program was to evaluate the operational effectiveness of an improved commercial off-the-shelf (COTS) JCB 215S, Series 3, four-wheel steer (4WS) backhoe equipped with a Rotar International b.v. ROTAR<sup>®</sup>, model HPL 800 S soil sifter mounted on the front of the backhoe (see Figure 1). The Improved Backhoe was tested under conditions approximating those found by humanitarian demining organizations in easy to moderately difficult soil and terrain conditions. The ROTAR<sup>®</sup> subsystem was tested for its ability to remove mines from berms that were created by plowing or tilling operations and to continue to operate after sustaining an AP-mine-equivalent explosive charge. Vehicle on- and off-road handling was evaluated, and logistic considerations (e.g., spares and fuel/oil consumption) of importance to a user were measured and/or noted. Human factors issues (e.g., operator visibility and comfort under various moving situations) and maintenance issues were also addressed.

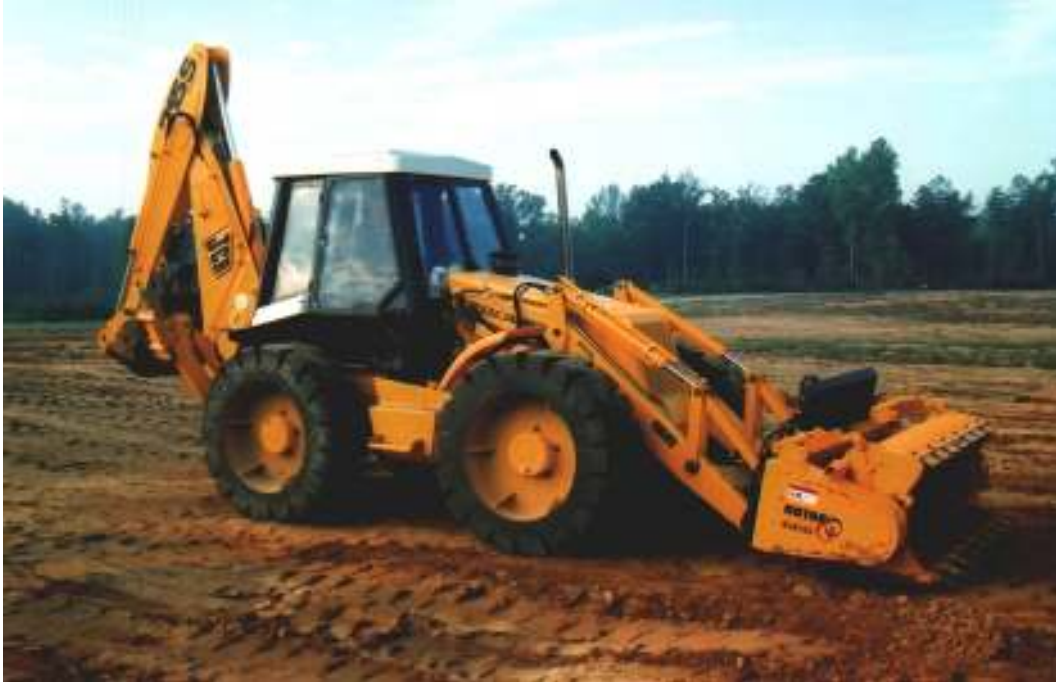
**Figure 1. Improved Backhoe With HPL 800 S ROTAR<sup>®</sup>**

Starting with a JCB 215S, Series 3, 4WS (also capable of 2 wheel steer (2WS) and crab steer) commercial backhoe, the Modeling and Mechanical Fabrication Shop of the U.S. Army Communications & Electronics Command, Night Vision and Electronic Sensors Directorate (NVESD), Ft. Belvoir, Virginia, made structural modifications to the vehicle to improve its survivability in a hostile, land-mine environment. The modifications included a blast-resistant cab and armored chassis intended to protect the operator and the vehicle from a small-arms fire (up to 12.75 mm) attack and from shrapnel caused by a detonated AP mine under the vehicle or an anti-tank (AT) mine in near proximity to the vehicle. (An AT mine detonated under the improved backhoe would more than likely disable the vehicle and cause injury to the operator.)

- The fiberglass engine cowling<sup>1</sup> was replaced with 12.7 mm (0.5 inch) 6061 aluminum plate. This plating was also installed under the engine and cab area of the body. A 6.35-mm (0.25-in.) T-1 steel blast plate was mounted across the front lifting arms to protect the hydraulic lines from AP and AT mine shrapnel.
- The fiberglass shell of the cab was replaced with 6.35-mm (0.25-in.) T-1 steel. The fore and aft wind screen and side curtains were replaced with 31.75 mm (1.25 in.) of LEXAN<sup>®2</sup>. Exposed vehicle hydraulic lines were hardened to withstand fragmentation damage.

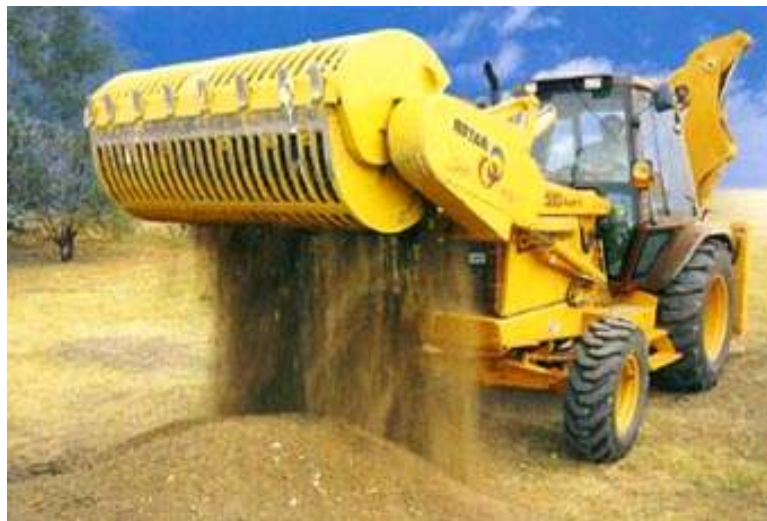
**Figure 3. COTS ROTAR<sup>®</sup> Soil Sifter**

The ROTAR<sup>®</sup> model HPL 800 S selected for this test was mounted on the front loader arms of the JCB backhoe using the same attachment points used to mount the standard loader bucket. The NVESD Modeling and Mechanical Fabrication Shop manufactured the interface to mate the ROTAR<sup>®</sup> to the quick-disconnect mounting points. The ROTAR<sup>®</sup> barrel is constructed with 20-mm S2-3 steel bars to form a grid of 45-mm squares. Figure 3 is a picture of a COTS ROTAR<sup>®</sup> mounted to a wheel loader. Table 4 gives the specifications of the HPL 800 S ROTAR<sup>®</sup> sifter. Appendix B contains the specifications for the ROTAR<sup>®</sup> used in this test program.

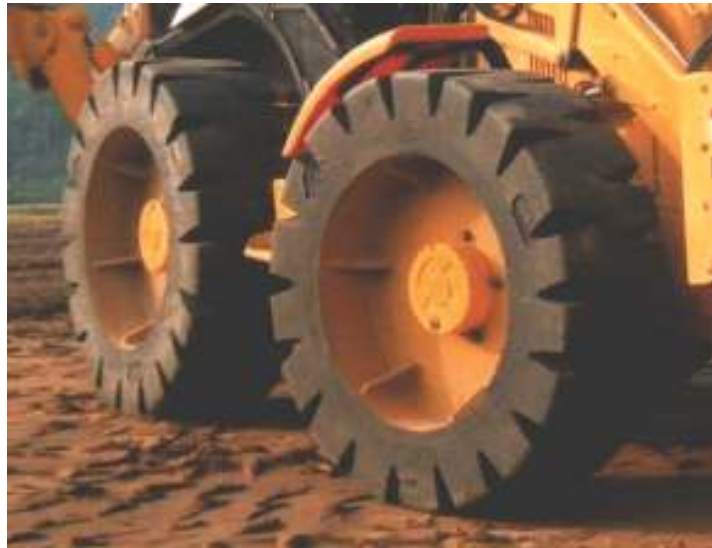
**Figure 4. SETCO Solid Rubber Tire**

The standard tires that came with the JCB backhoe were replaced with COTS SETCO solid rubber tires, manufactured by the SETCO Tire Company, Idabel, Oklahoma (see Figure 4). SETCO tires are a commercial product and are adaptable to any wheeled loader. Using SETCO tires (vs. standard tires) added 4,680 pounds (2,123 kg) to the gross vehicle weight of the Improved Backhoe.<sup>3</sup> The SETCO tires will withstand the blast from a 500-gm AP mine, with only slight blast abrasion to the rubber tire and *no* damage/deformation to the metal tire rim.

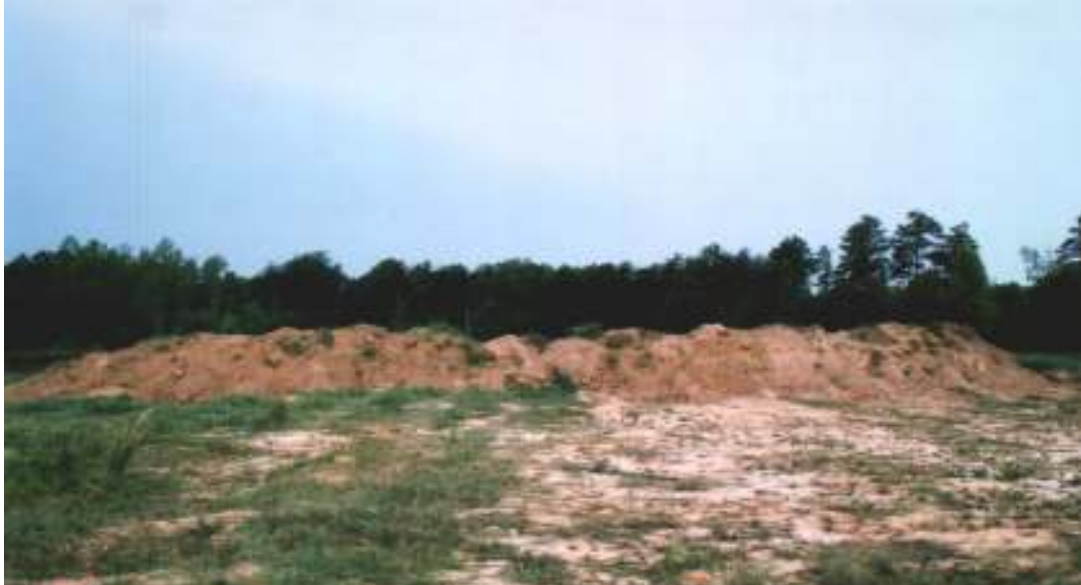
**Figure 7. Berm at Test Site 1**

**Foliage coverage:** Grass covered

**Total operating time:** 13 hrs over 4 days

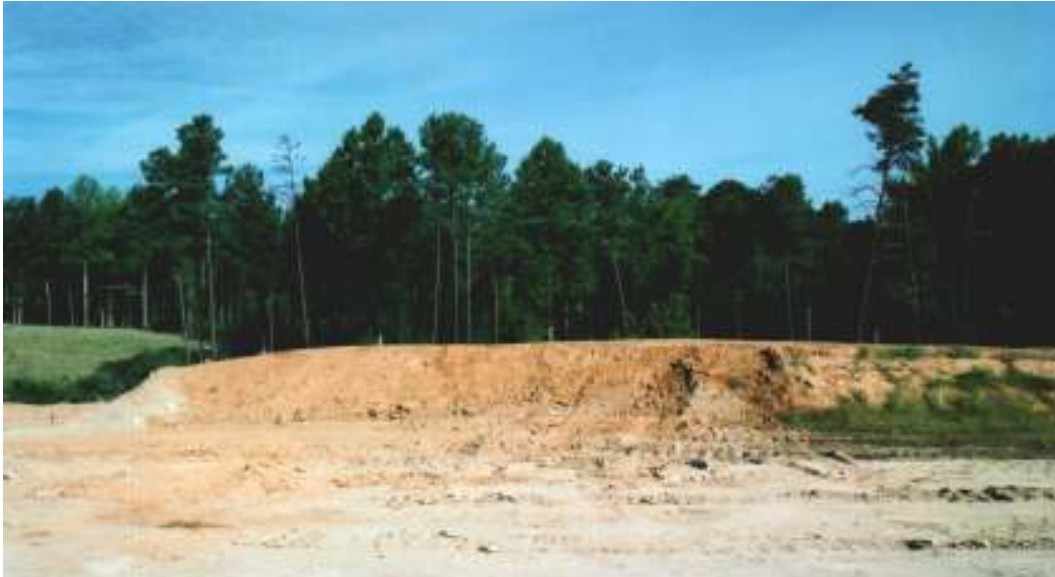
**Figure 8. Berm at Test Site 2**

**Soil type:** Red clay with sand mixture (when dry, loose and powdery; when damp, soil stuck together) with loam soil underneath (dark, oily, smelly, clay-like)

**Foliage coverage:** Almost none

**Total operating time:** 7 hrs 38 min over 3 days

The Improved Backhoe cleared the designated area of the berm shown in Figure 8. In dry soil conditions, the Improved Backhoe turns the soil to powder. When the soil is wet or damp, the dirt was compacted to almost rock hardness. Other than the simulated mines, some rock, and some long field grass, no other pieces of debris were found during the berm-clearing operation.

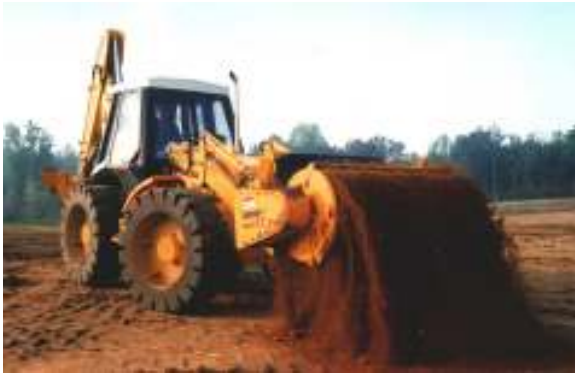
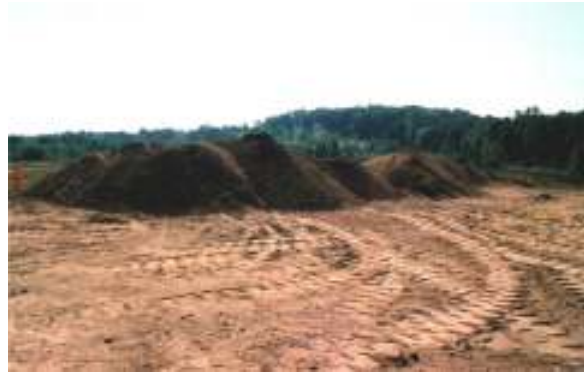
Figures 10 and 11 are pictures of the ROTAR<sup>®</sup> sifting berm soil and the sifted soil from the Test Site 1 berm.

**Figure 10. ROTAR<sup>®</sup> Sifting Berm Soil**

**Figure 11. The Sifted Soil From the Test Site 1 Berm**

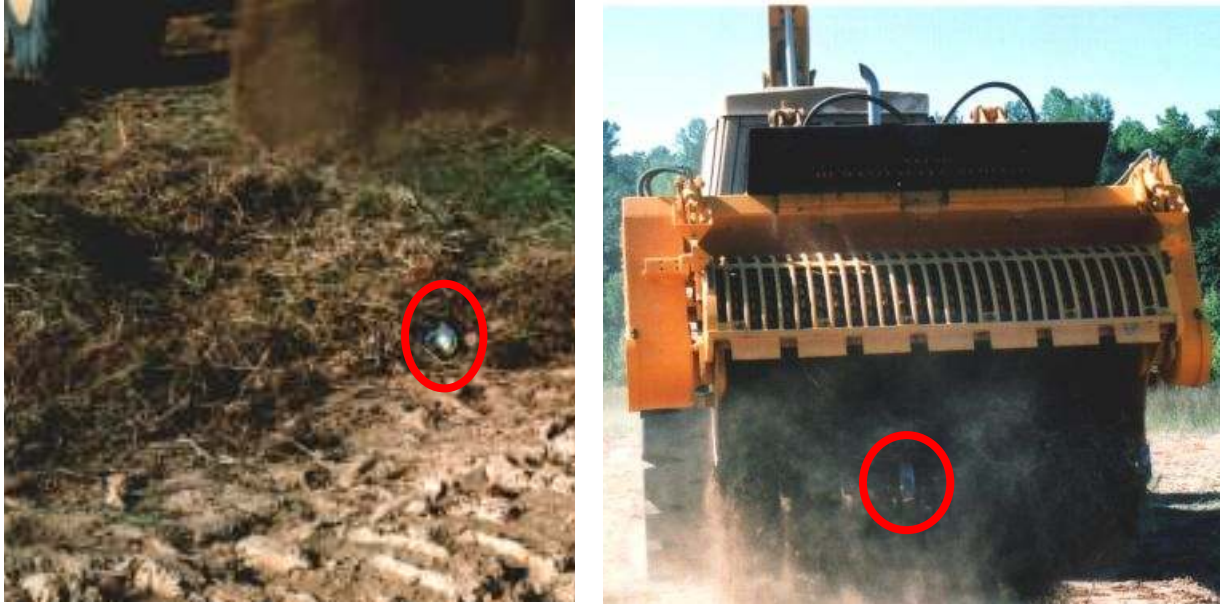
**Figure 12. Mines Recovered by ROTAR<sup>®</sup>**

The Test Site 1 berm was totally processed and leveled. In addition to the simulated mines, the ROTAR<sup>®</sup> also sifted out mortar training rounds and many pieces of debris including concertina wire, barbed wire, engine parts, pieces of railroad track, metal debris and the long grass growing on and buried in the berm. Figure 12 shows the mines recovered by the ROTAR<sup>®</sup>.

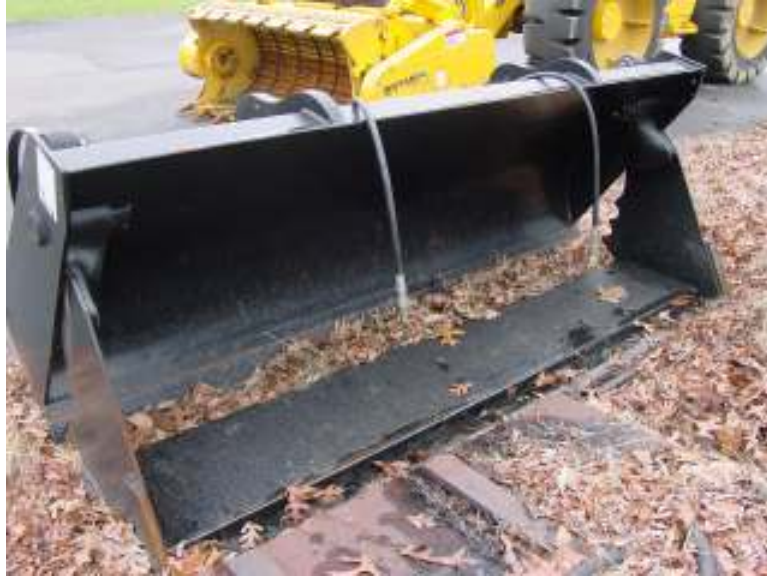
**Figure 15. The 6-in-1 Bucket**

The time required to remove the ROTAR<sup>®</sup> and install the 6-in-1 bucket was 10 min. After the sifted dirt was spread, the bucket was removed, and the ROTAR<sup>®</sup> was installed.

Again, the time lapse was 10 min. The change-out process was facilitated by having someone on the ground to guide the backhoe operator (whose vision was blocked by the steel blast shield on the lifting arms) in lining up the attachment points on the bucket or ROTAR<sup>®</sup> and the ends of the lifting arms.

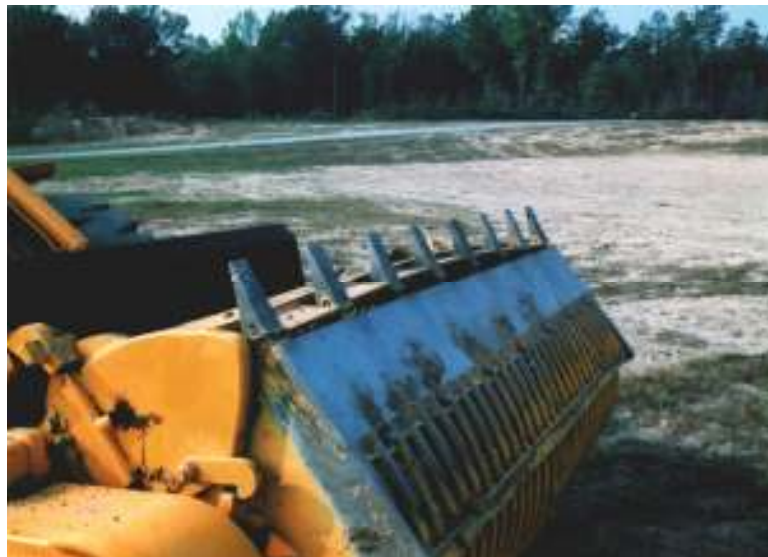
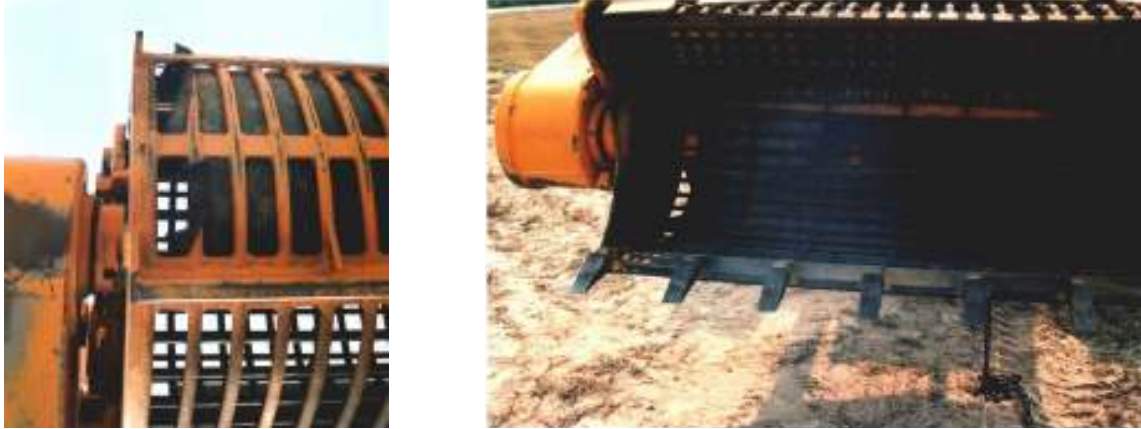
Six blast tests were conducted against the ROTAR<sup>®</sup>. The sizes of the explosive charges used were ¼-, ½-, and 1-lb blocks of TNT. Two blast tests were conducted for each size explosive: one with the ROTAR<sup>®</sup> barrel half filled with dirt (in which the explosive was buried) and the other with no dirt in the barrel (the explosive was suspended on the axis of rotation). In all cases, the explosive was remotely detonated. For the 1-lb explosive test, the test in the half-filled barrel resulted in damage to the barrel's steel liner at the midpoint of its

length. Therefore, when the explosive test was conducted without dirt in the barrel, the explosive was suspended on the axis of rotation, at a point one-fourth the length of the barrel from the right side of the barrel. Table 8 presents the results of the explosive test in the ROTAR<sup>®</sup>. Some of the blast damage to the steel liner caused pieces of the steel liner to be pushed through the mesh of the reinforcing bars of the barrel. The protruding steel liner had to be beaten almost flush with the barrel bars to eliminate interference with the ROTAR<sup>®</sup> frame. Figure 16 is a picture of the bowing distortion to the ROTAR<sup>®</sup> barrel from the 1-lb block of TNT in Test 6. Figure 17 shows the damage to the steel liner from this series of tests.

**Figure 16. Blast Distortion (Bowing) to ROTAR<sup>®</sup>**

**Figure 17. Blast Test Damage to Steel Liner**

Blast tests were conducted using ¼-, ½-, and 1-lb (113, 227, 454 gm) charges of TNT against the ROTAR<sup>®</sup> both half full and empty of dirt. *After each blast test, regardless of the size of explosive charge used, the ROTAR<sup>®</sup> was fully functional and operable.* However, some damage was sustained. With dirt in the ROTAR<sup>®</sup>, no damage was caused by the ¼- and ½-lb (113 and 227 grams) charges of TNT. The 1-lb charge of TNT, when detonated with dirt in the ROTAR<sup>®</sup>, caused a hole to be punched through the steel liner and caused slight bowing of the horizontal bars. Without dirt in the ROTAR<sup>®</sup>, damage was caused to the steel liner by each of the TNT charges (¼, ½, and 1 lb), and the bowing of the horizontal bars was noticeable after the 1-lb charge test.

Subsequent to the test, the horizontal bars were straightened and the steel liner was replaced.

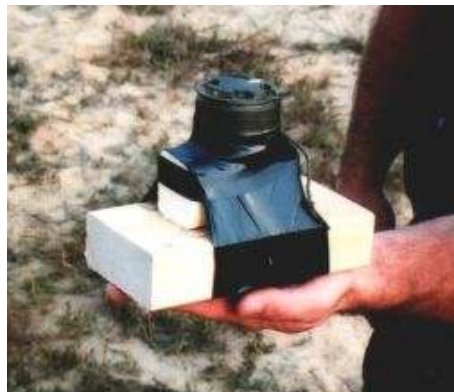
**Figure 18. A 1-lb Explosive Charge**

The blast test against the SETCO tires was designed to investigate two survivability issues. The first issue was to determine the ability of the SETCO tire to withstand repeated AP mine blasts (8 tests) at different points on the tire's diameter from ½-lb blocks of TNT. The second issue was to determine the ability of the SETCO tire to withstand the blast from a large AP mine containing 1 lb of TNT (9<sup>th</sup> test). Figure 18 shows a 1-lb explosive charge.

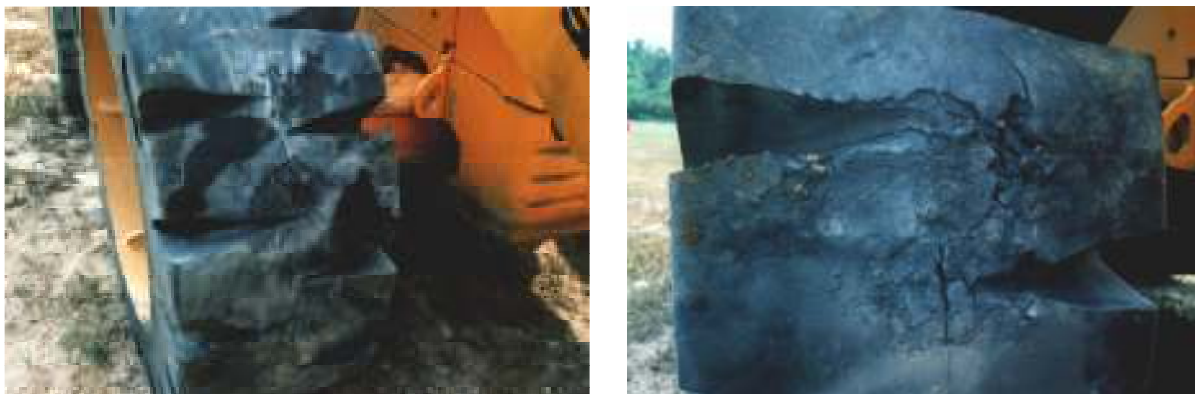
**Figure 19. Tire Damage From ½-lb (left) and 1-lb (right) Mine Charge**

The procedure followed in each test was to bury the block of TNT, to which a small AP mine had been taped to act as a fuse for the TNT. The mine and TNT were buried flush with the surface in front of the front right wheel of the Improved Backhoe vehicle. The soil in the test area was a dry sand-clay mixture. The Improved Backhoe was then pulled forward by another vehicle until the right front wheel rolled onto the AP/TNT mine causing a detonation. In all 8 tests with the ½-lb blocks of TNT, the damage to the tire was similar. The blast charred the tire and generally took an oval pattern in the 4–5 in. (102 mm–127 mm) by 6–8 in. (152 mm–203 mm) size range. Gouging of the tire face ranged in depth from 0.75 in. (19 mm) to 1.375 in. (35 mm). The mines were buried so detonation would occur near the center of the tire. Therefore, on almost all 8 tests, there was some splitting of the tire along the center mold seam at the point of the blast (1–2 in. long and 1+in. deep) (25–50 mm long and ~ 25

mm deep). Since the tire does not flex while being driven, there was no progression of the splits during subsequent use. The resultant blast crater was 12–15 in. (305–381 mm) in diameter and 8–12 in. (203–305 mm) deep, depending on the looseness of the soil. Surface scarring caused by blast forces escaping out from under the tire generally scrubbed the earth in a circular pattern out to about 44 in. (1,118 mm). Figure 19 shows the damage from ½-lb and 1-lb mine charges.

The test using the 1-lb block of TNT caused a bit more damage but in no way incapacitated the operation of the Improved Backhoe. The damage to the face of the tire by the blast measured about 6 in. (152 mm) in diameter, with cracks penetrating to a depth of 1.5 in. (38 mm). The blast crater was about 20 in. (508 mm) in diameter and 15 in. (381 mm) deep. The surface scrubbing created a circle of 58 in. (1,473 mm).

A single SETCO tire was subjected to 9 blast tests: 8 blasts of a small AP mine and ½ lb (227 grams) of TNT and 1 blast of an M14 AP mine and a 1 lb (454 grams) of TNT. The ½-lb charge of TNT caused minimal abrasion to the face of the tire. The 1-lb charge of TNT caused only minor blast abrasion. When blasts took place directly under the mold seam of the tire, minor cracks at the seam line were evident. No damage was caused to the metal rim. Given the amount of damage to this tire, we estimate that this tire could withstand upwards of 100 blast occurrences before having to be replaced.

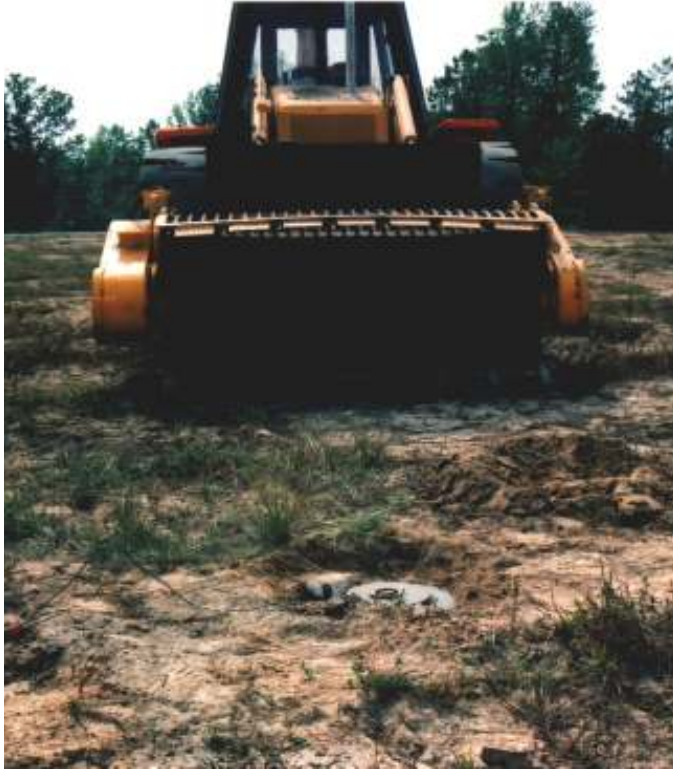
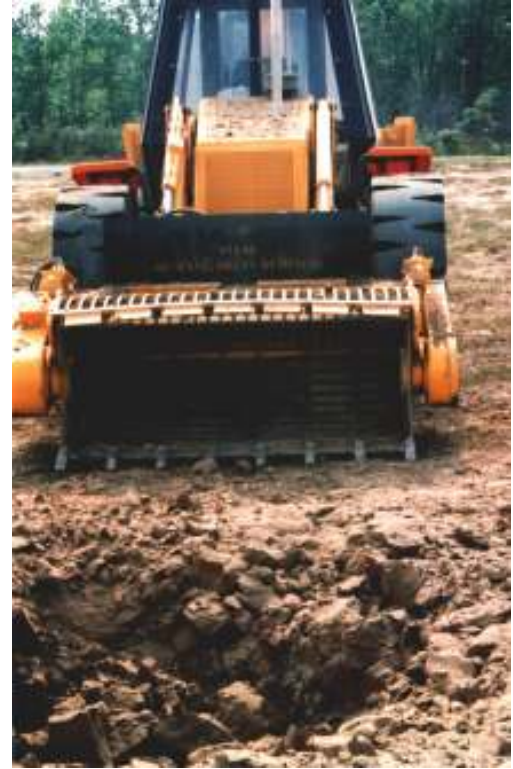
The Improved Backhoe was subjected to the blast affects of a 10 kg AT mine buried at a depth of 5 cm, at a distance of 3 m in front of the ROTAR<sup>®</sup> when the ROTAR<sup>®</sup> was in a normal, retracted position. For the test, the ROTAR<sup>®</sup> was lifted 8 cm off the ground. The purpose was to determine what damage might be caused by mine shrapnel and blast debris from an AT mine detonated within the working radius of the ROTAR<sup>®</sup>. The result was no visible damage to any part of the vehicle. Figure 20 shows the Improved Backhoe before AT mine detonation, and Figure 21 shows the Improved Backhoe after AT mine detonation.

**Figure 20. Improved Backhoe Before AT Mine Detonation**

**Figure 21. Improved Backhoe After AT Mine Detonation**

There was no noticeable degradation to the performance of the backhoe because of the additional weight from armoring the chassis and using the heavier SETCO tires. During blast tests on the ROTAR<sup>®</sup> and the SETCO tire, parts of the vehicle not subjected to the blast tests did not sustain any damage. The one blast test against the chassis (an AT mine set off in front of the vehicle) did not damage the backhoe.
