Journal of Conventional Weapons Destruction

Volume 8
Issue 2 *The Journal of Mine Action*

U.S. Humanitarian Demining Research and Development Program Provides "REACH-IN" Technology

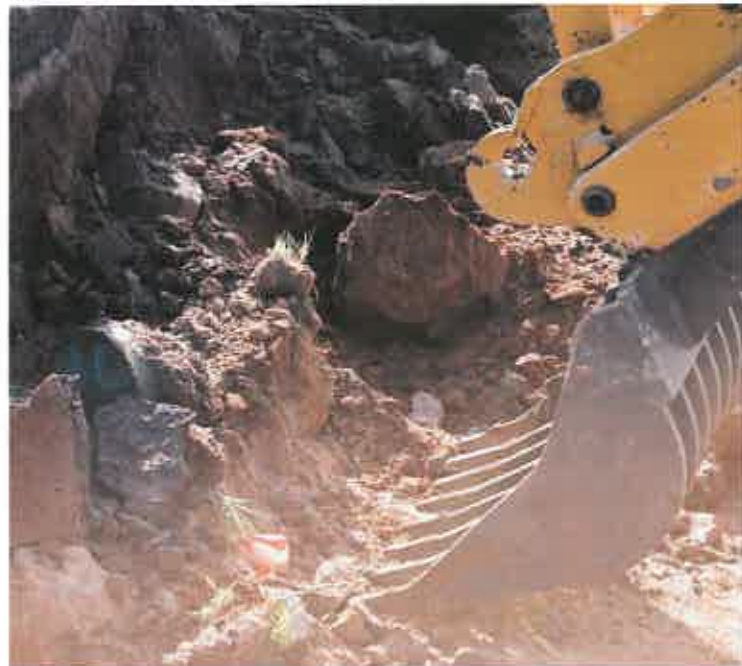
Wall collapses revealing AT mine.

The approach developed to meet the challenge at Las Canoas is a two-step mechanical process that is designed to advance an excavated trench face across a mined area and leave cleared ground in its wake. The process is based from a mine-protected excavator equipped with a standard bucket and four special-purpose tools. Clearance begins from a trench dug outside of the boundary of the minefield. The excavator "reaches in" to the hazardous areas from the safe side of the trench. One of the two special-purpose excavating tools is used to "rake" the vertical wall on the contaminated side of the trench. The objective of this step is to expose AT mines in the face of the wall and gently collapse the wall.

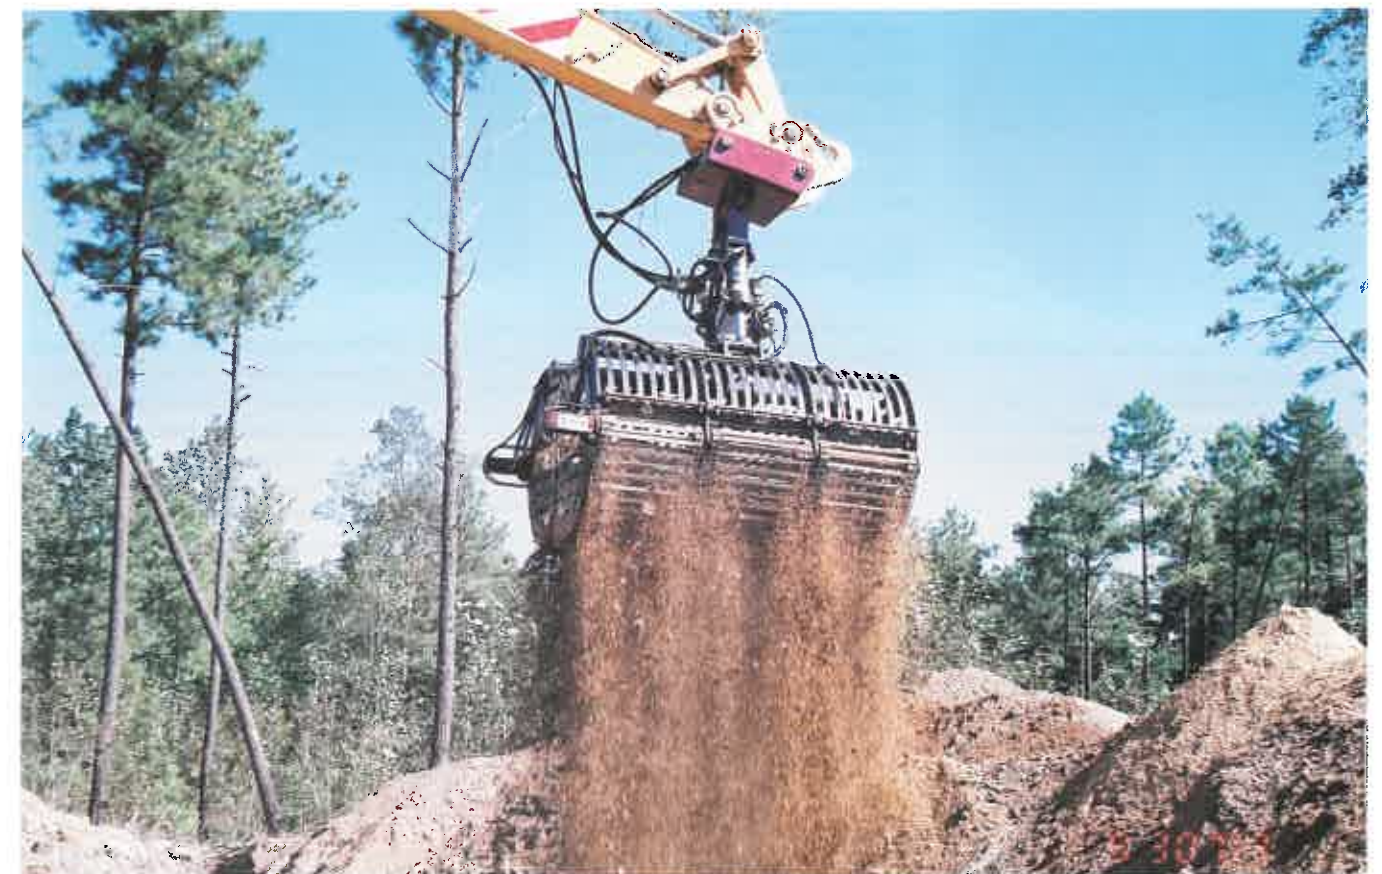
Sifting/Backfilling trench.

Large mines exposed from this initial raking are destroyed in situ. The excavator works from one end of the trench to the other, excavating into the contaminated wall face between 40 and 60 centimeters with each pass. When sufficient spoils have accumulated at the base of the contaminated wall, the raking tool is exchanged for one of two special-purpose sifting tools. The loosened spoils on the mined side of the trench, which have already been scoured visually for large mines, are lifted in the sifter. The sifting occurs over

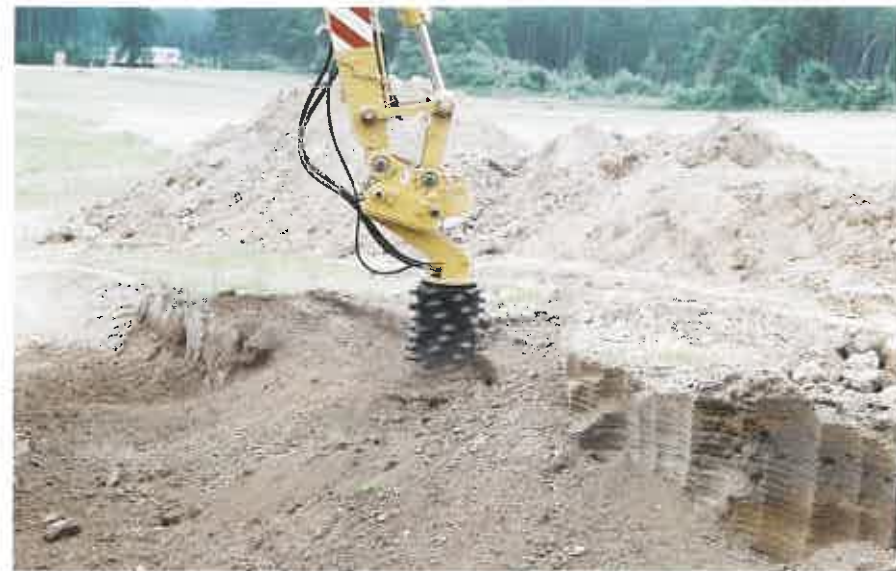
Shaving contaminated wall with vertical mill.

In addition to the standard quick-release digging bucket, four special purpose tools are fitted for use with the Sifting Excavator. The vaned bucket is used for picking and raking at the base of the contaminated wall in order to collapse the bank and expose AT mines. In addition there is a "vertical mill" for shaving the bank with a horizontal milling action. The vertical mill is intended as an alternative to the vaned bucket for use in heavily rooted soils, hard soils (which are resistant to collapse) or locations where precise control of the digging action is required. The first of the sifting tools is the Rotar sifting bucket for scooping up loosened soils and separating soil from mines and other unsiftable debris. The second sifting implement is the Bertani Bucket, originally designed and sold commercially for harvesting beets. Because of a larger volume and more aggressive sifting action, the Bertani is capable of reducing piles faster than the Rotar; however it does not pick up material as cleanly, nor does it have provision for retaining granular materials inside the bucket until the sifting action has begun.

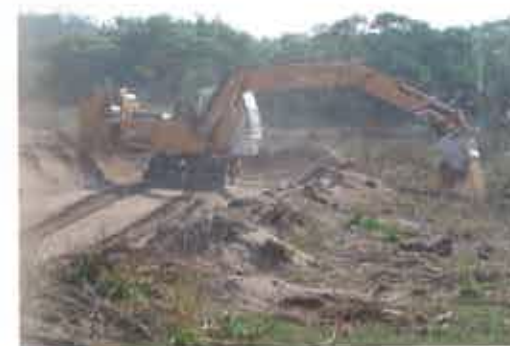
Minefield operations at Las Canoas.
